Biological Assessment

Four bridges on Chuckwalla Valley Road between Interstate 10/Corn Springs Road and Interstate 10/Palen Dunes Drive, Unincorporated Riverside County

Chuckwalla Valley Road Bridge Replacements Project

Replacement of four bridges on Chuckwalla Valley Road between Interstate 10/Corn Springs Road
and Interstate 10/Palen Dunes Drive, Unincorporated Riverside County, California

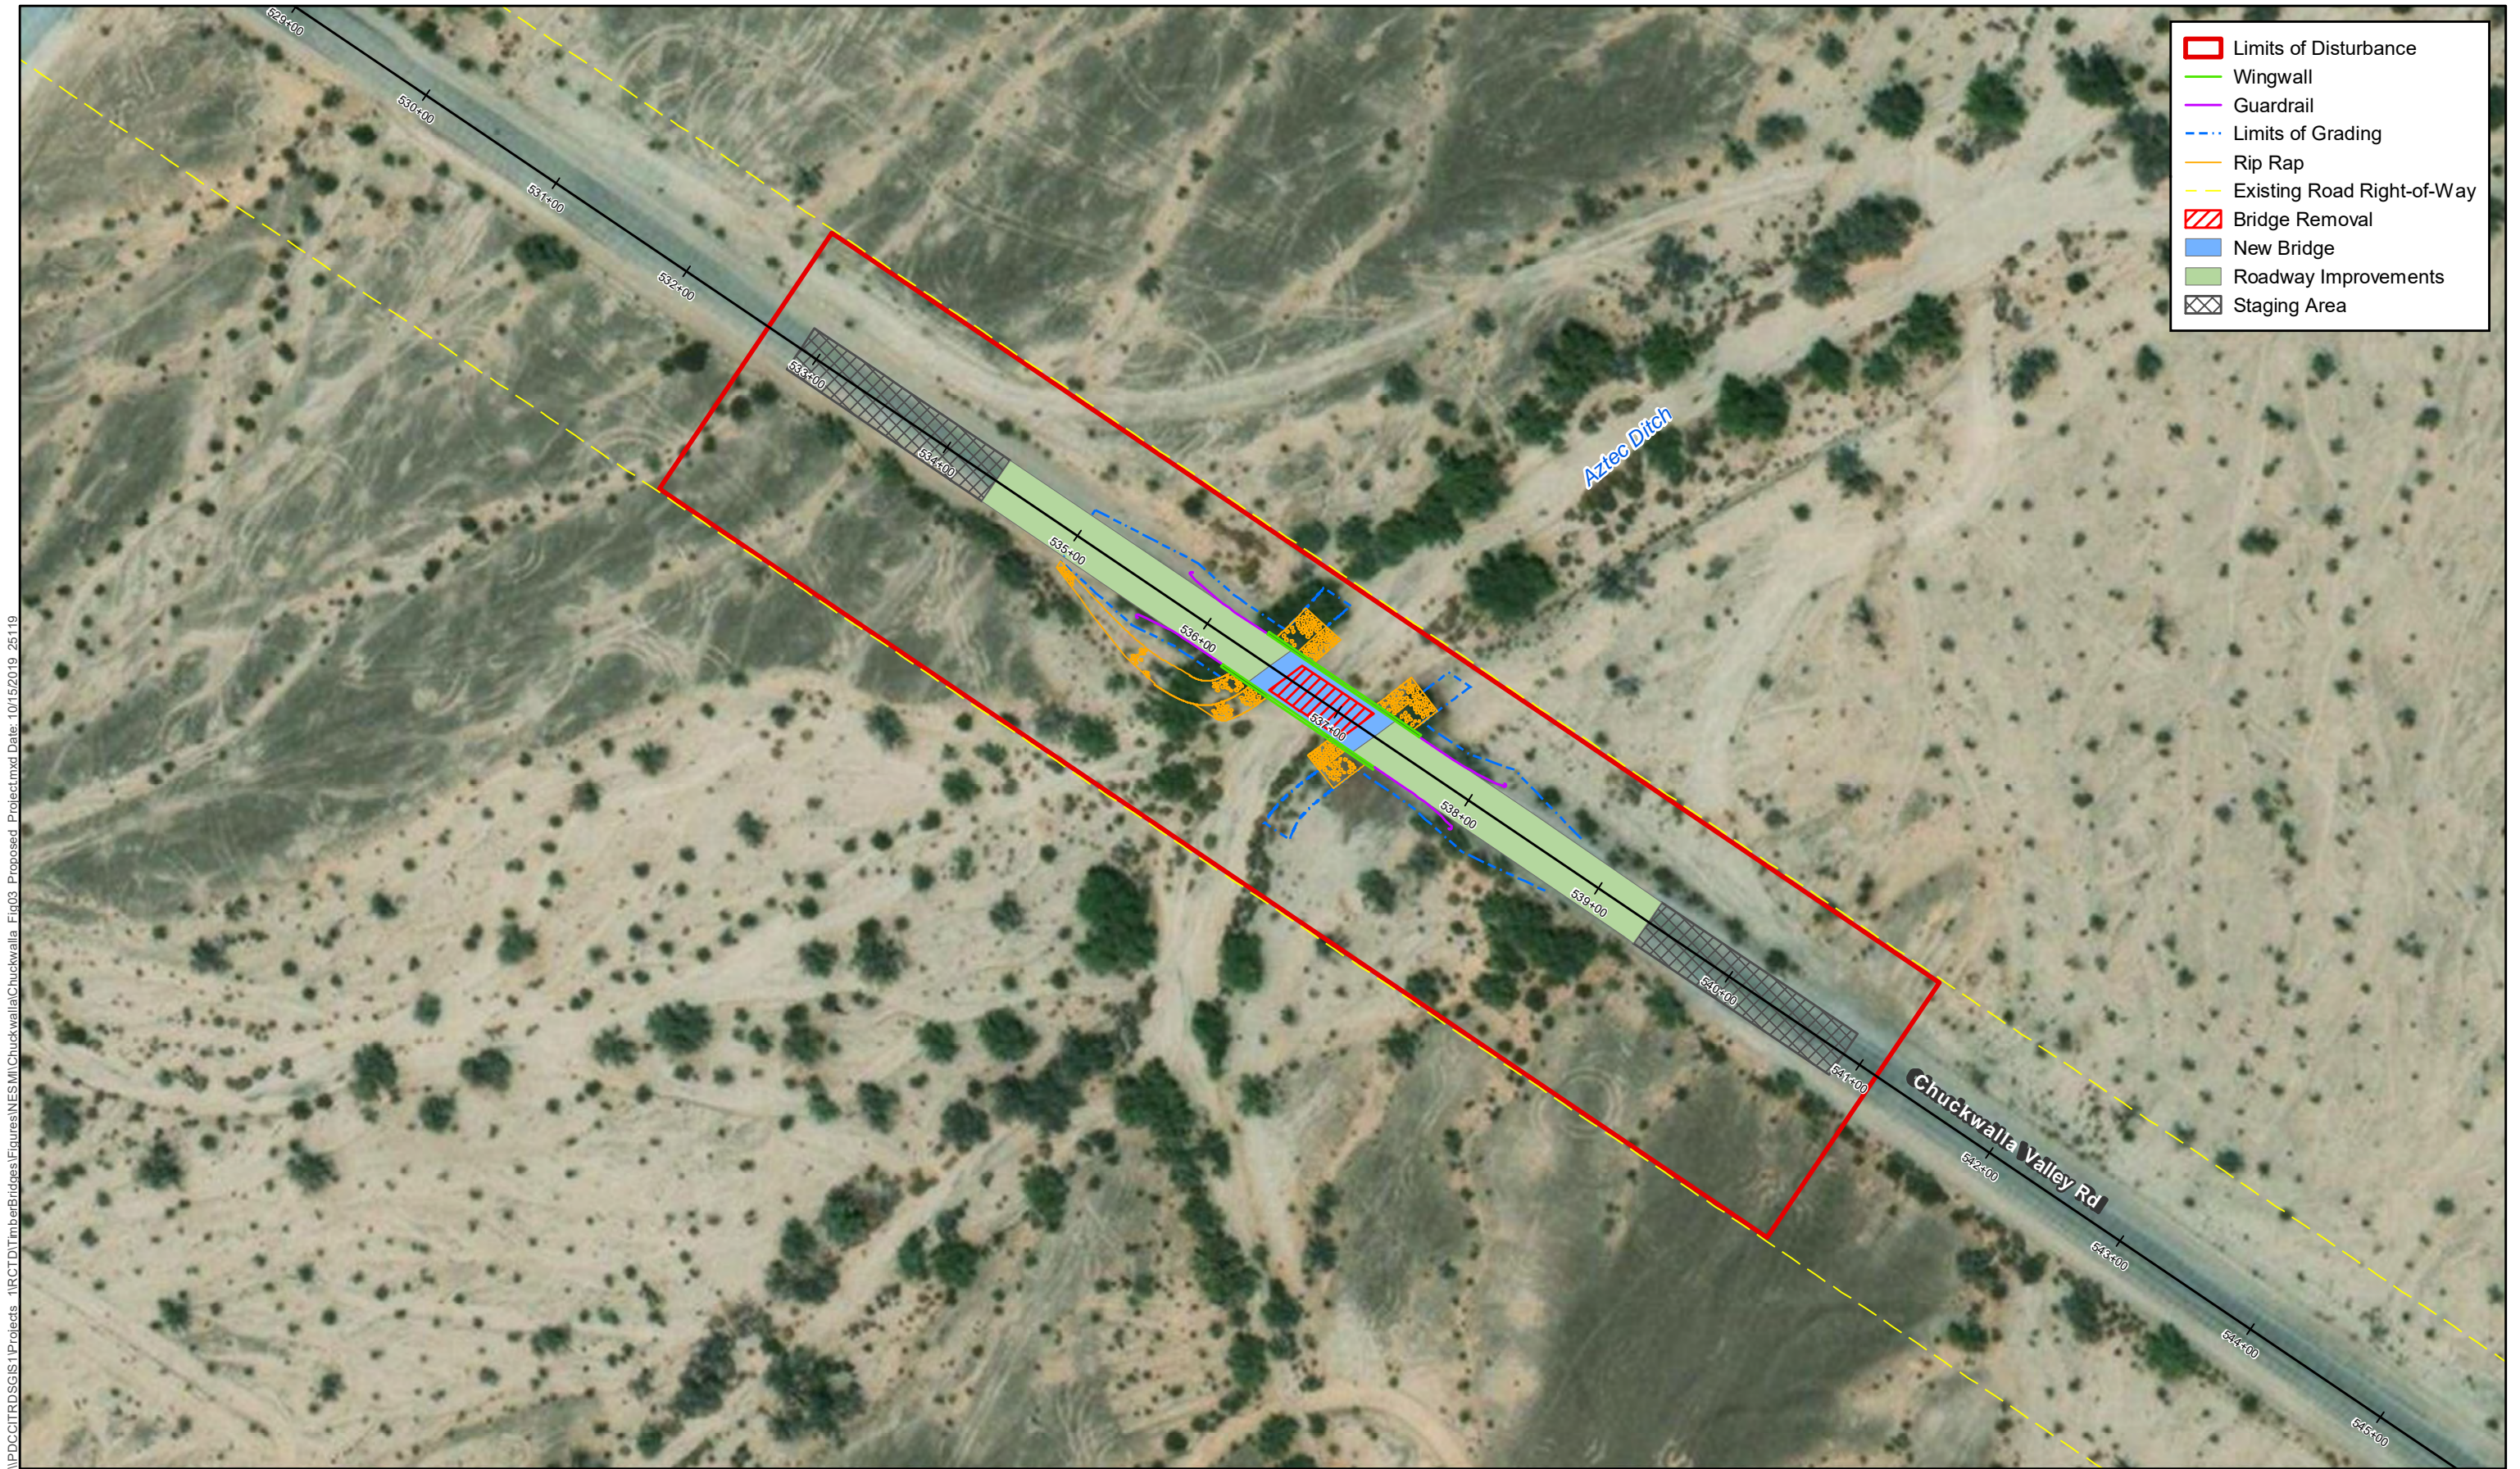
Figure 4 - Sheet 1
Proposed Project Design - Aztec Ditch Bridge (No. 56C0102)
Chuckwalla Valley Road Bridge Replacement

The proposed Project would replace the existing 2-lane timber bridges with new 2-lane modern bridges with a curb-to-curb roadway width of 32 feet at the same locations. Modern traffic barriers/railings meeting current Caltrans safety design standards would also be constructed. The proposed road width would consist of two 12-foot-wide travel lanes, one lane in each direction, and a 4-foot-wide shoulder on each side. Modern traffic barriers/railings meeting current Department safety design standards would be constructed. The proposed bridges would be approximately 60 to 80 feet long, depending on the channel hydraulic capacity and water surface freeboard requirements. Raising the elevation of the bridges is not anticipated. However, if raising the bridge elevation is found to be necessary to meet freeboard requirements, the total vertical increase is not anticipated to exceed 1 foot. Additionally, approach roadway improvements would be provided and channel improvements would be administered to avoid future scour problems. It is envisioned that the channel bottom will remain earthen. Proposed Project design and Project impacts of each bridge are depicted in Appendix A, Figures 4 and 5.

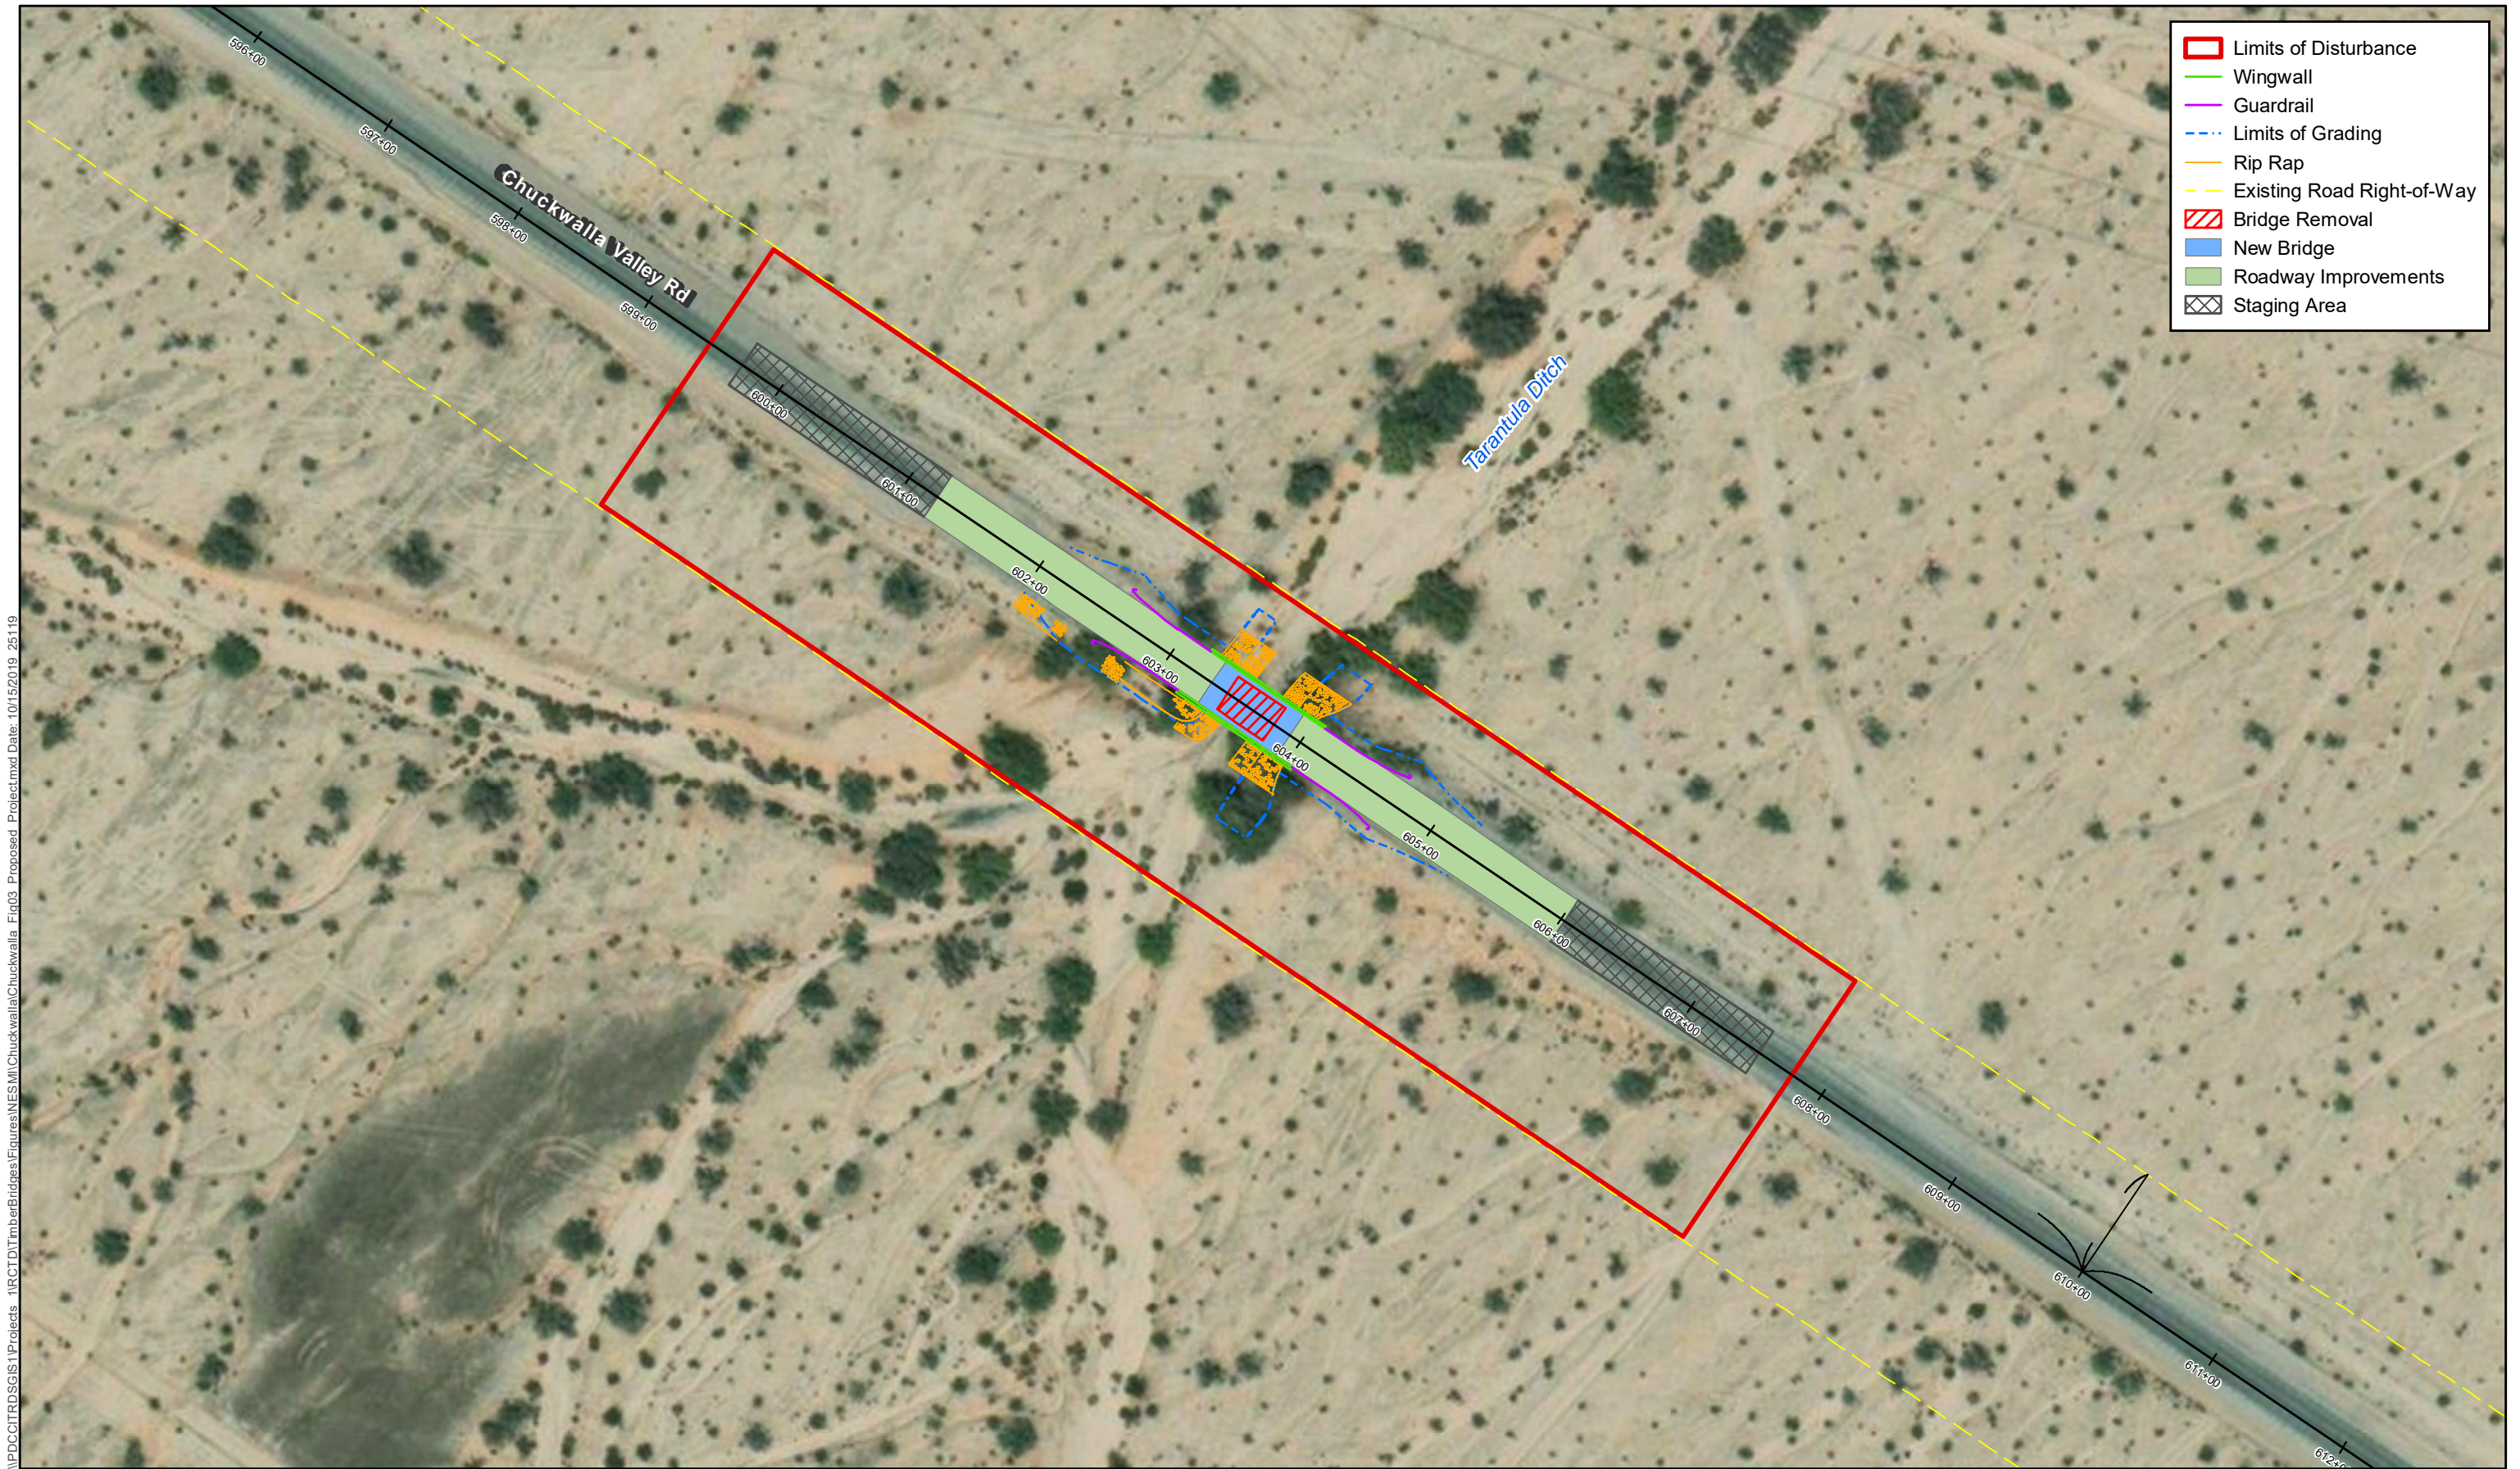
Figure 4 - Sheet 2
Proposed Project Design- Tarantula Ditch Bridge (No. 56C0103)
Chuckwalla Valley Road Bridge Replacement

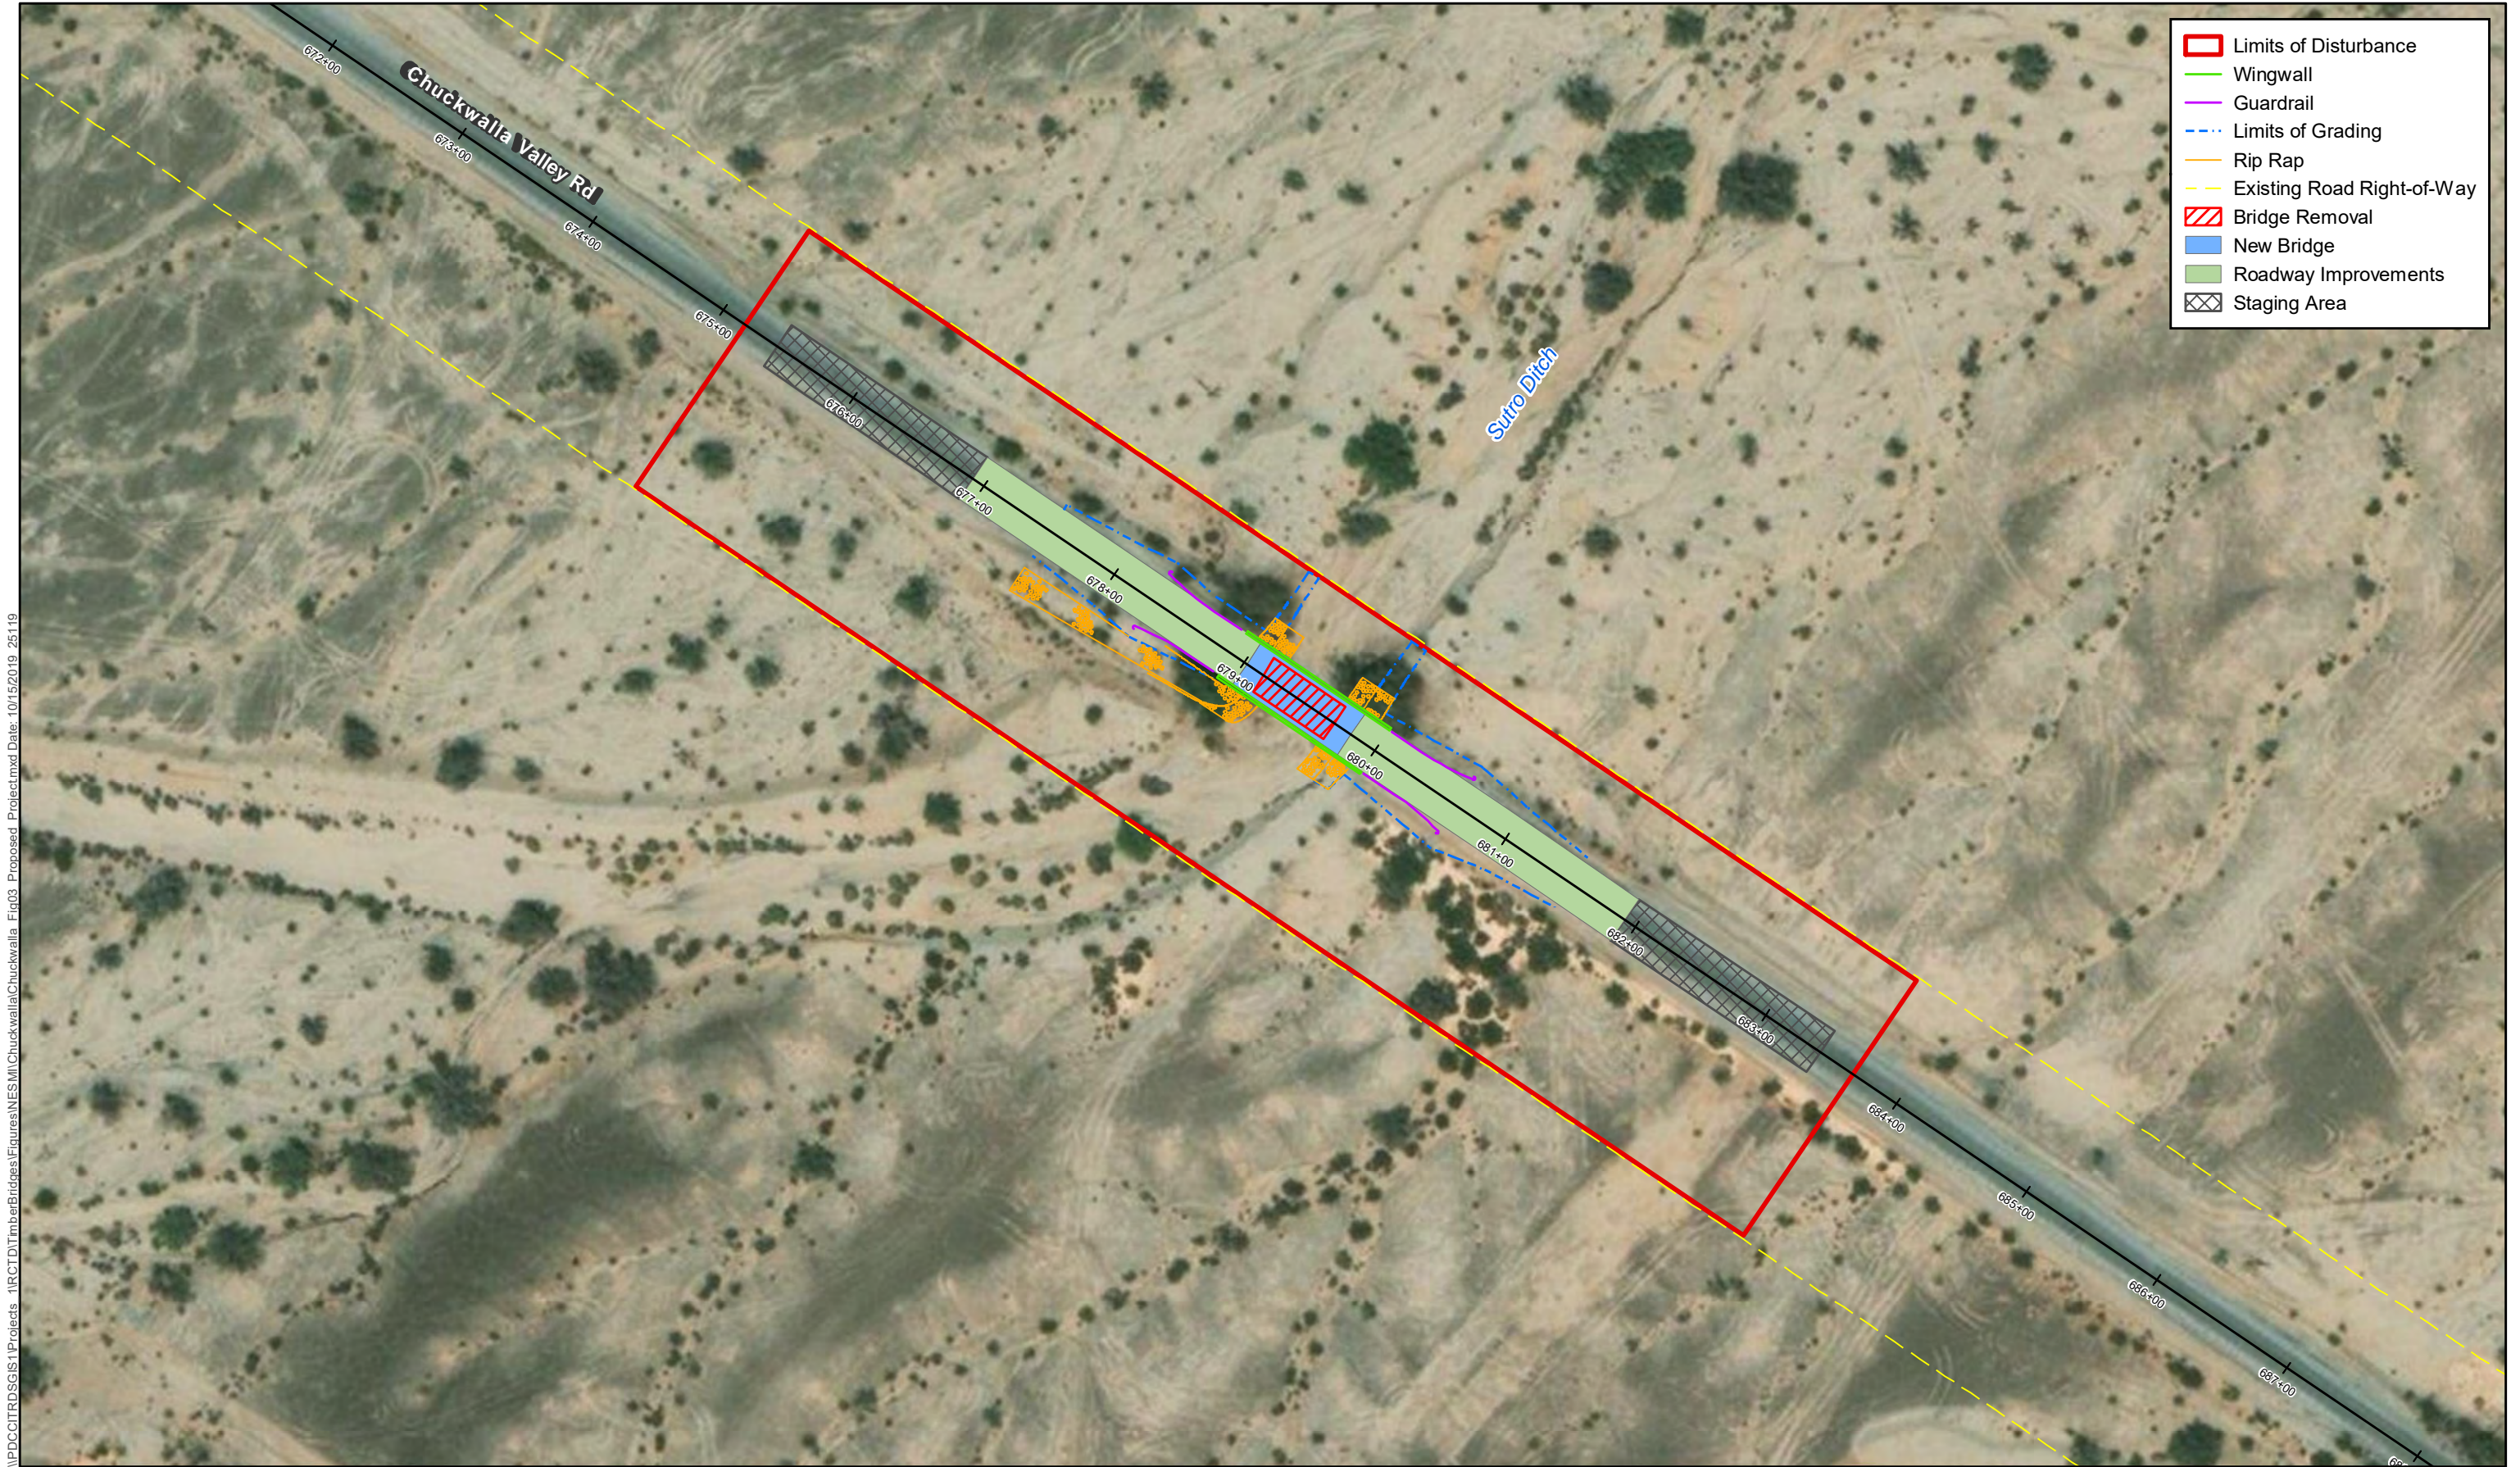
Figure 4 - Sheet 3
Proposed Project Design - Sutro Ditch Bridge (No. 56C0104)
Chuckwalla Valley Road Bridge Replacement

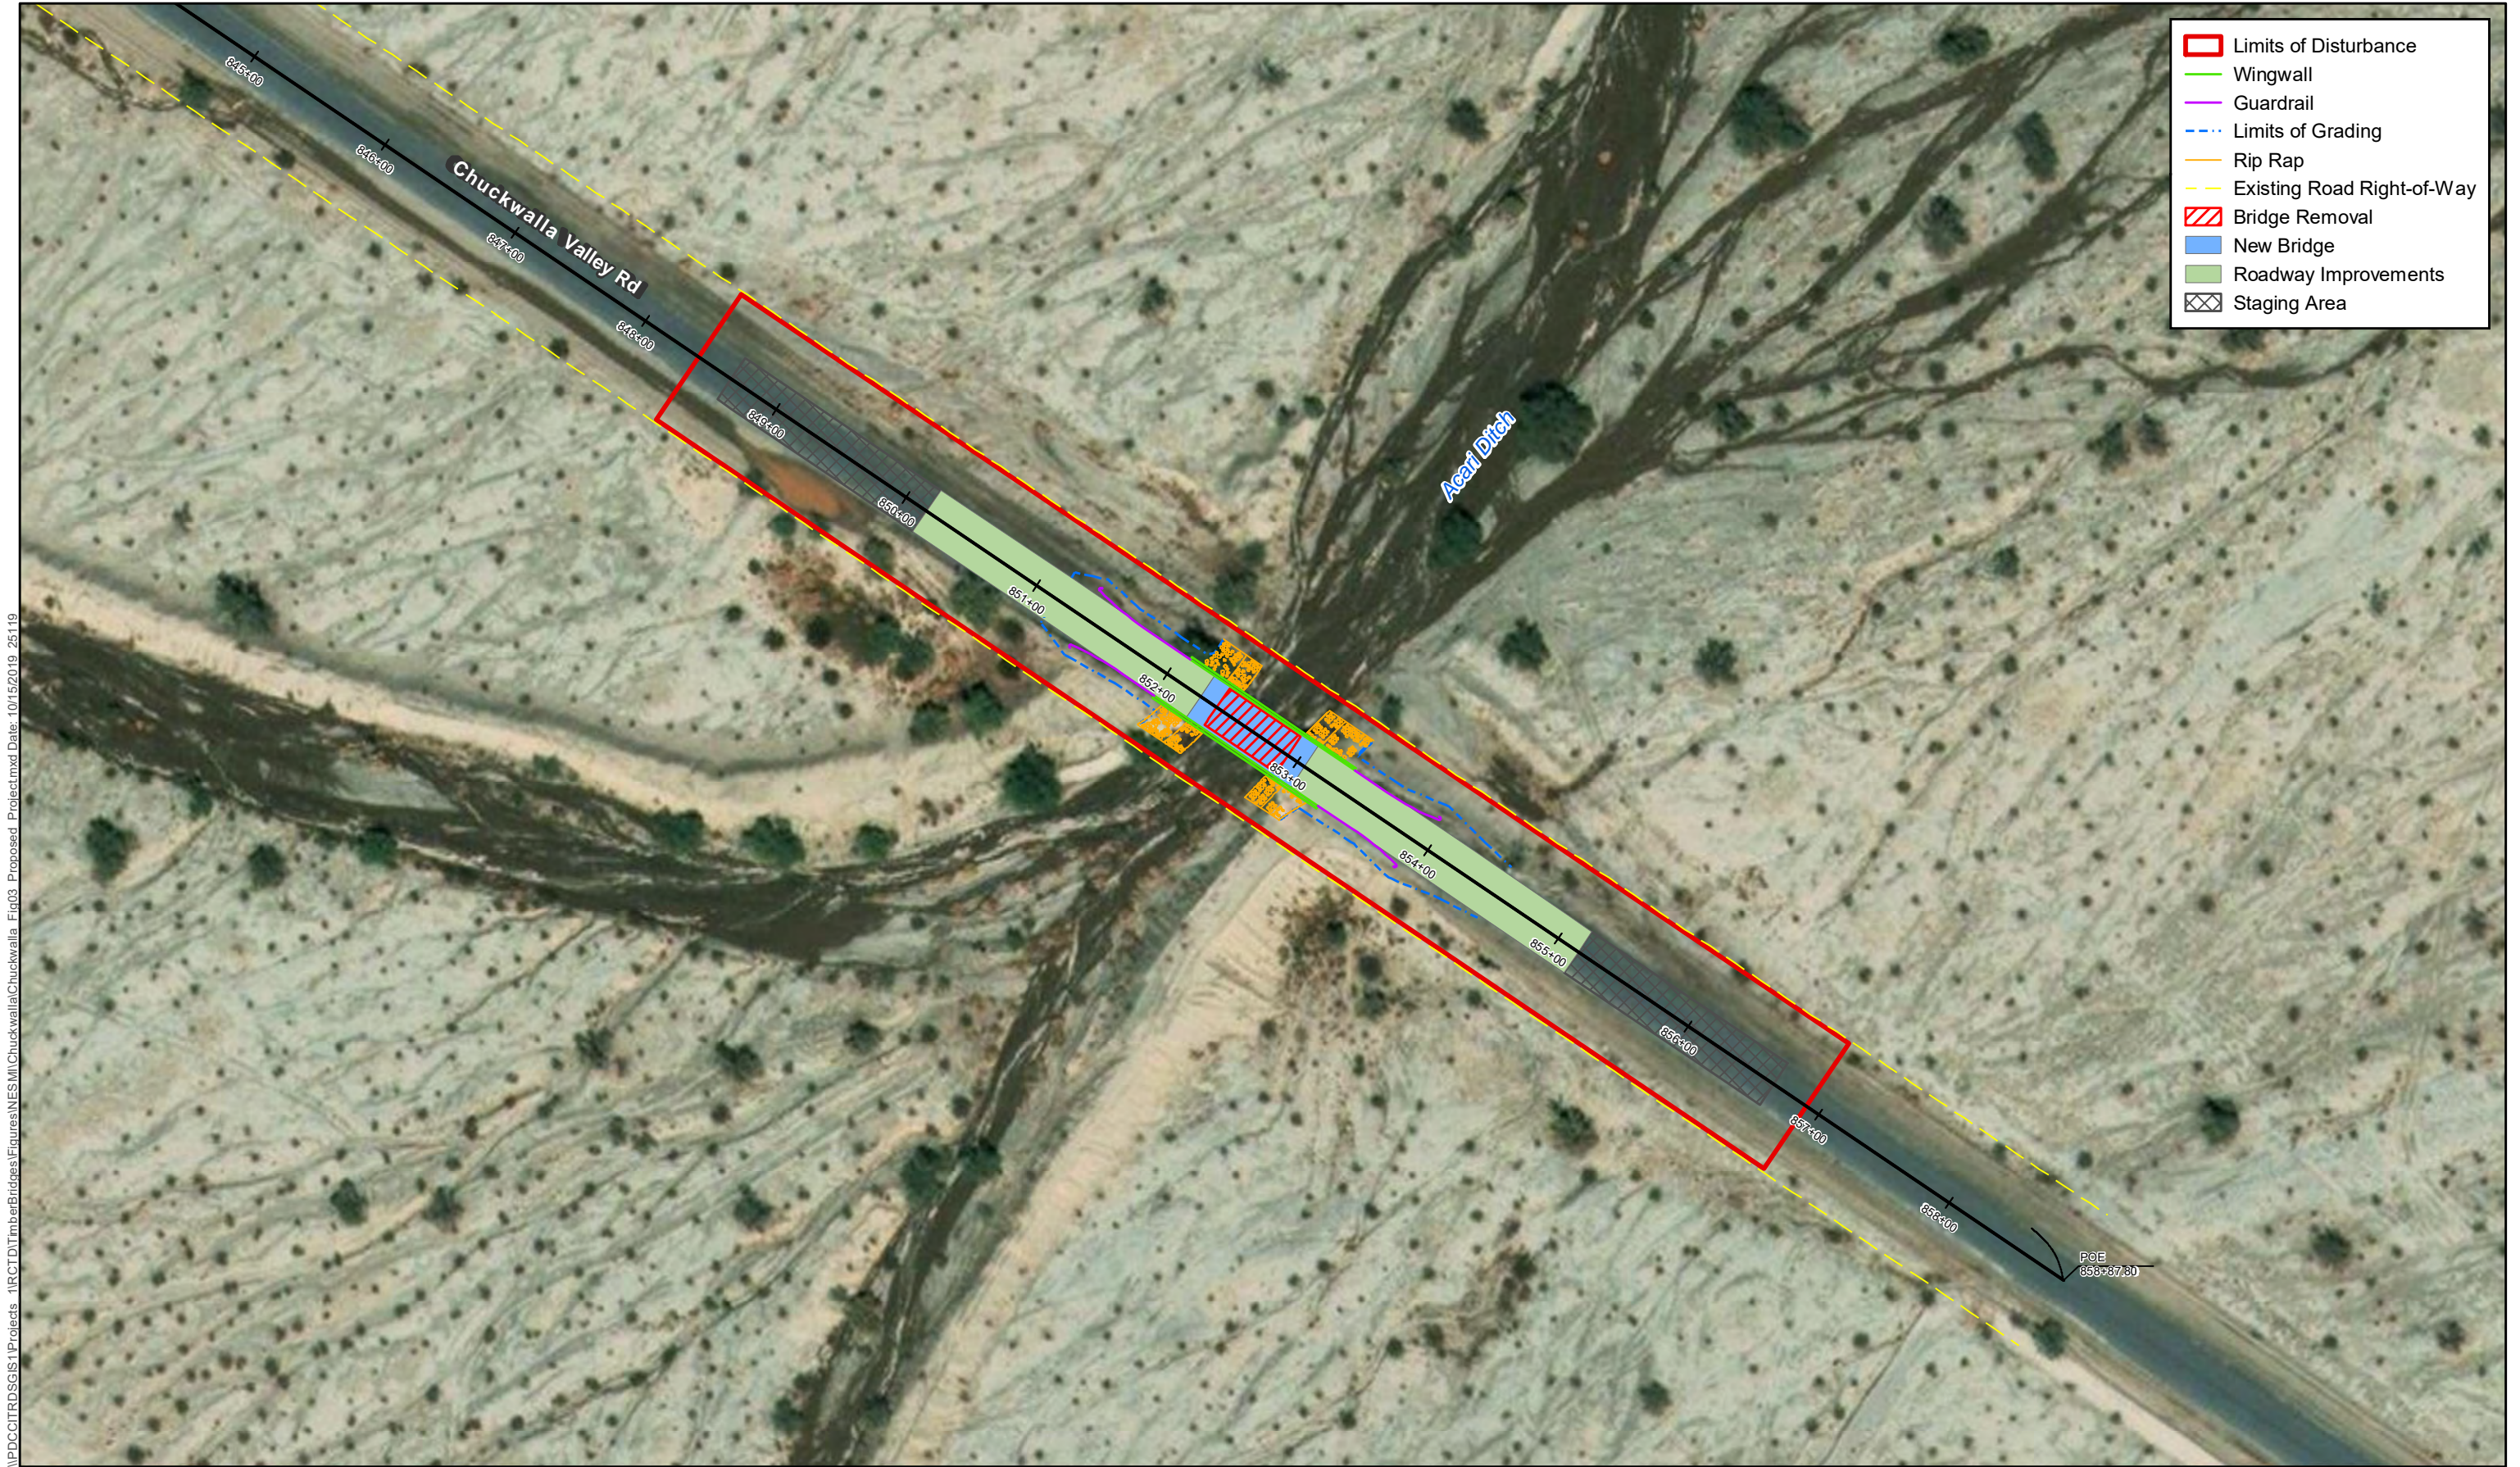
Figure 4 - Sheet 4
Proposed Project Design - Acari Ditch Bridge (No. 56C0108)
Chuckwalla Valley Road Bridge Replacement

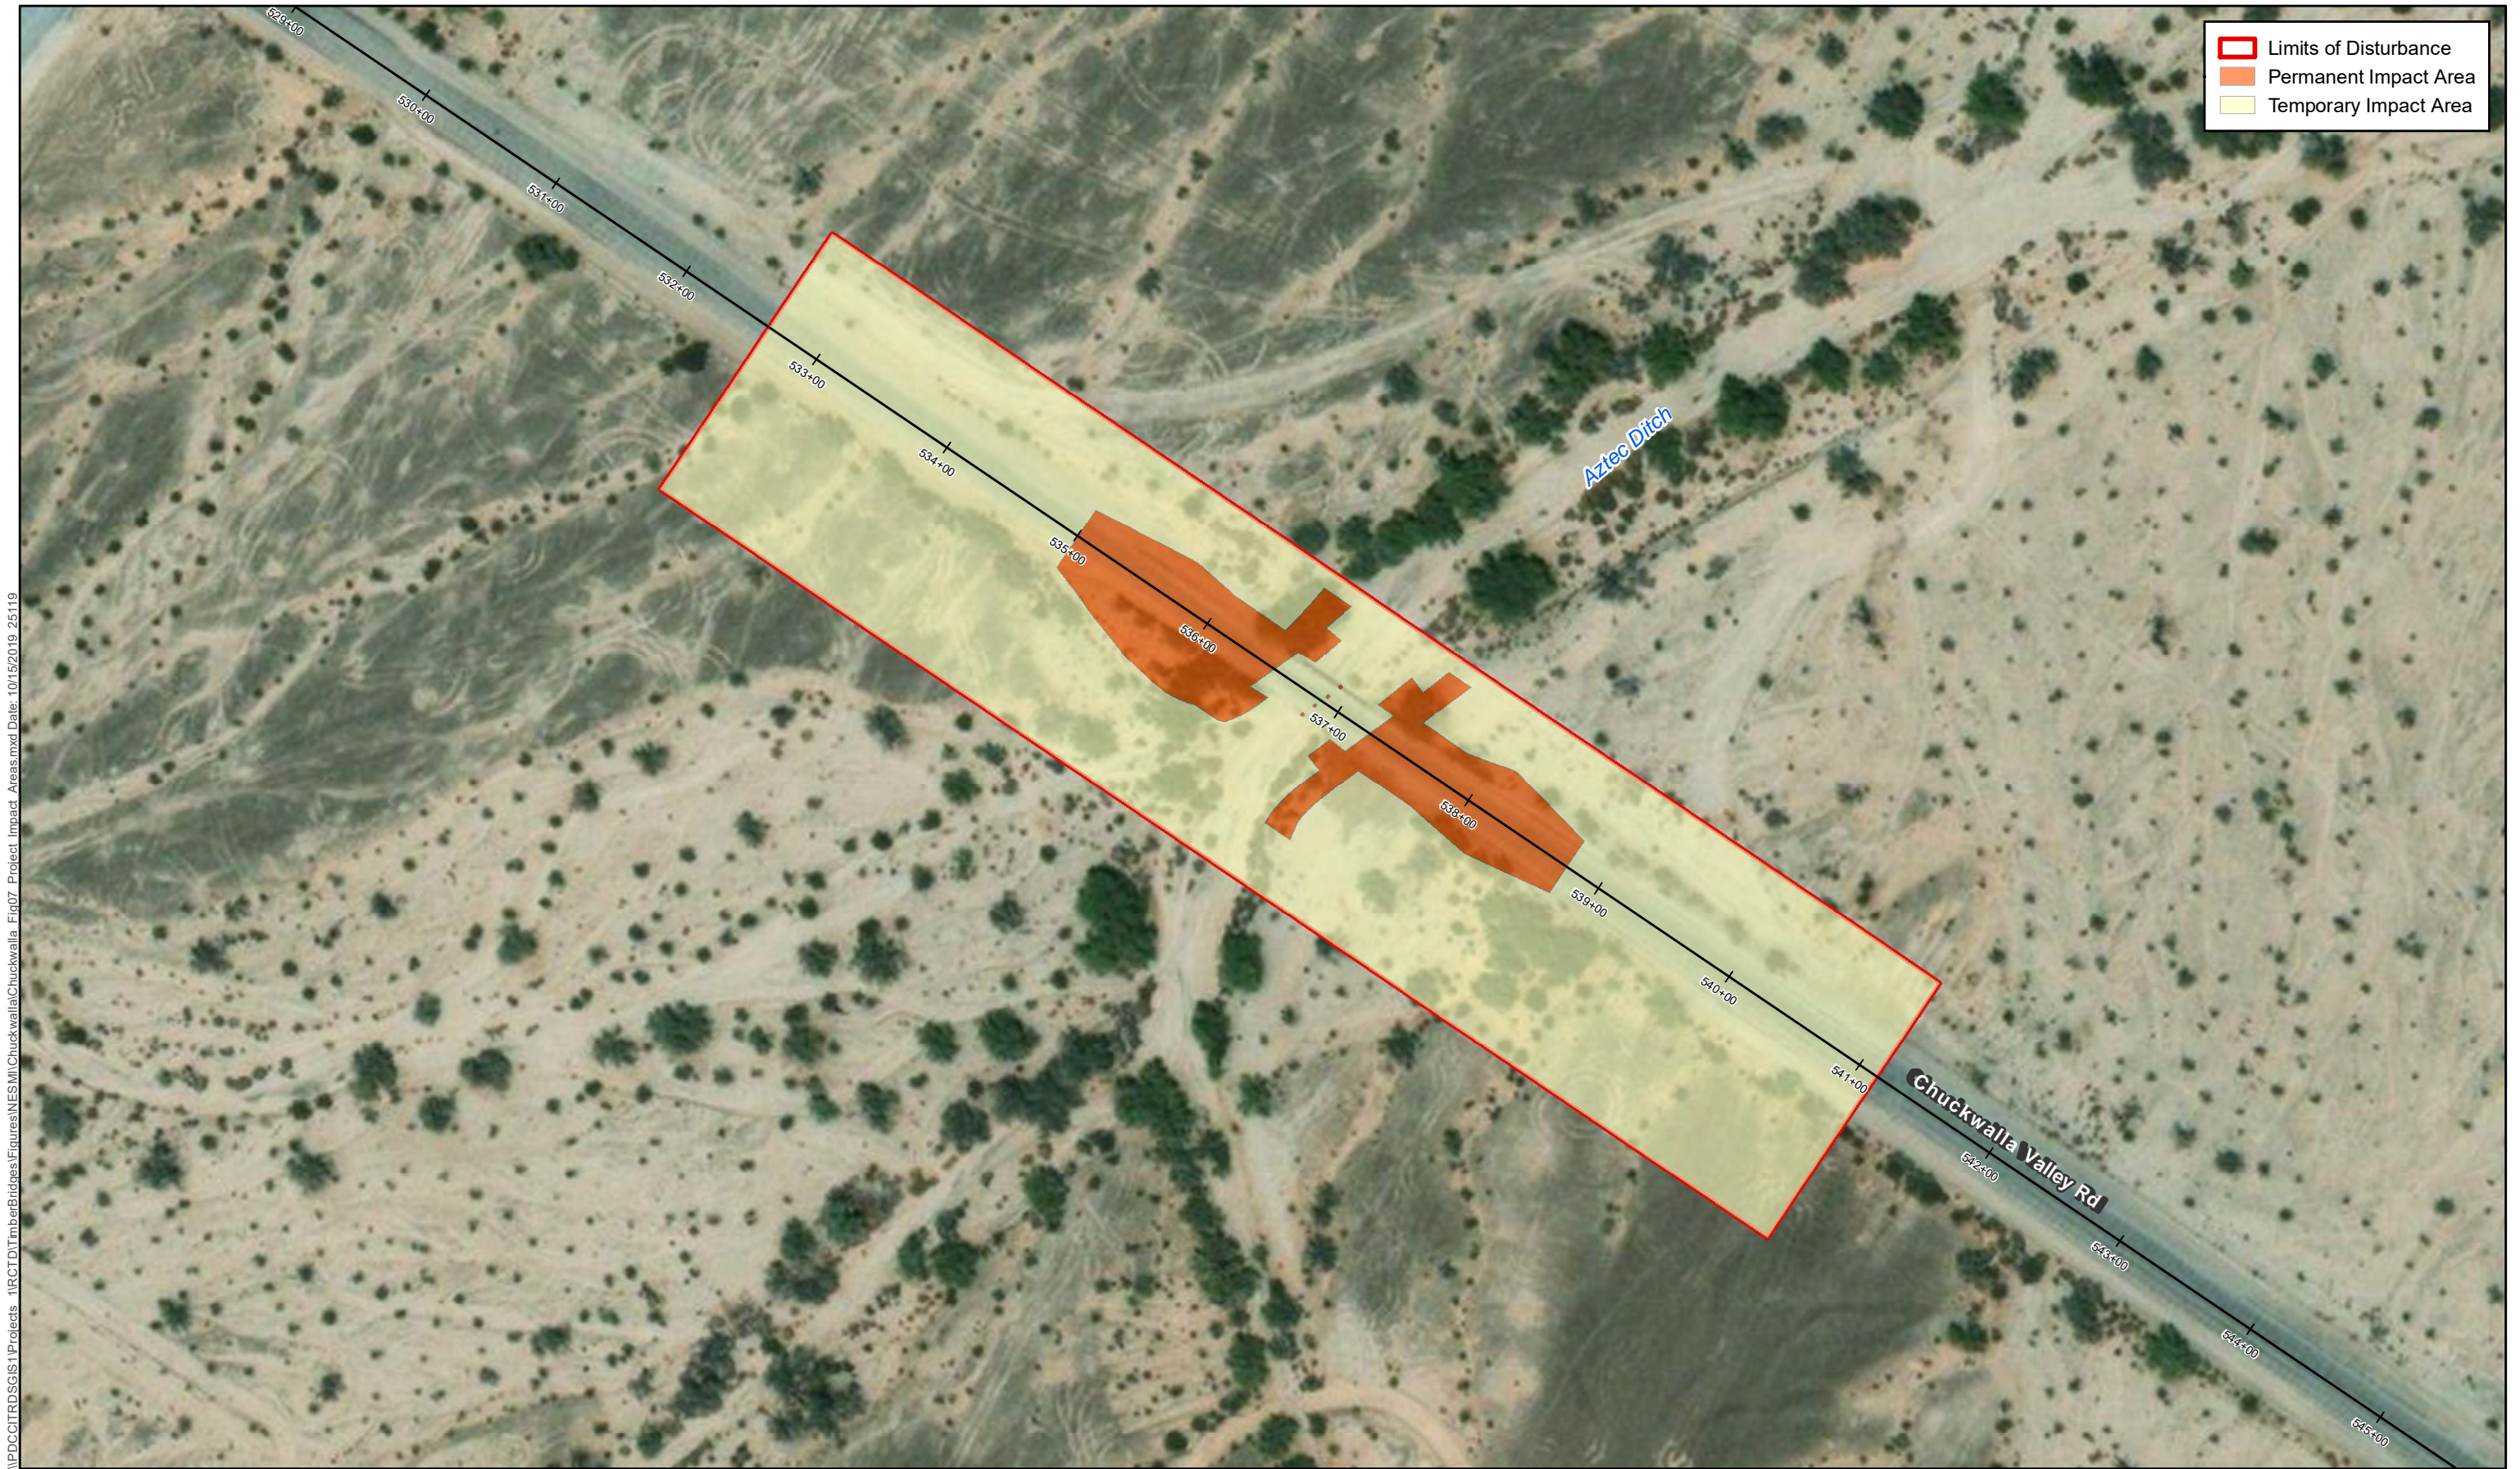
Figure 5 - Sheet 1
Project Impact Areas - Aztec Ditch Bridge (No. 56C0102)
Chuckwalla Valley Road Bridge Replacement
