Biological Assessment

Four bridges on Chuckwalla Valley Road between Interstate 10/Corn Springs Road and Interstate 10/Palen Dunes Drive, Unincorporated Riverside County

Chuckwalla Valley Road Bridge Replacements Project

Replacement of four bridges on Chuckwalla Valley Road between Interstate 10/Corn Springs Road
and Interstate 10/Palen Dunes Drive, Unincorporated Riverside County, California

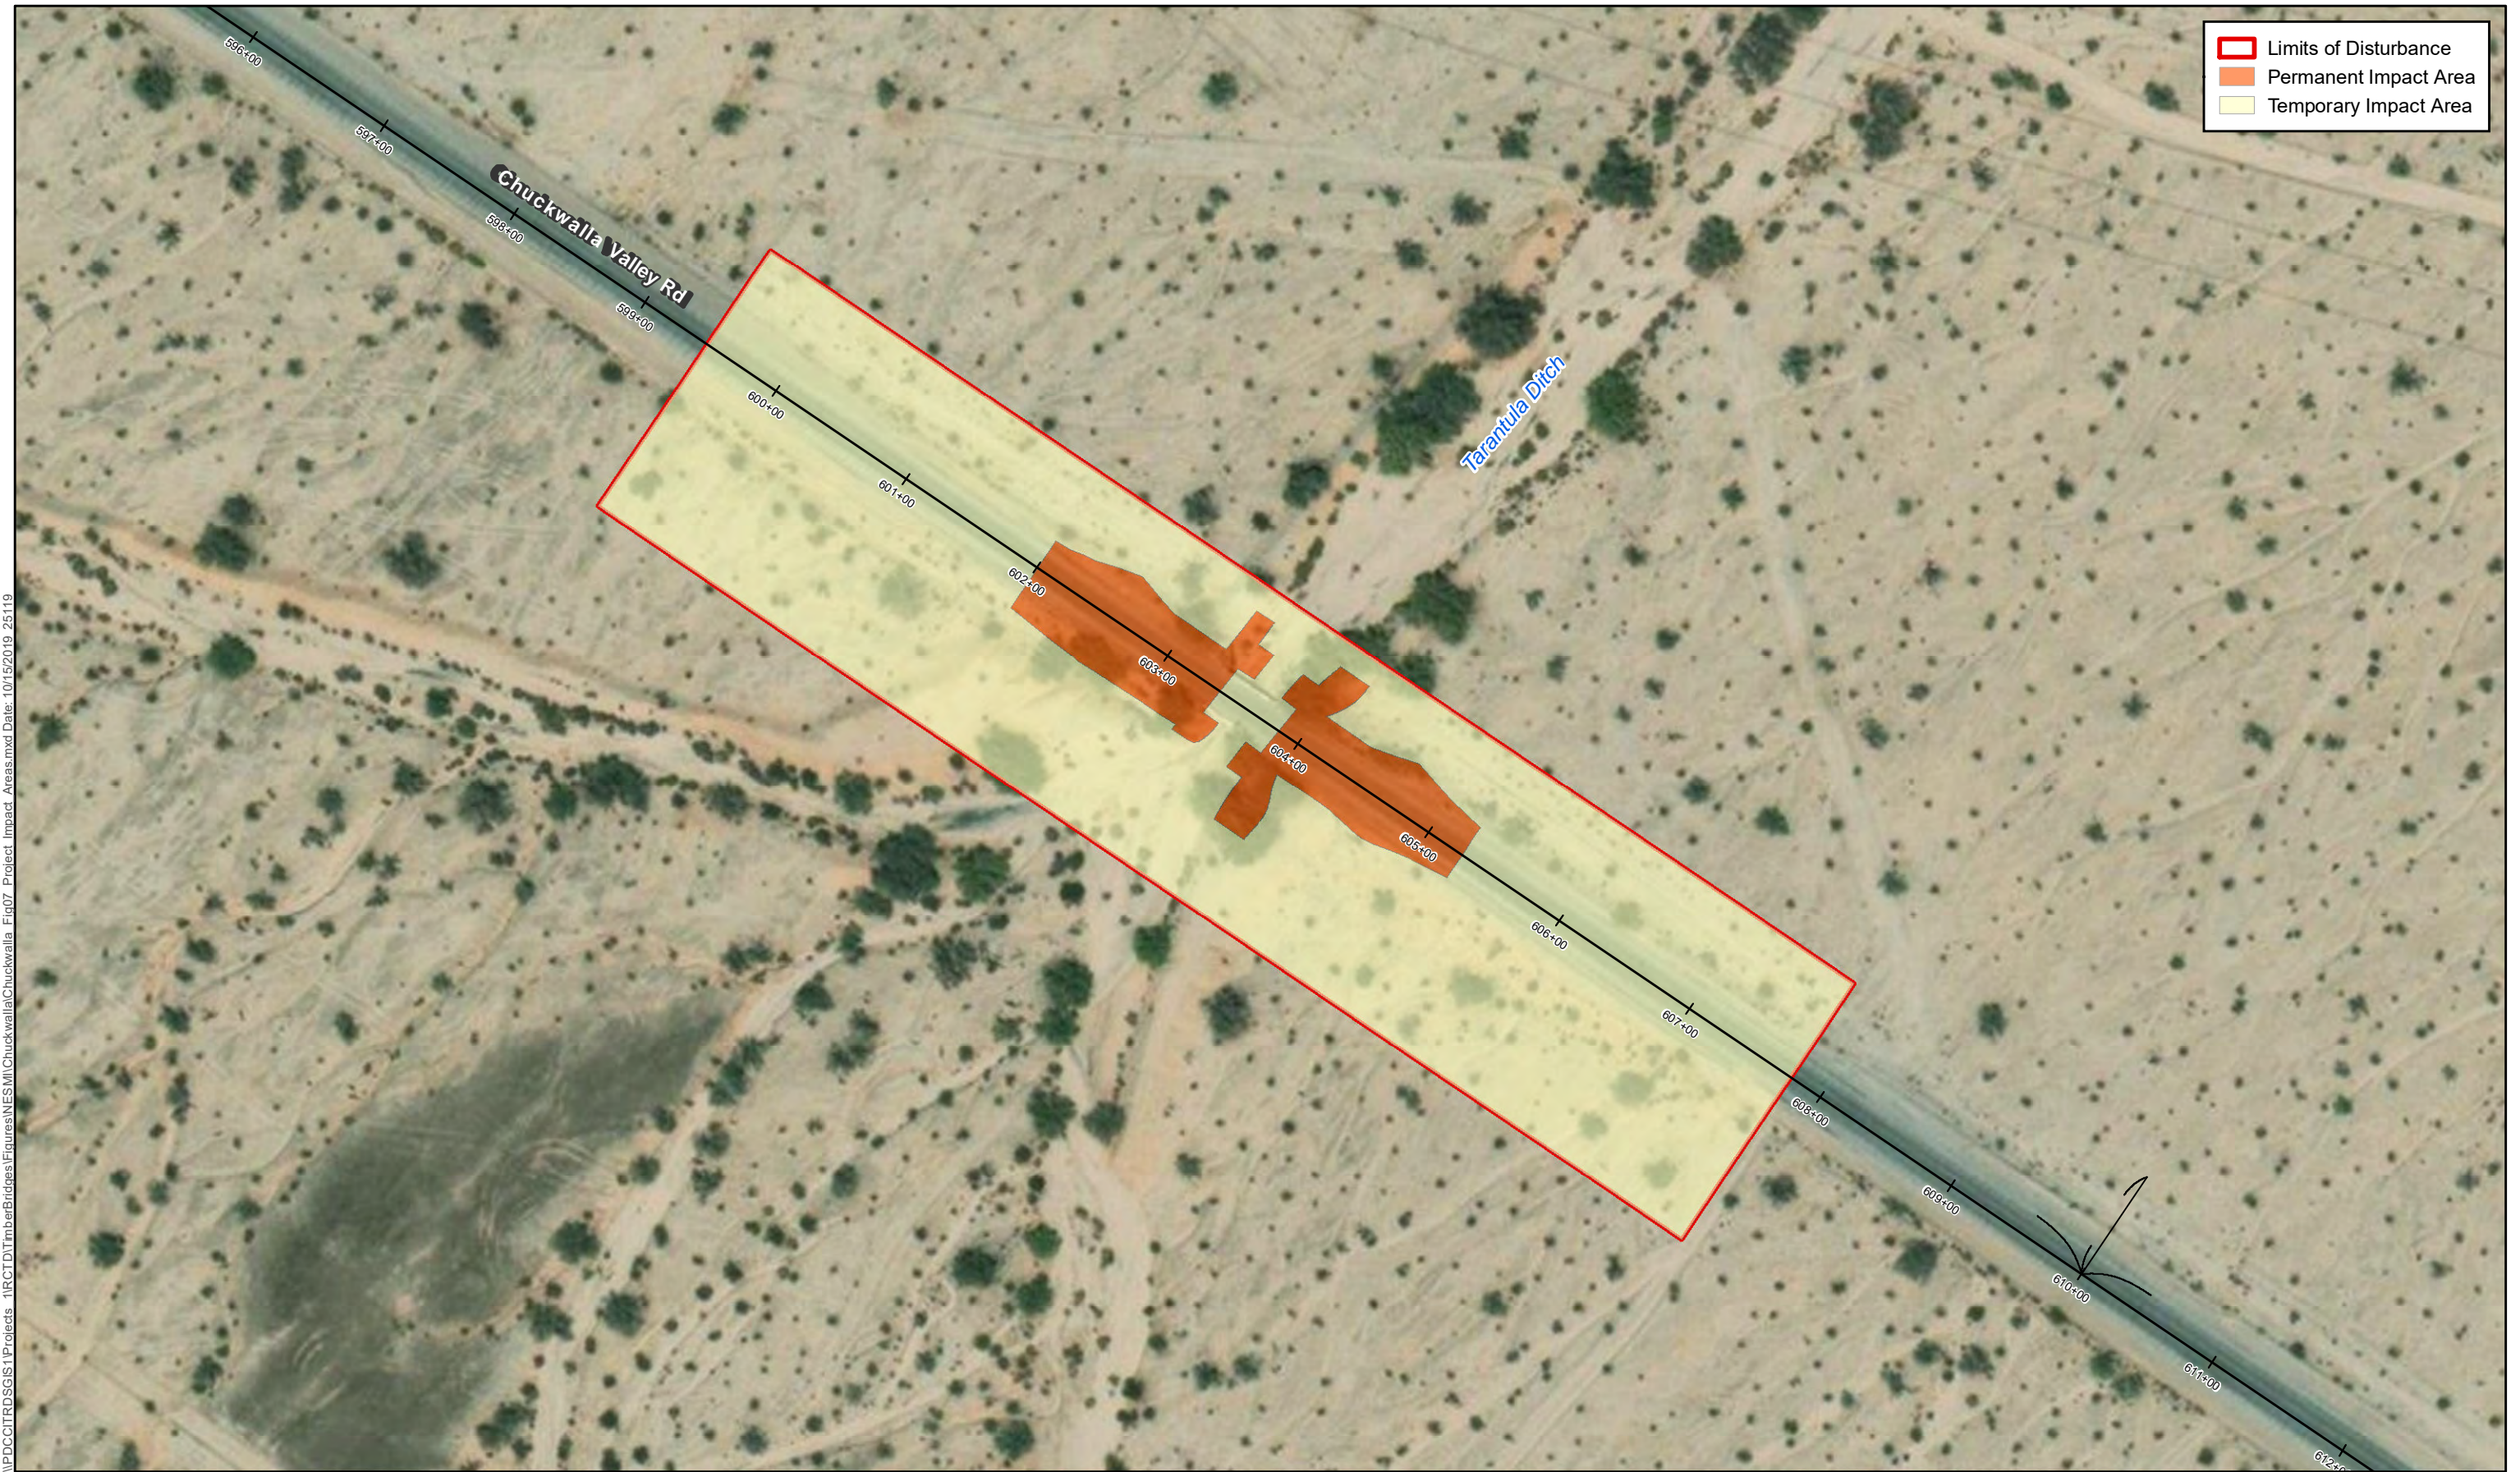
Figure 5 - Sheet 2
Project Impact Areas - Tarantula Ditch Bridge (No. 56C0103)
Chuckwalla Valley Road Bridge Replacement

The proposed Project would replace the existing 2-lane timber bridges with new 2-lane modern bridges with a curb-to-curb roadway width of 32 feet at the same locations. Modern traffic barriers/railings meeting current Caltrans safety design standards would also be constructed. The proposed road width would consist of two 12-foot-wide travel lanes, one lane in each direction, and a 4-foot-wide shoulder on each side. Modern traffic barriers/railings meeting current Department safety design standards would be constructed. The proposed bridges would be approximately 60 to 80 feet long, depending on the channel hydraulic capacity and water surface freeboard requirements. Raising the elevation of the bridges is not anticipated. However, if raising the bridge elevation is found to be necessary to meet freeboard requirements, the total vertical increase is not anticipated to exceed 1 foot. Additionally, approach roadway improvements would be provided and channel improvements would be administered to avoid future scour problems. It is envisioned that the channel bottom will remain earthen. Proposed Project design and Project impacts of each bridge are depicted in Appendix A, Figures 4 and 5.

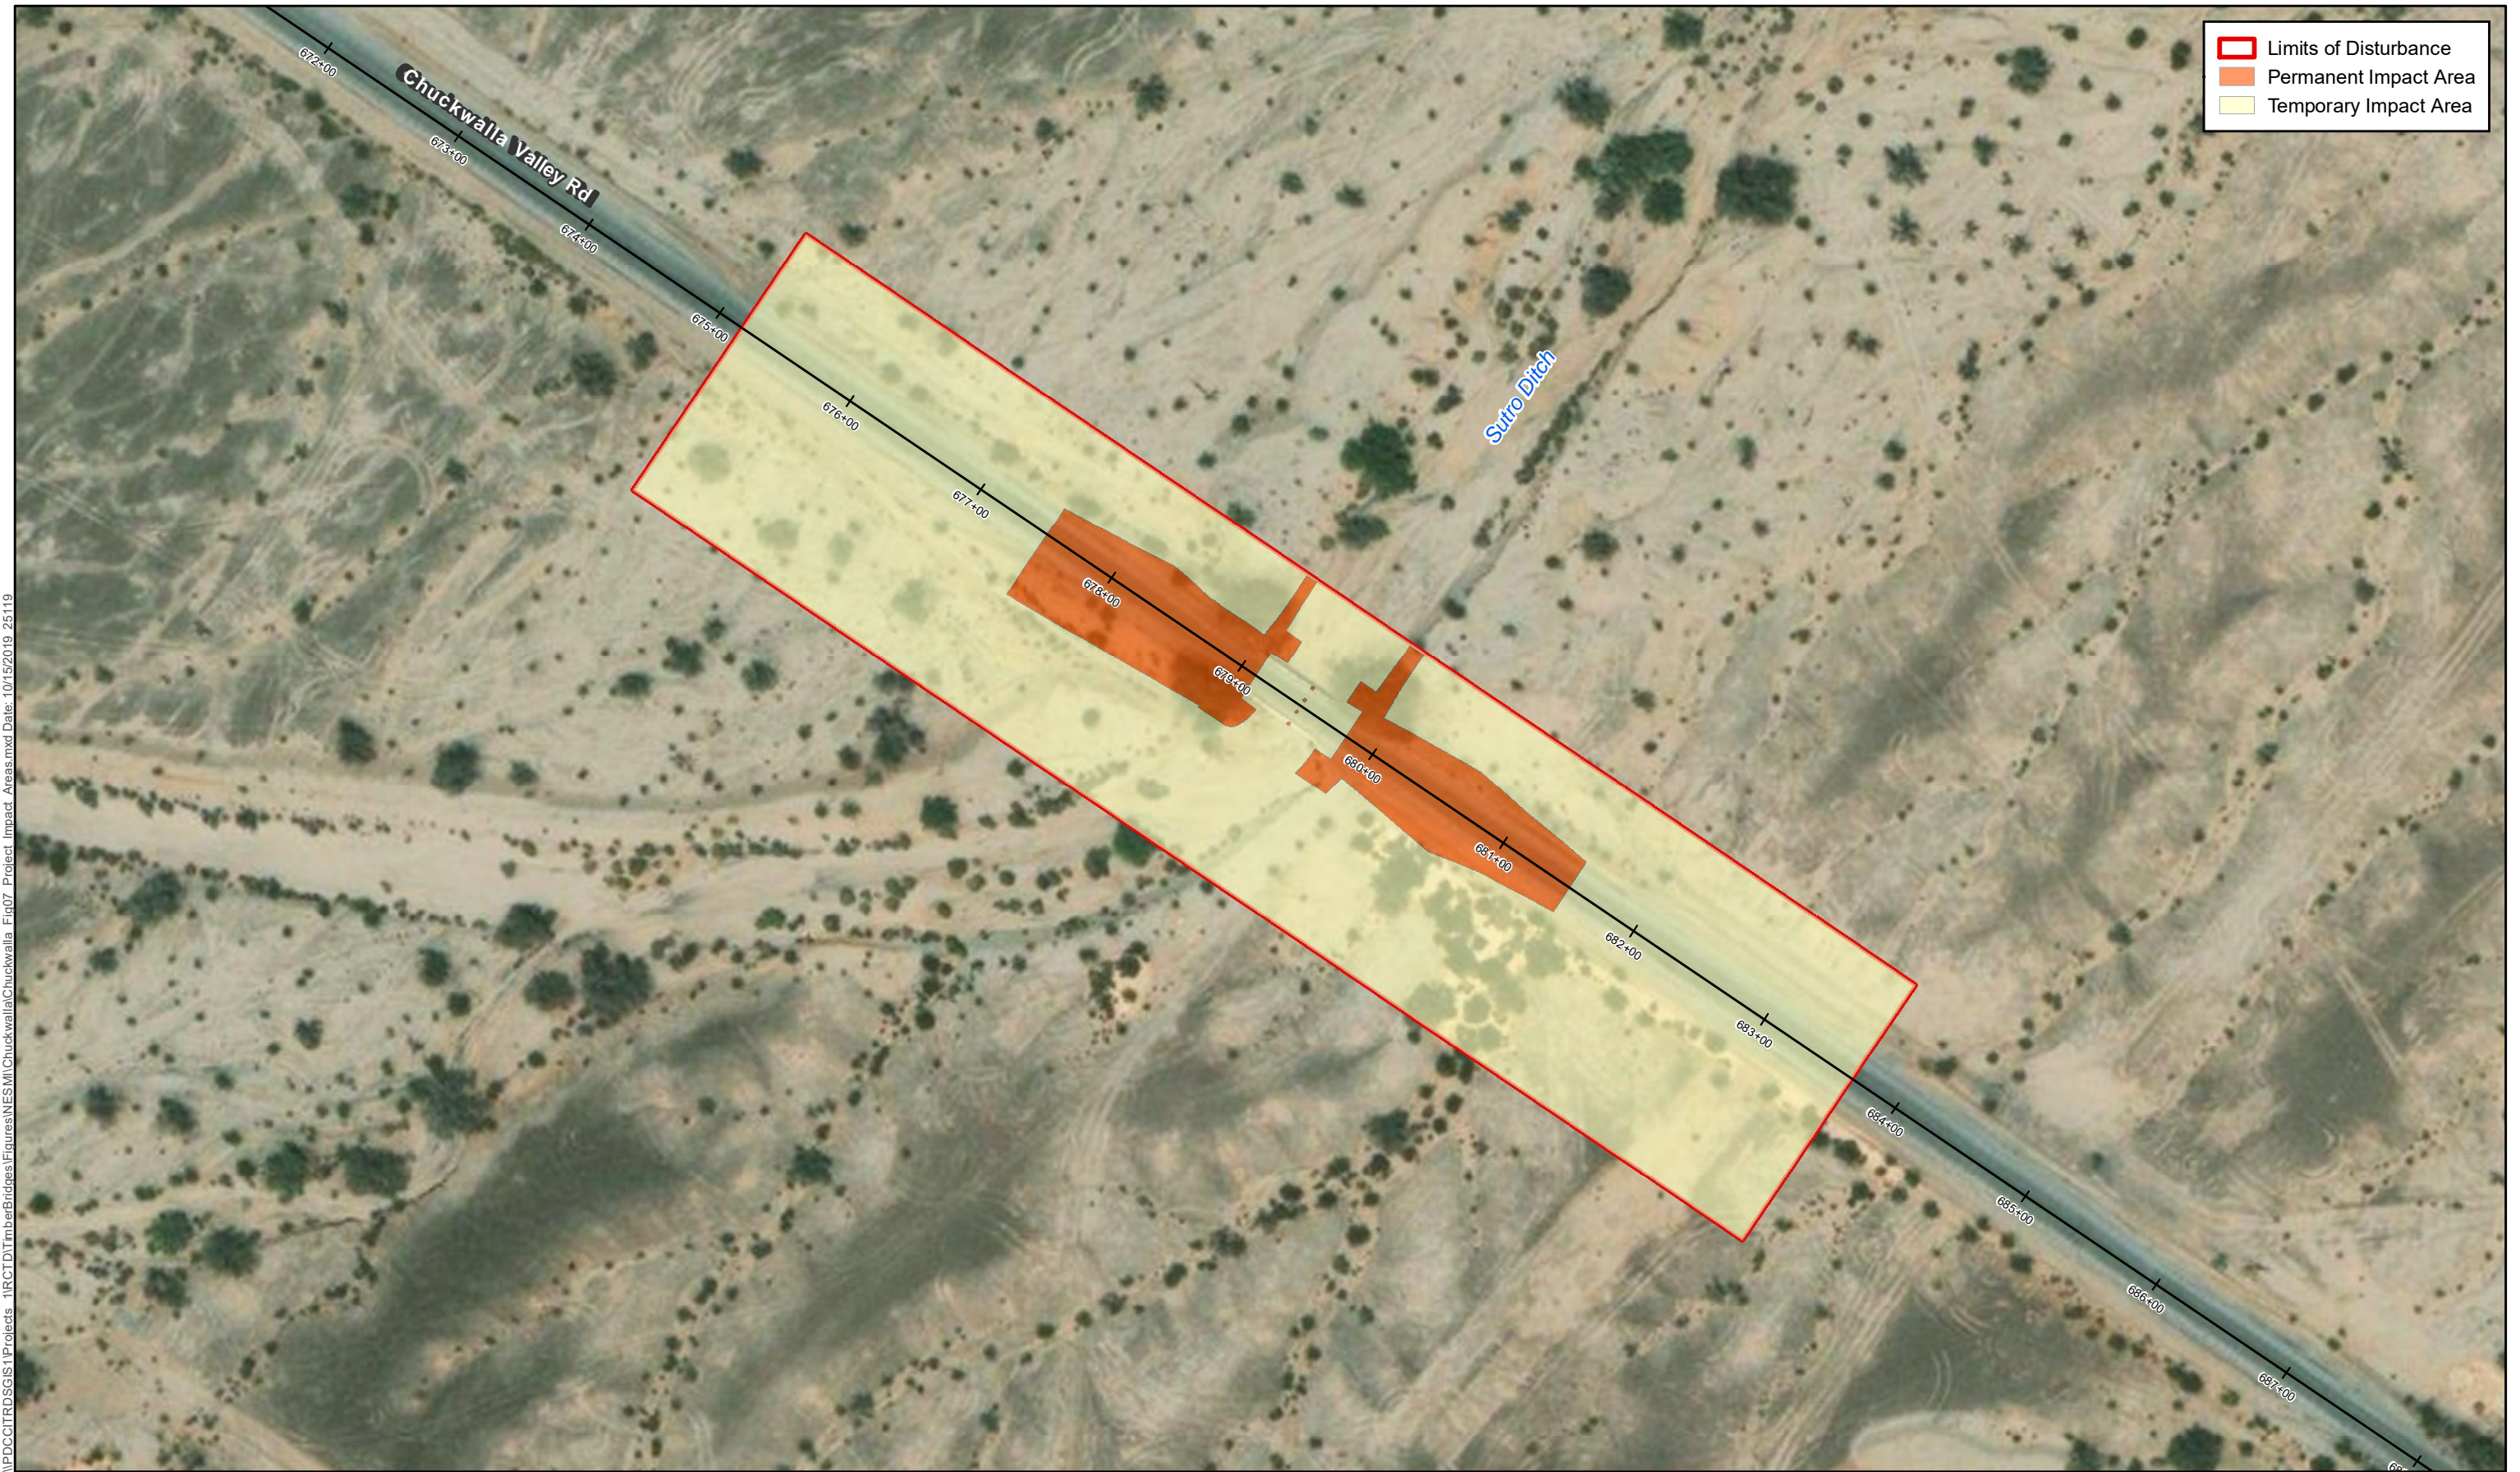
Figure 5 - Sheet 3
Project Impact Areas - Sutro Ditch Bridge (No. 56C0104)
Chuckwalla Valley Road Bridge Replacement

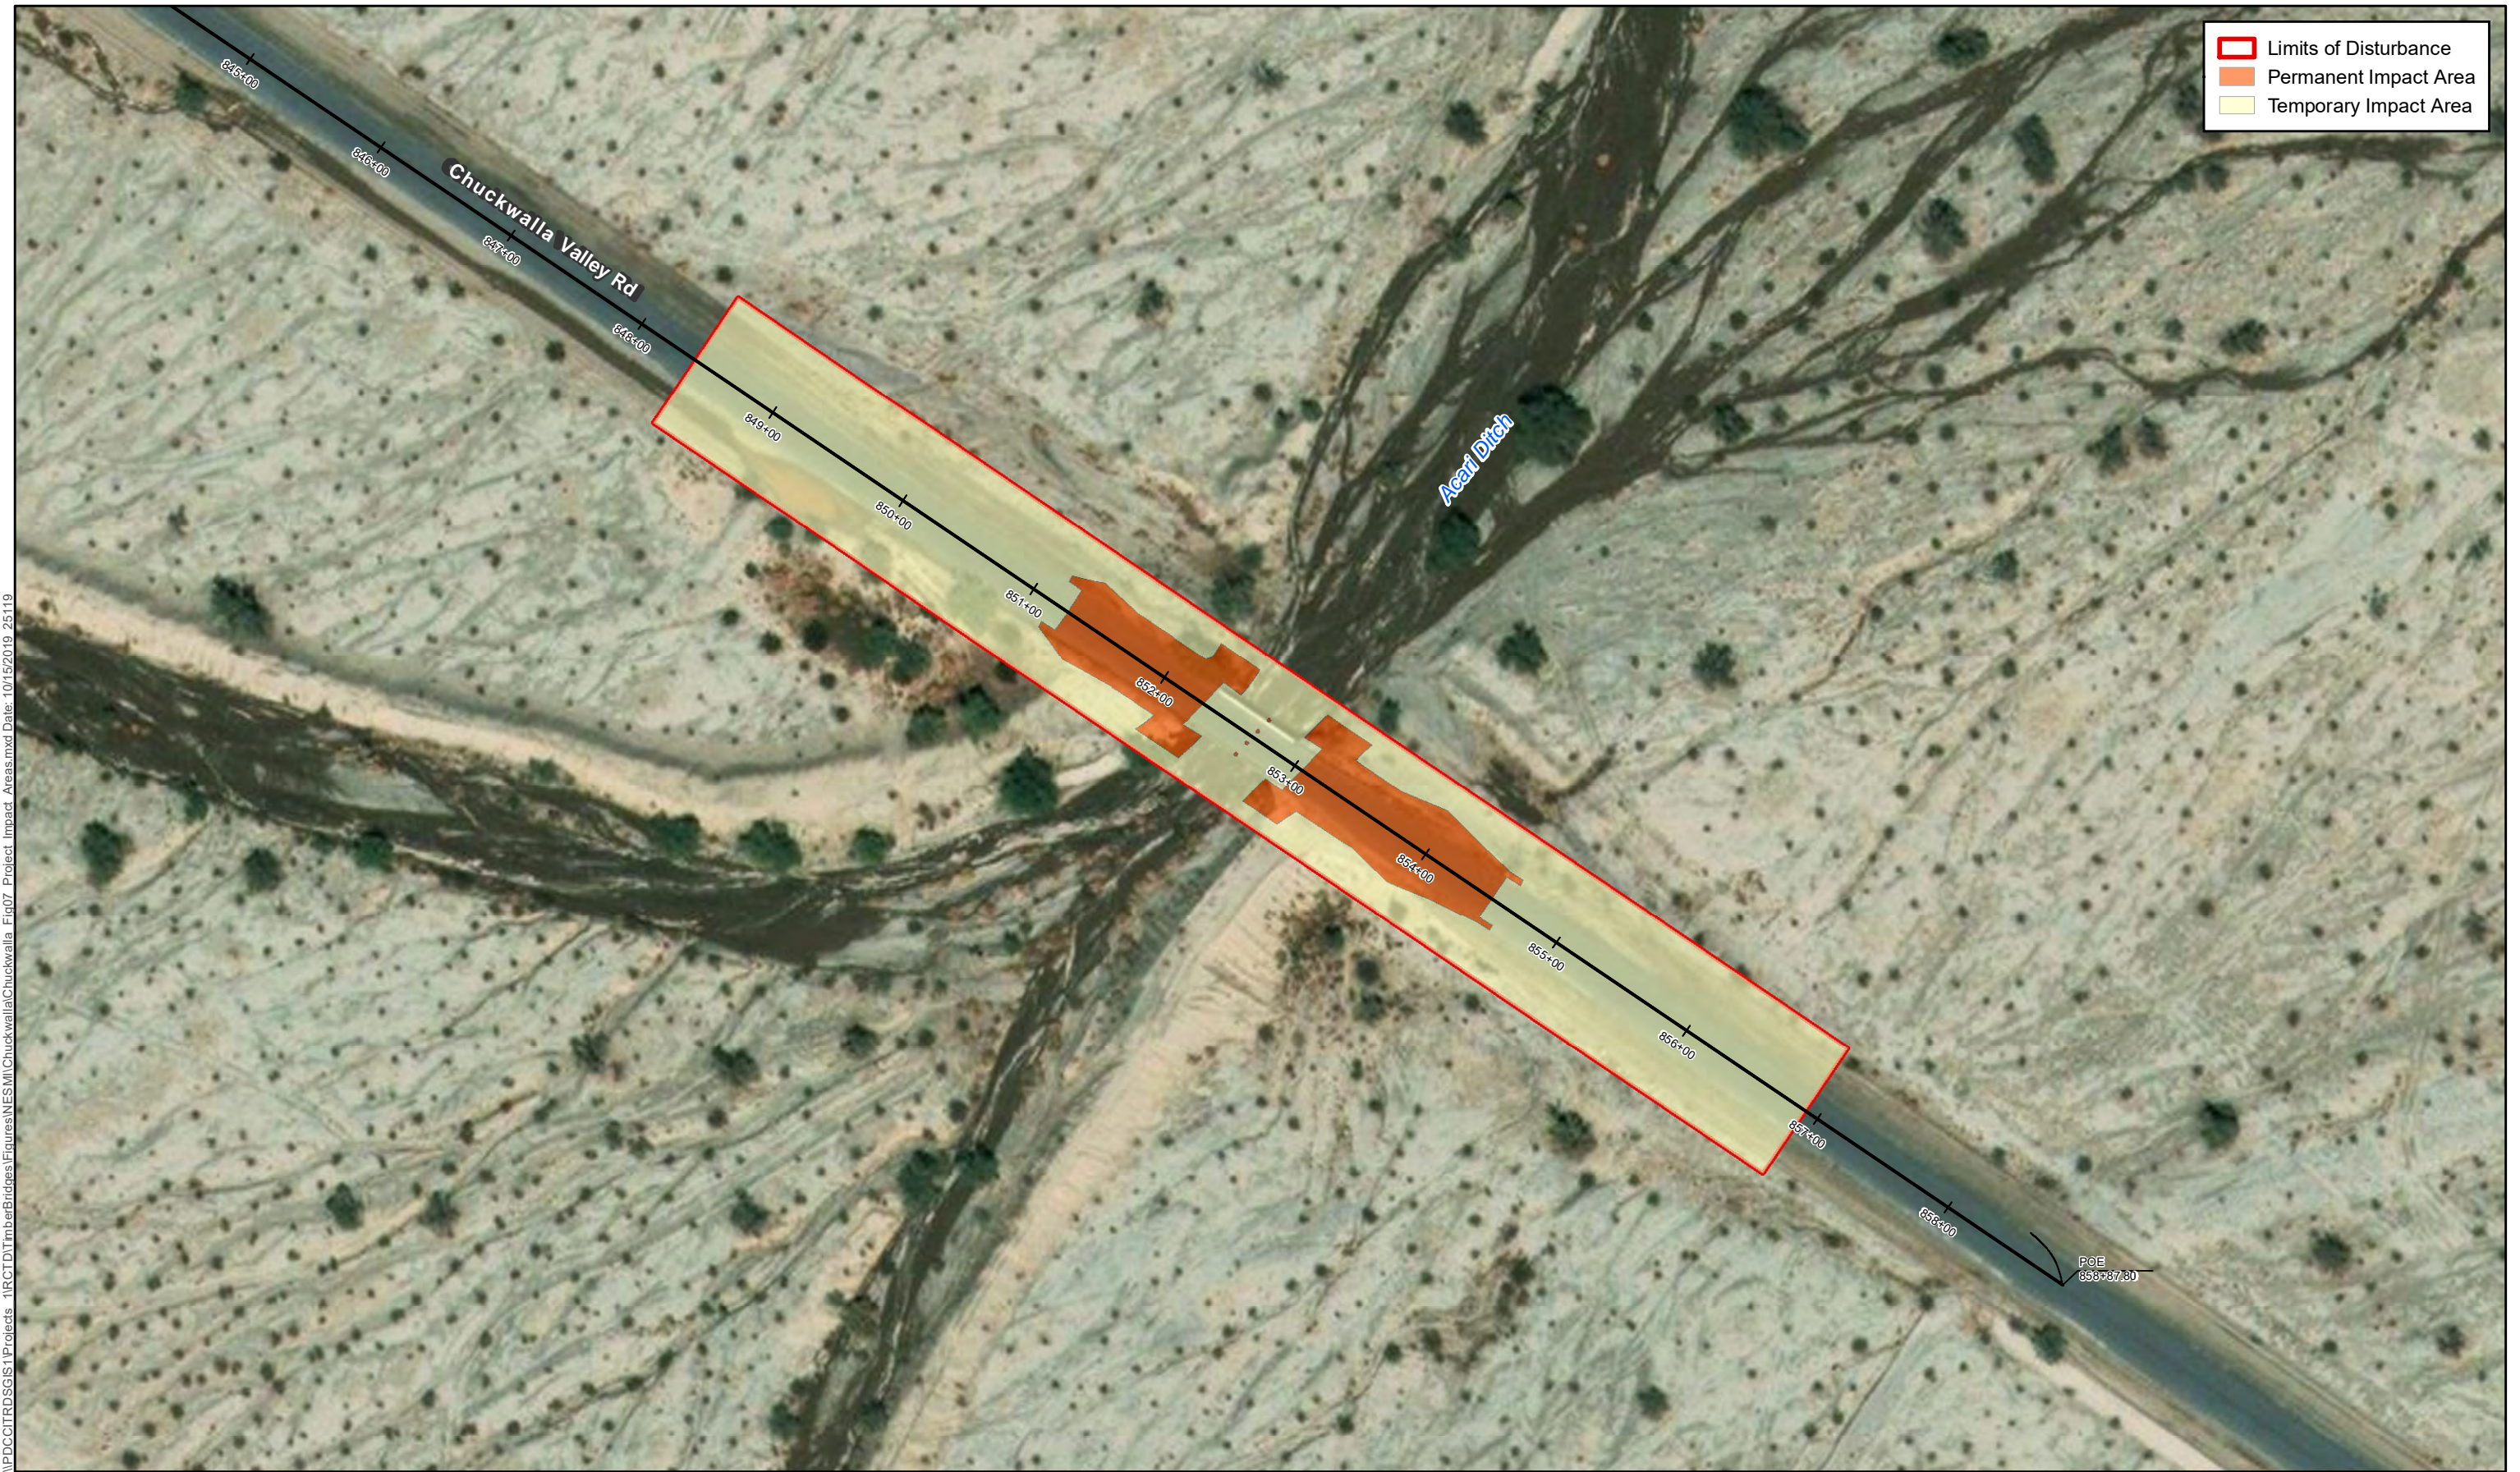
Figure 5 - Sheet 4
Project Impact Areas - Acari Ditch Bridge (No. 56C0108)
Chuckwalla Valley Road Bridge Replacement

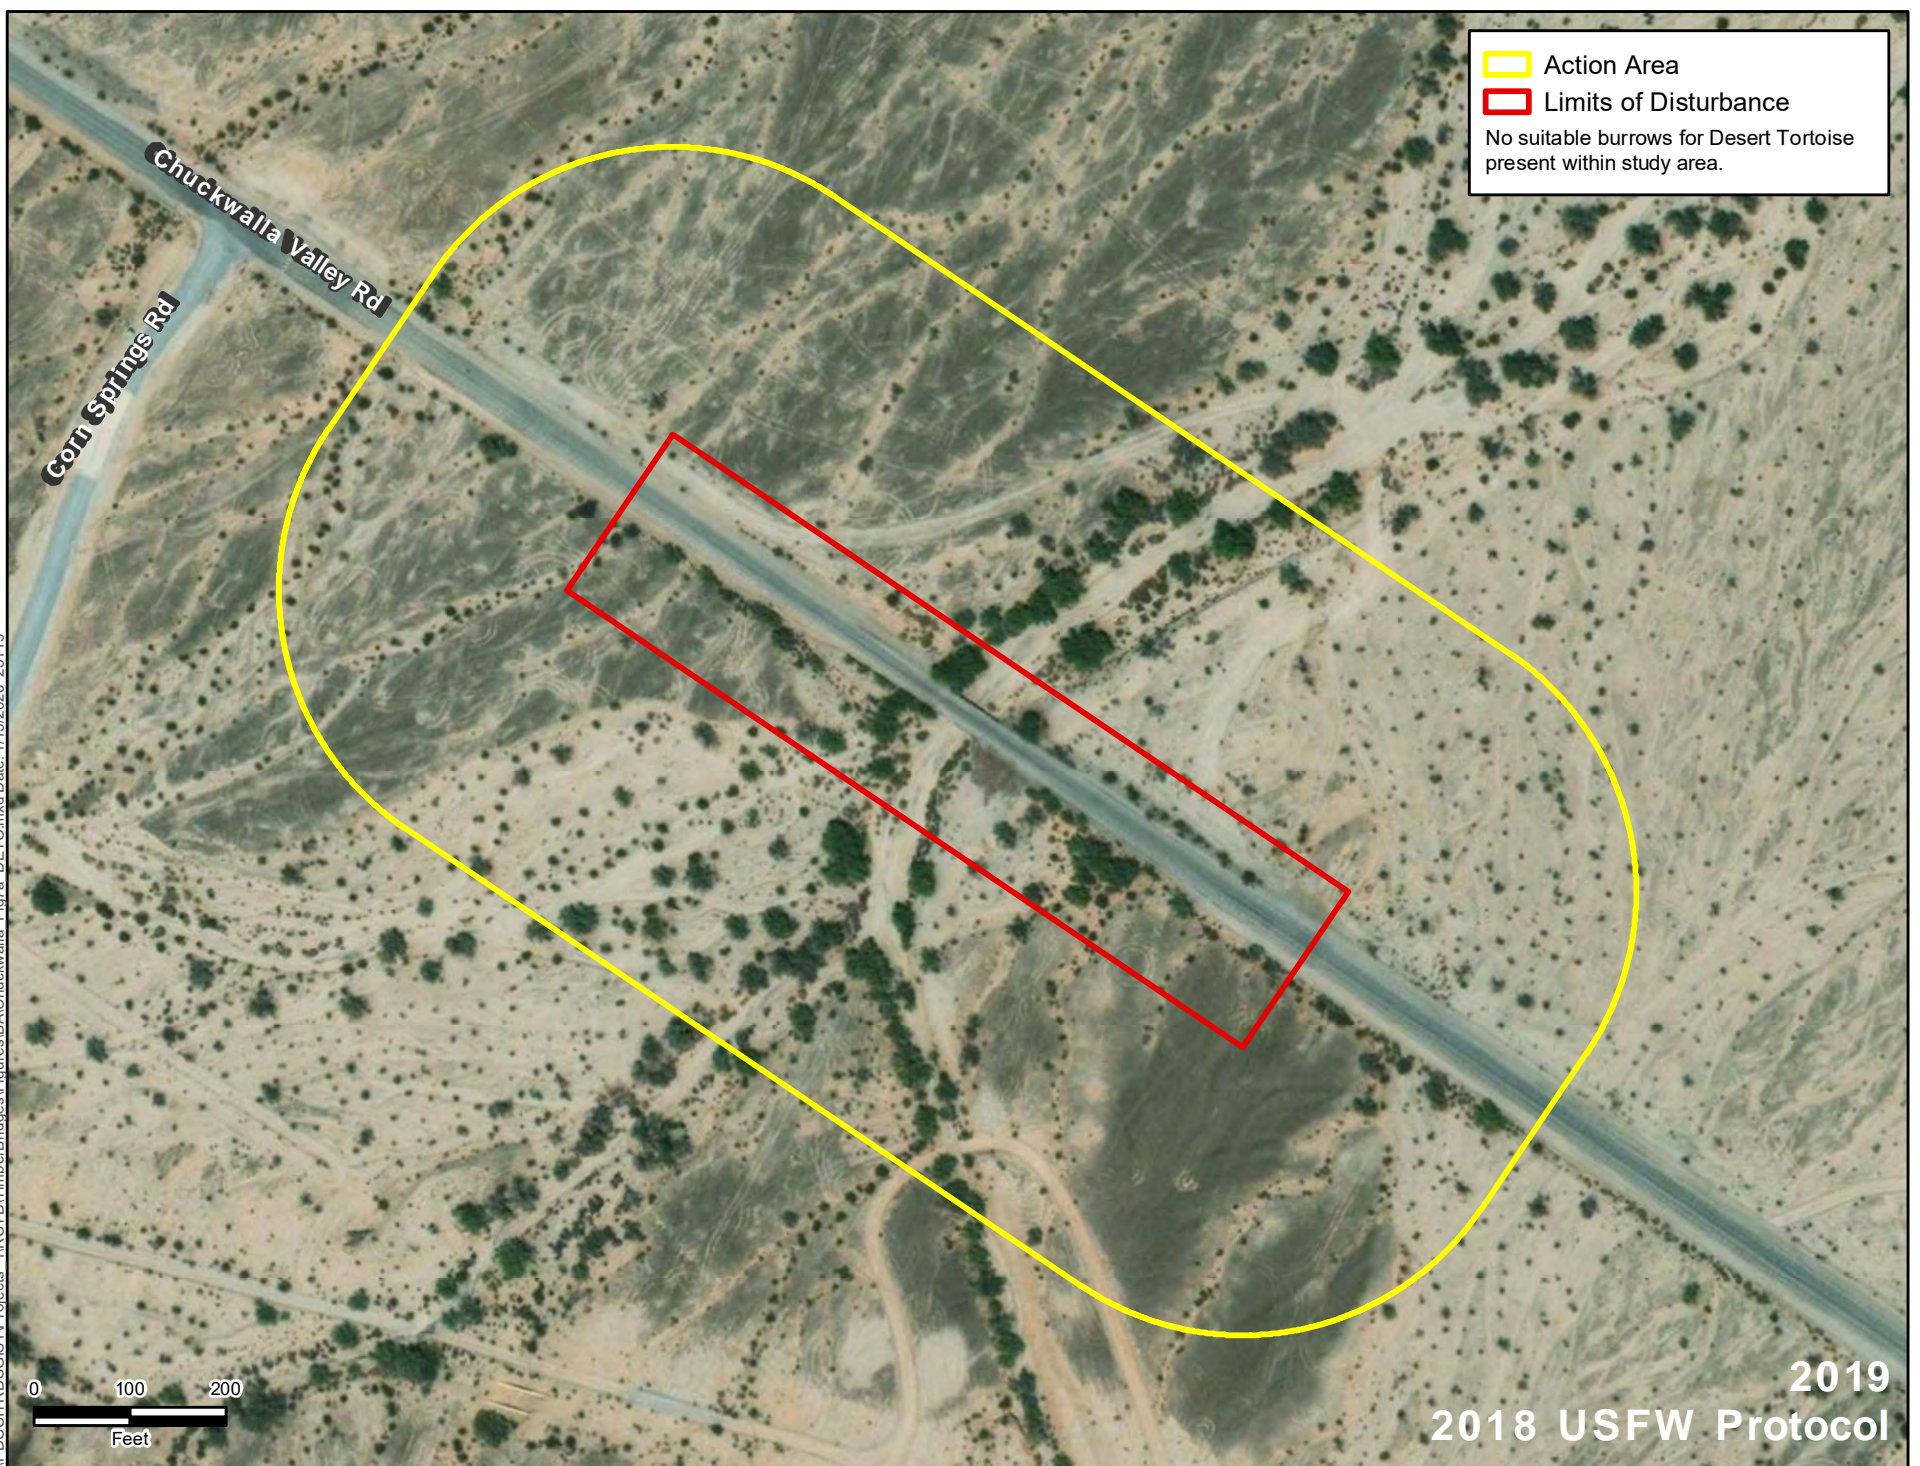
Figure 7a
2017/2019 Desert Tortoise Survey Results
Aztec Ditch Bridge (No. 56C0102)
Chuckwalla Valley Road Bridge Replacement

There were a few burrows documented during the 2017 survey season within the ZOI² that were potentially suitable for desert tortoise, but no potential burrows were found in 2019 surveys within the Action Area (Appendix A, Figures 7a through 7d). The desert wash and creosote bush scrub may be used by individuals foraging in the Action Area. There are also some shrubs in the Action Area that could be used for shade. All of the CNDDDB records of desert tortoise occur southwest of Chuckwalla Valley Road with the nearest CNDDDB record approximately $\frac{3}{4}$ mile from the I-10/ Chuckwalla Valley Road interchange. No desert tortoise or definitive desert tortoise sign was observed during either the 2017 or 2019 surveys. Because desert tortoise was not found during protocol surveys, it is considered absent from the Action Area.

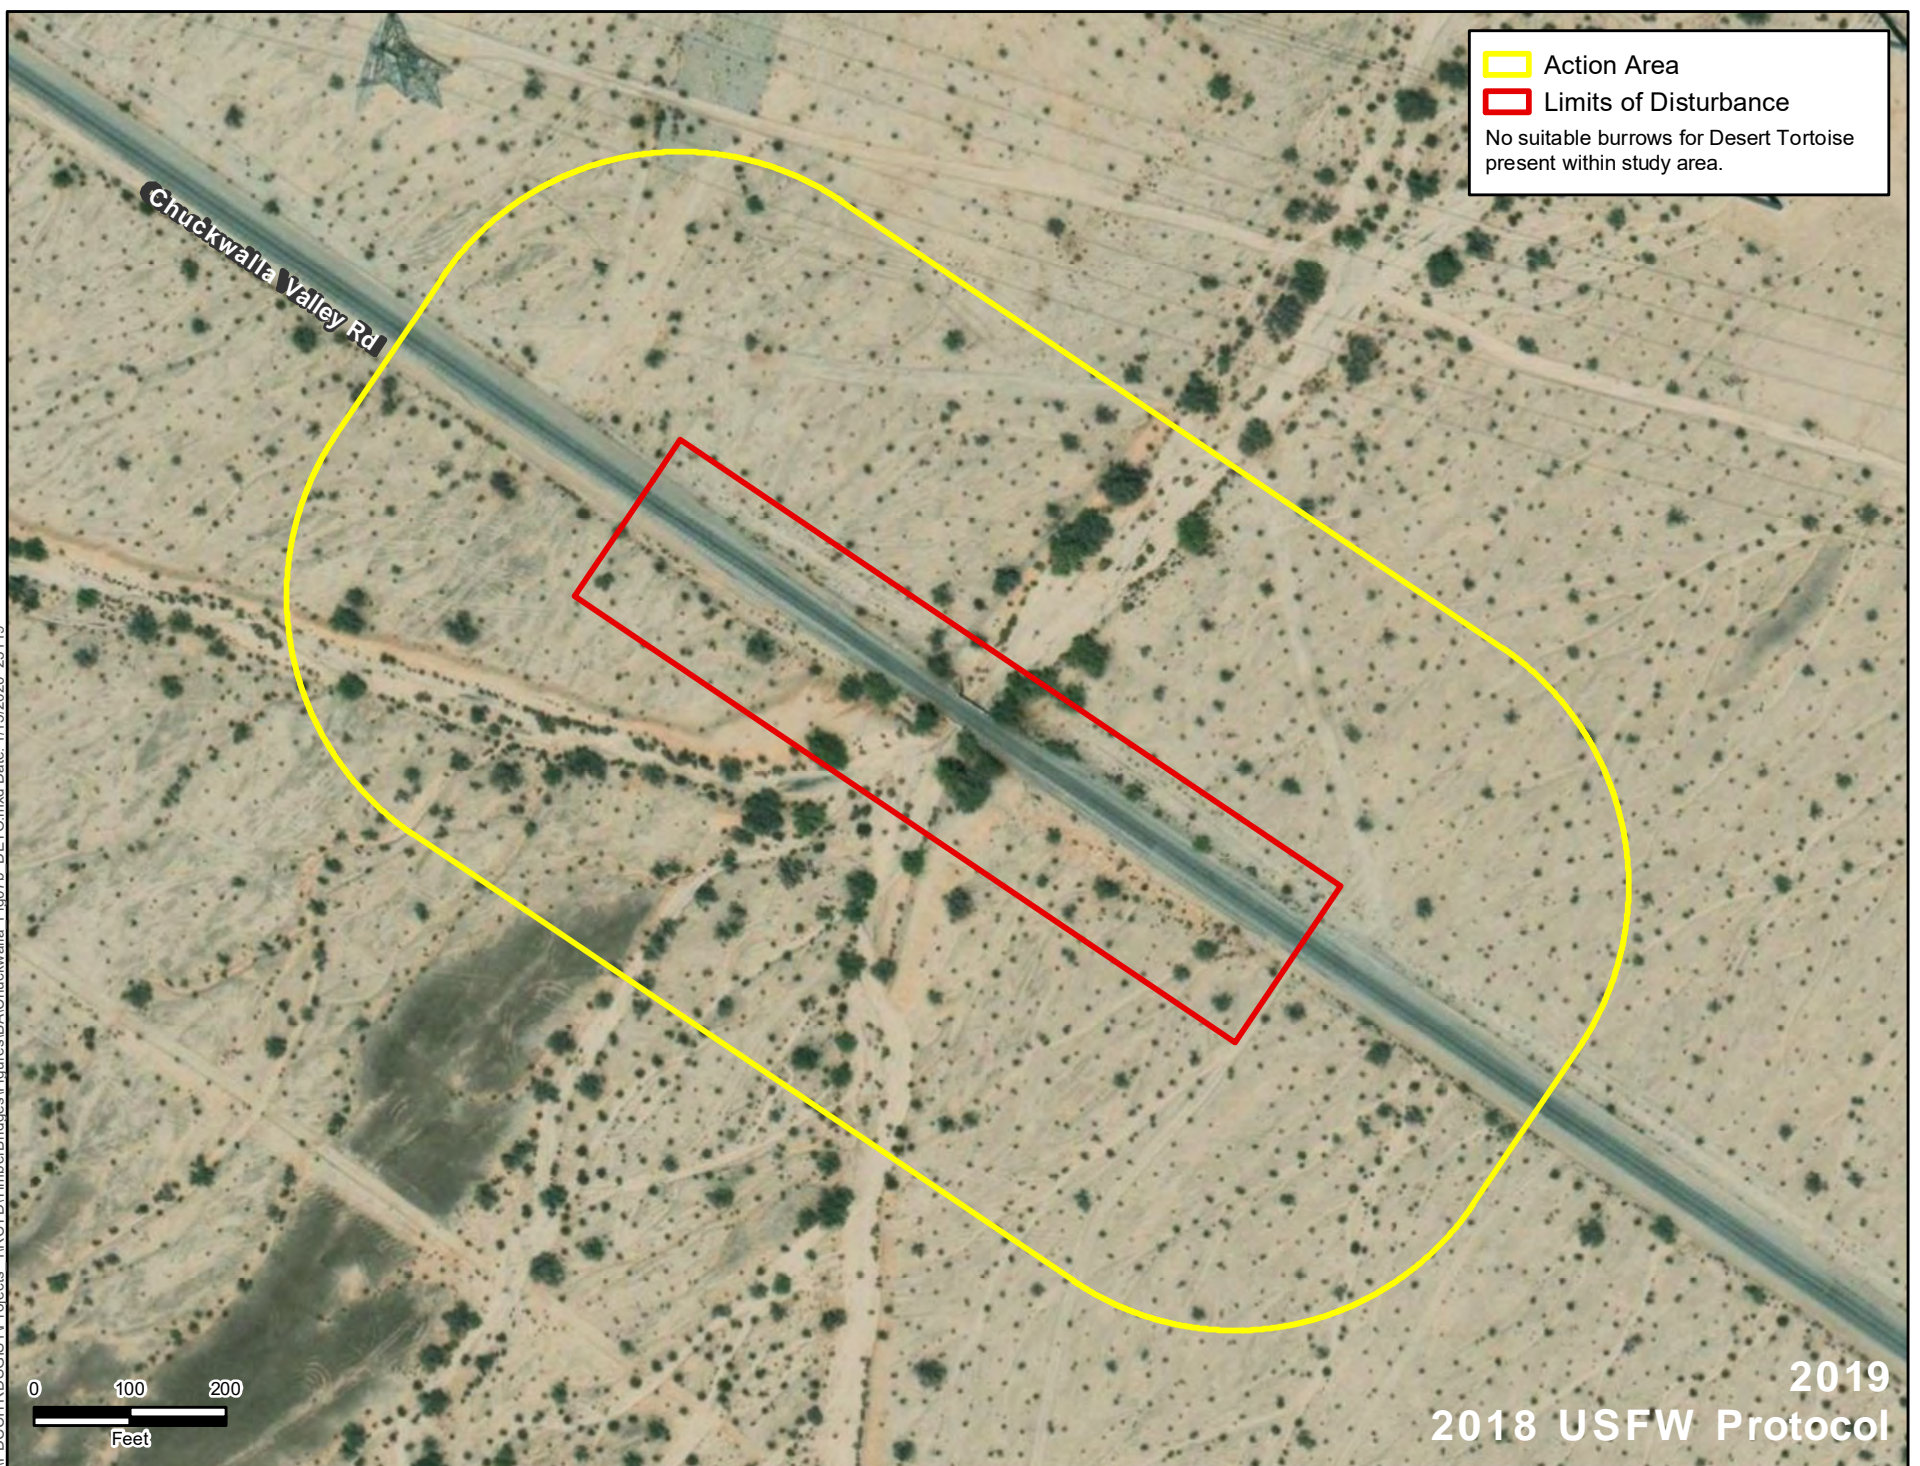
Figure 7b
 2017/2019 Desert Tortoise Survey Results
 Tarantula Ditch Bridge (No. 56C0103)
 Chuckwalla Valley Road Bridge Replacement

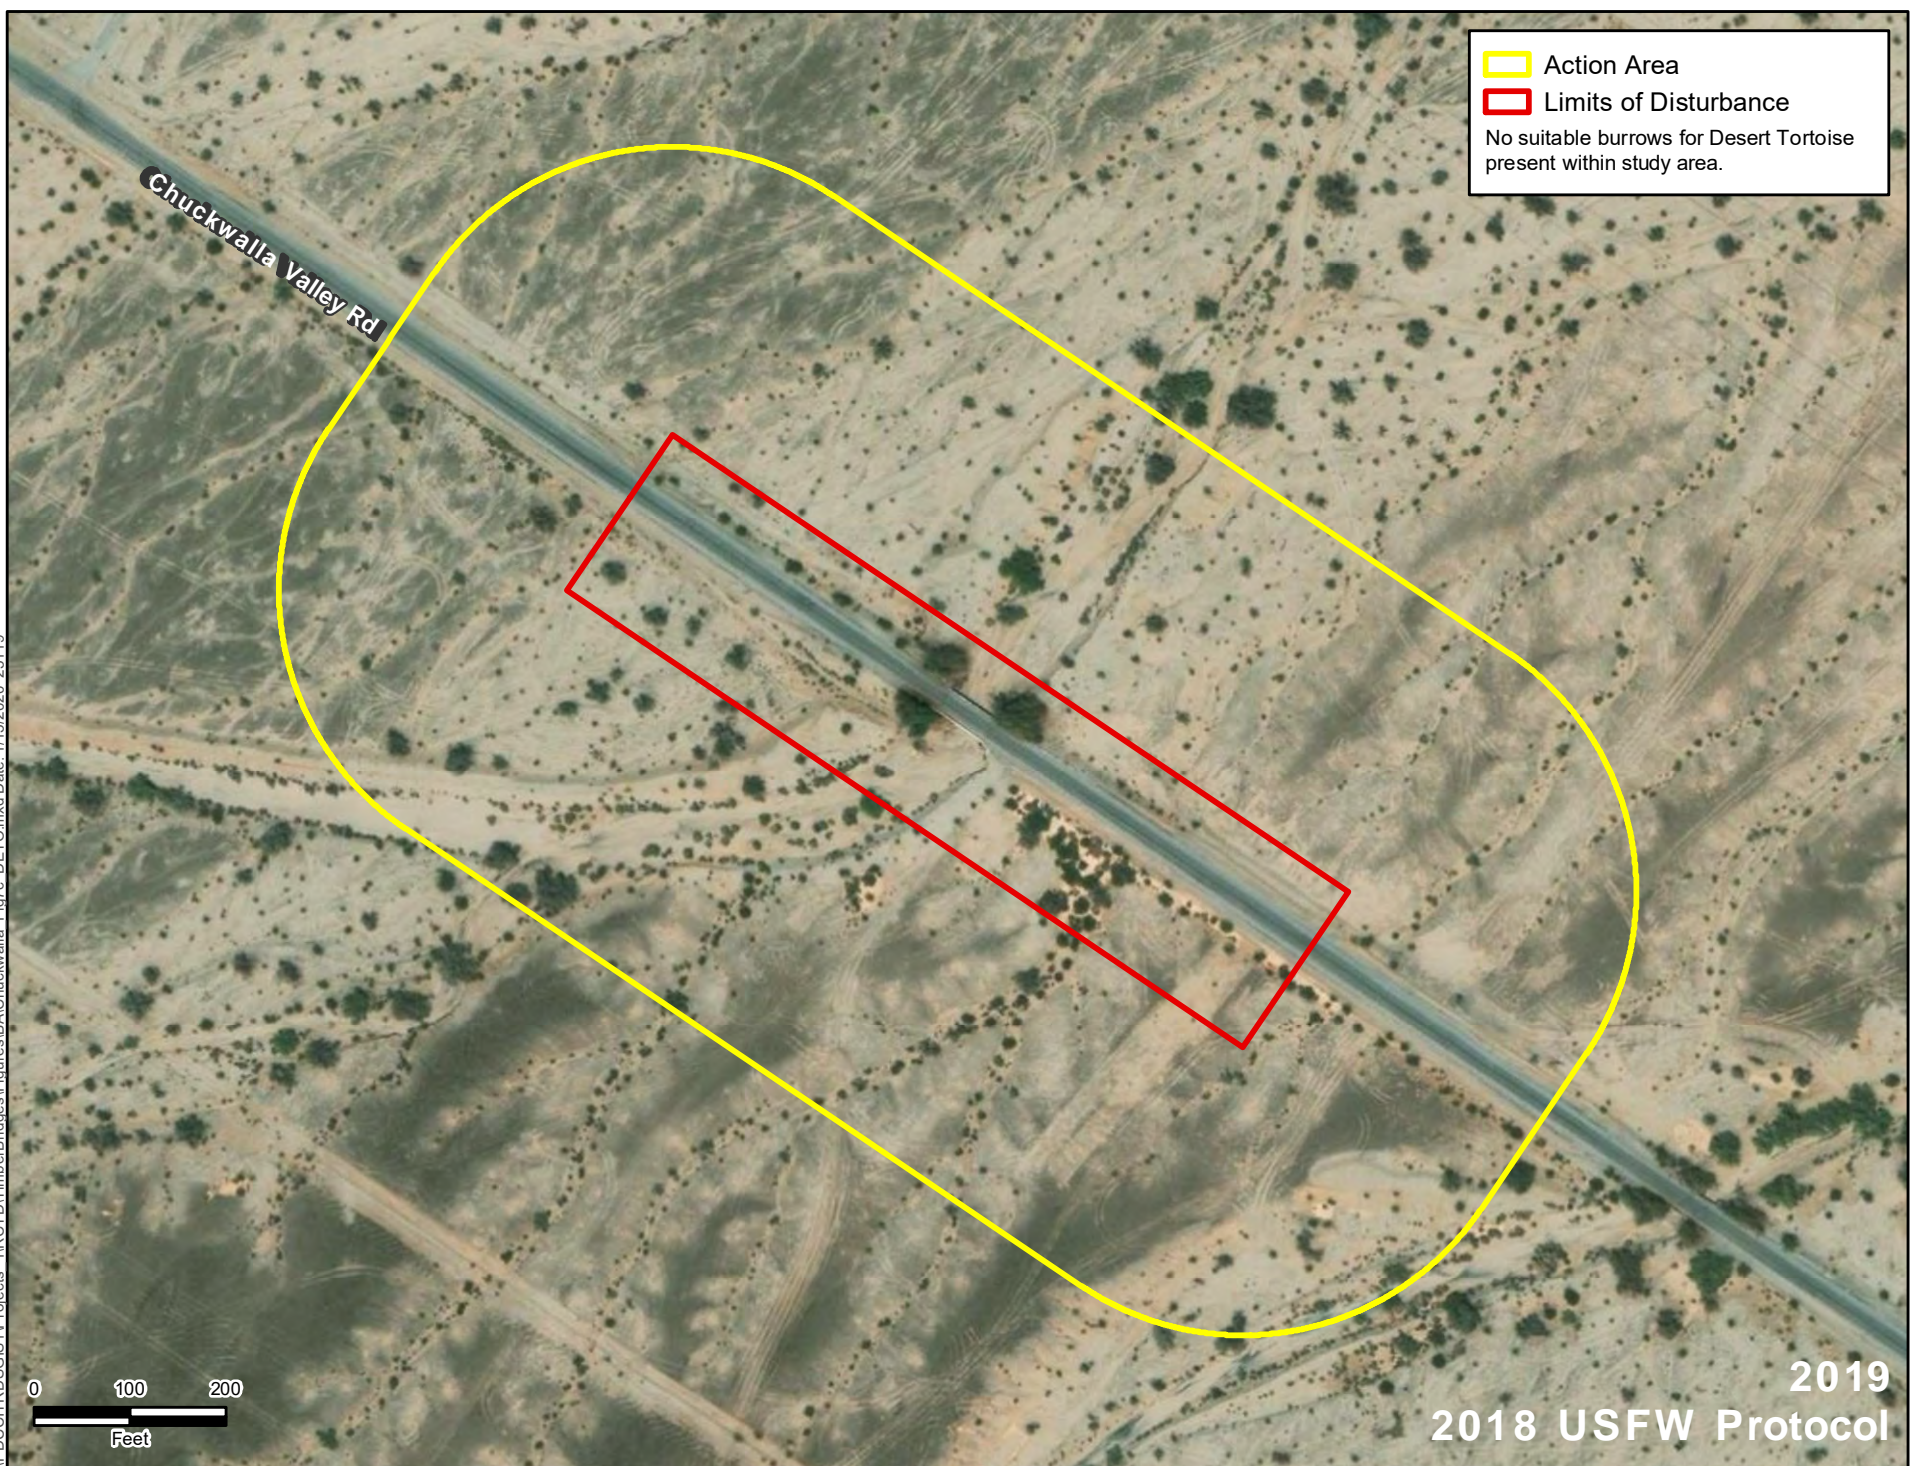
Figure 7c
2017/2019 Desert Tortoise Survey Results
Sutro Ditch Bridge (No. 56C0104)
Chuckwalla Valley Road Bridge Replacement
