Biological Assessment

Four bridges on Chuckwalla Valley Road between Interstate 10/Corn Springs Road and Interstate 10/Palen Dunes Drive, Unincorporated Riverside County

Chuckwalla Valley Road Bridge Replacements Project

Replacement of four bridges on Chuckwalla Valley Road between Interstate 10/Corn Springs Road
and Interstate 10/Palen Dunes Drive, Unincorporated Riverside County, California

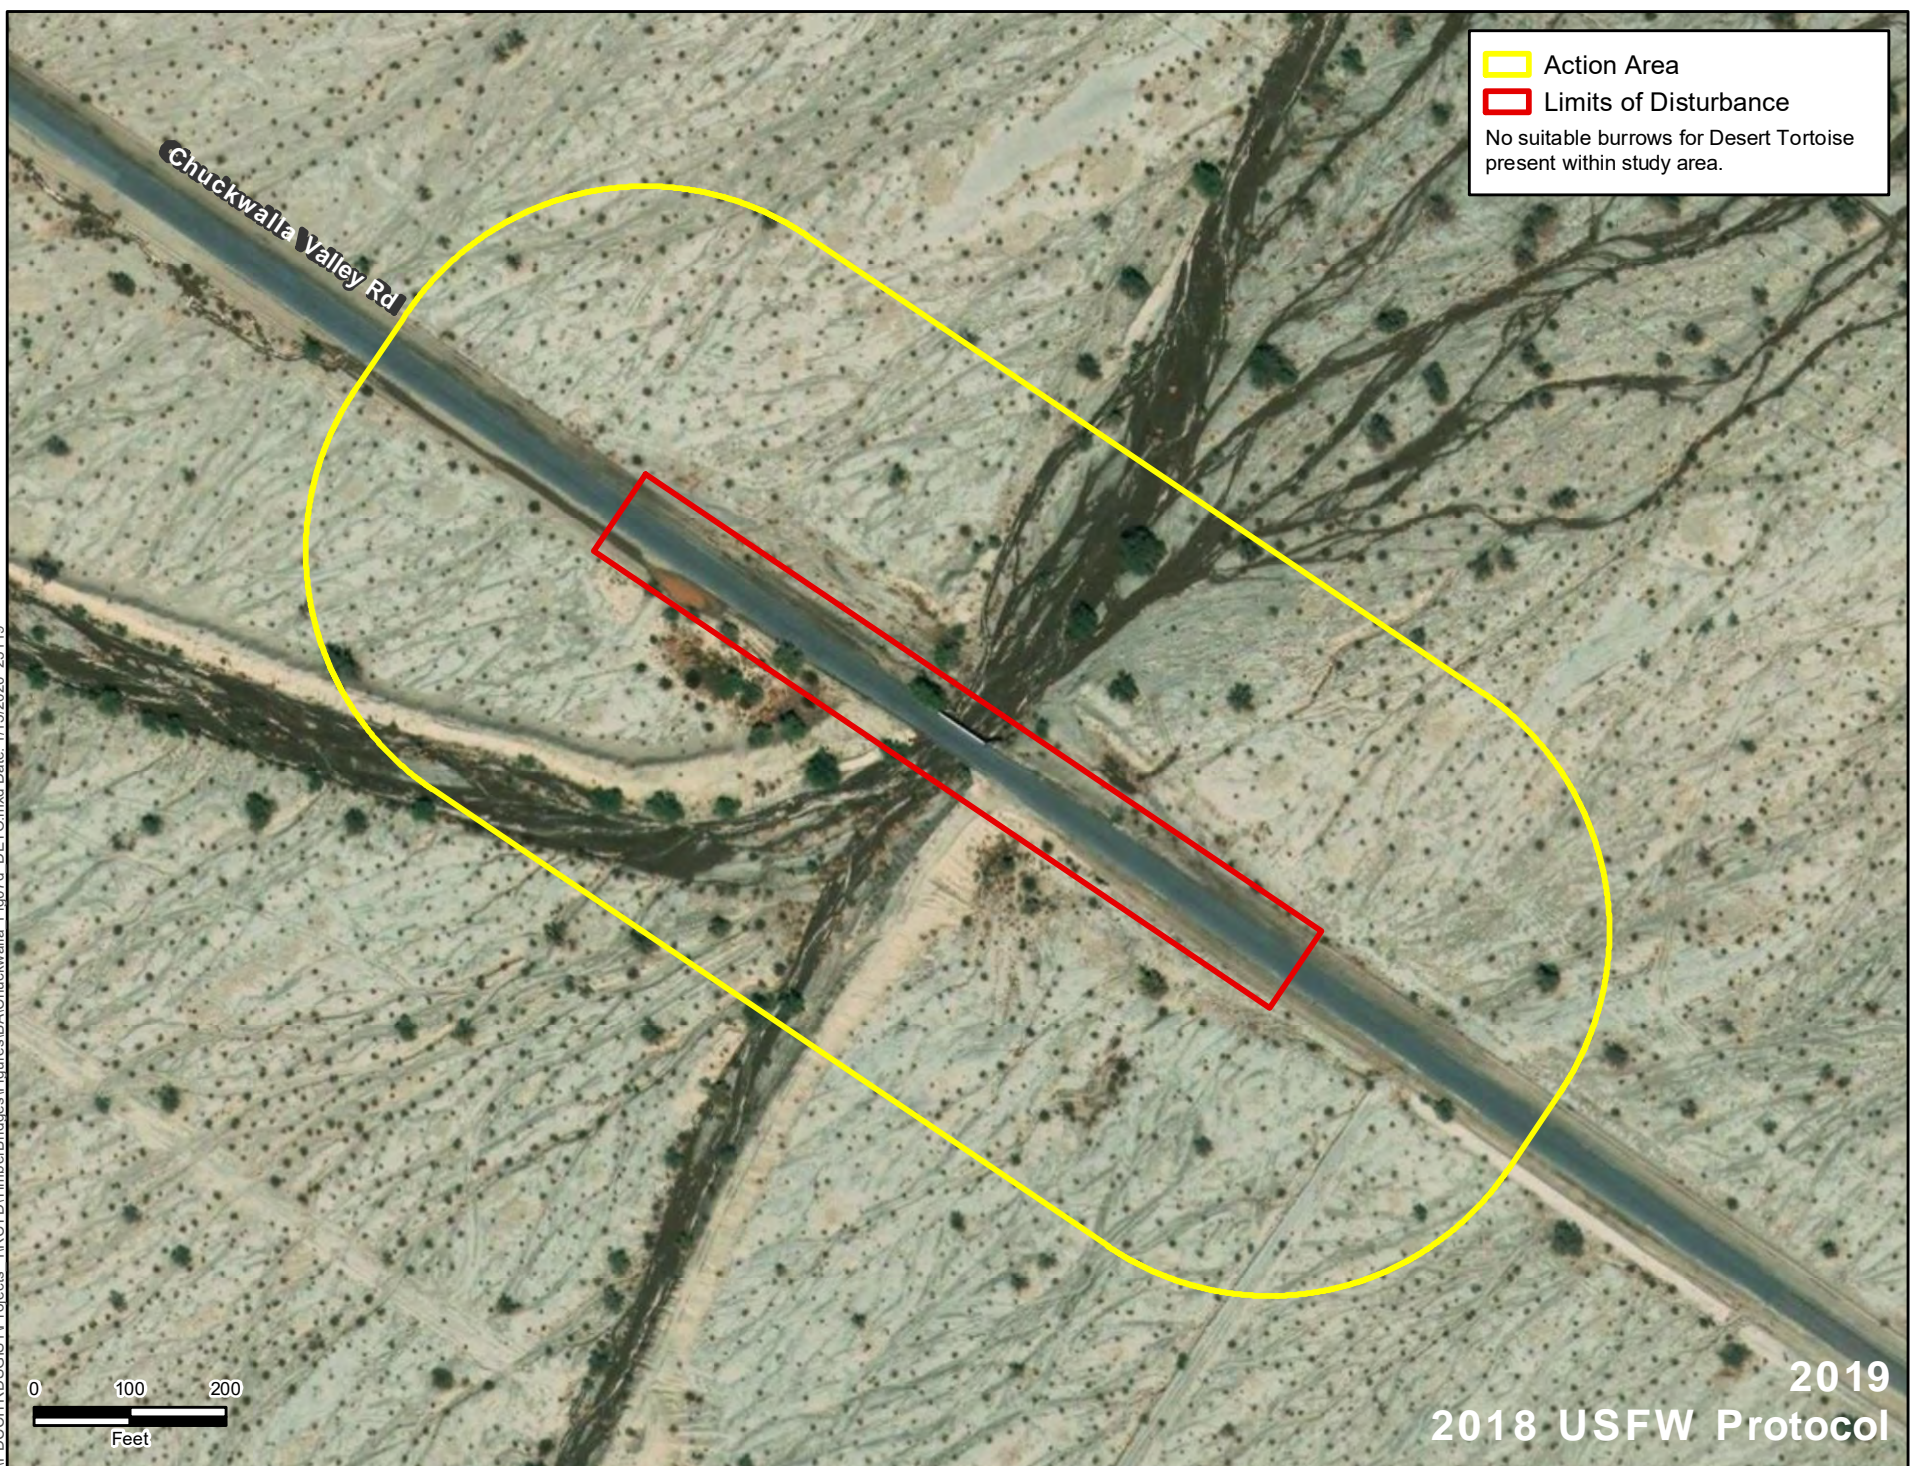
Figure 7d
 2017/2019 Desert Tortoise Survey Results
 Acari Ditch Bridge (No. 56C0108)
 Chuckwalla Valley Road Bridge Replacement

There were a few burrows documented during the 2017 survey season within the ZOI² that were potentially suitable for desert tortoise, but no potential burrows were found in 2019 surveys within the Action Area (Appendix A, Figures 7a through 7d). The desert wash and creosote bush scrub may be used by individuals foraging in the Action Area. There are also some shrubs in the Action Area that could be used for shade. All of the CNDDDB records of desert tortoise occur southwest of Chuckwalla Valley Road with the nearest CNDDDB record approximately $\frac{3}{4}$ mile from the I-10/ Chuckwalla Valley Road interchange. No desert tortoise or definitive desert tortoise sign was observed during either the 2017 or 2019 surveys. Because desert tortoise was not found during protocol surveys, it is considered absent from the Action Area.

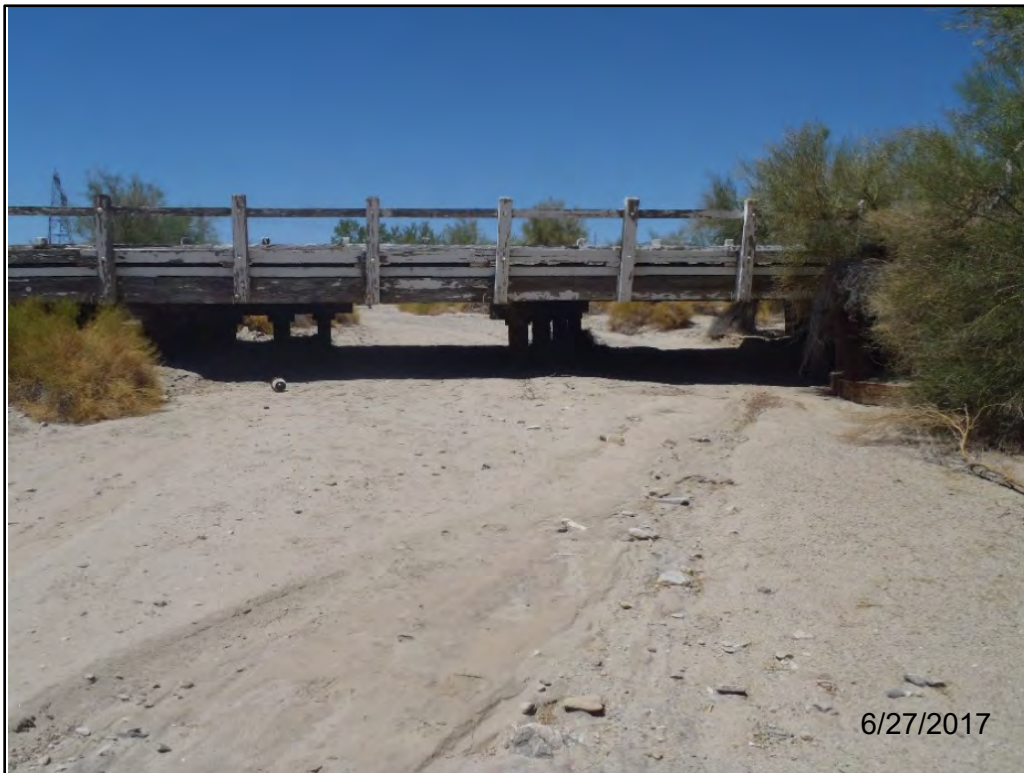
Photo 1. View southwest of timber Aztec Ditch Bridge (#56C0102) and the desert wash.

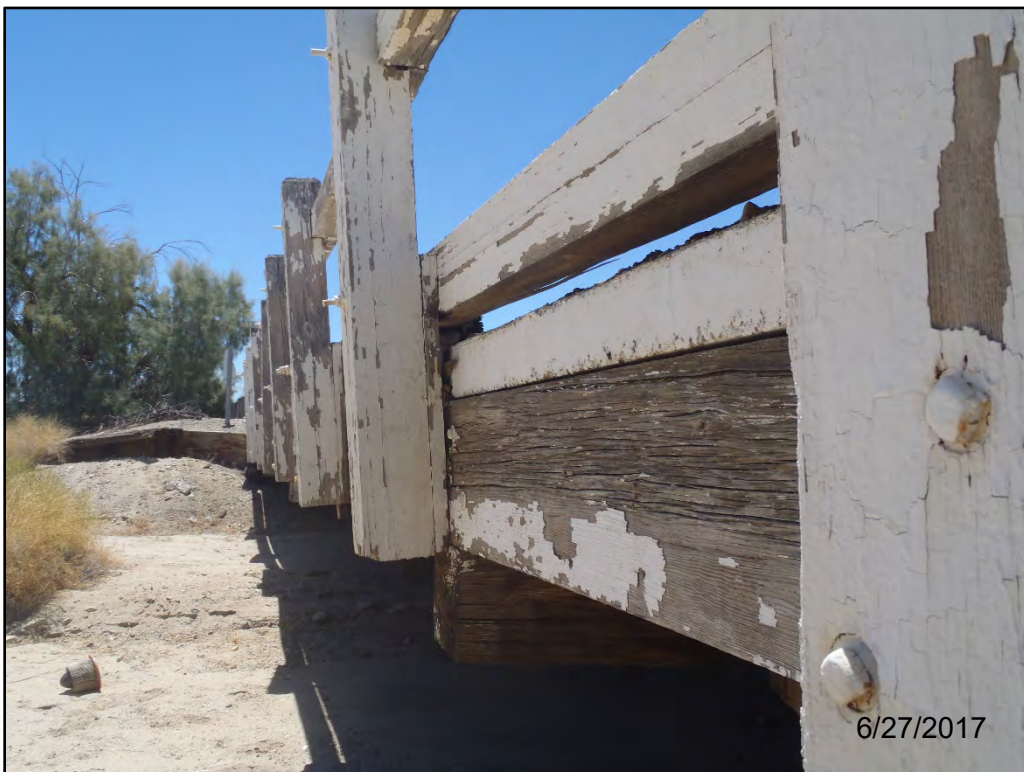
Photo 2. View of the timber bridge at Aztec Ditch (#56C0102).

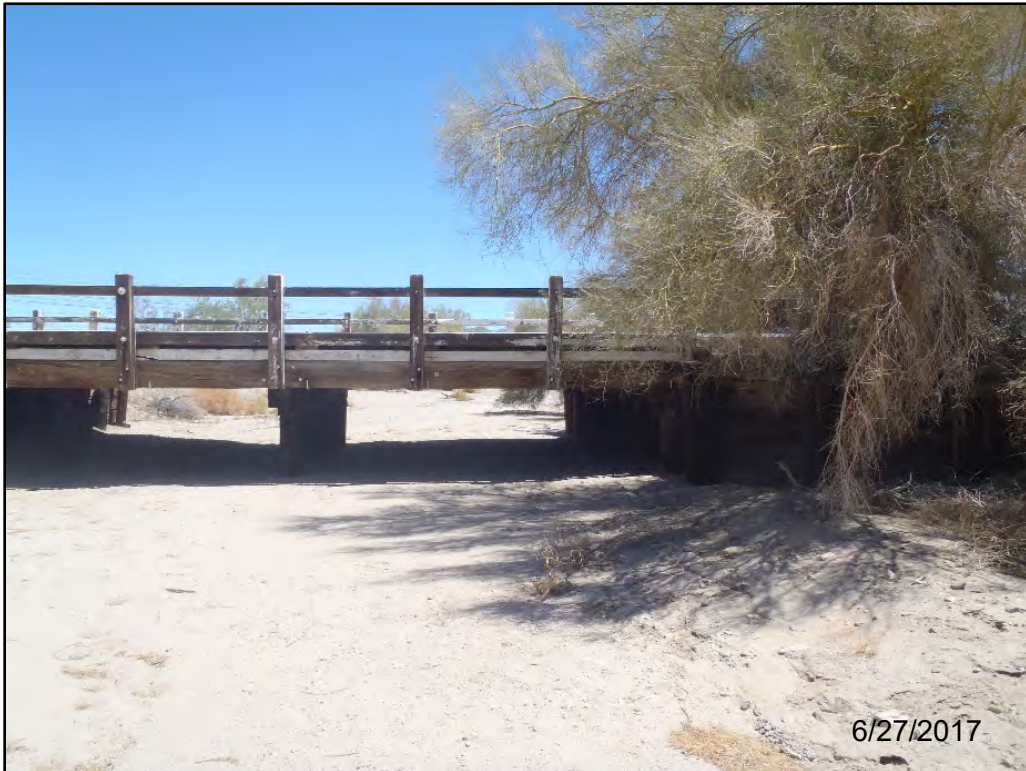
Photo 5. View southwest of Tarantula Ditch Bridge (#56C0103) and the desert wash under the existing timber bridge.

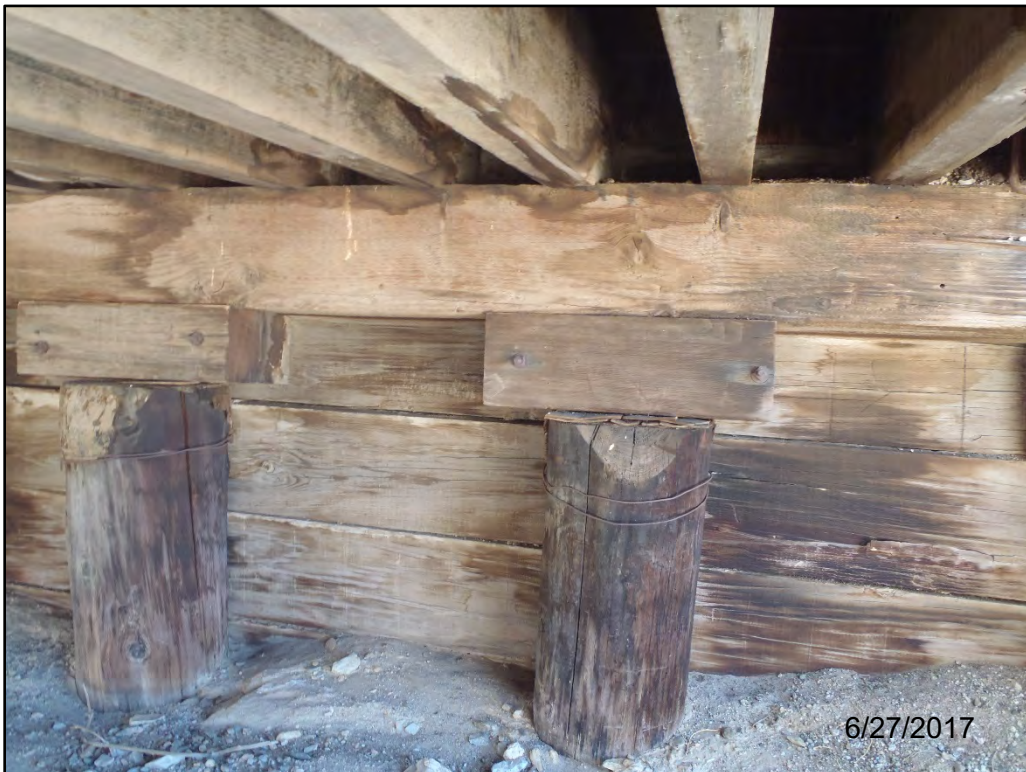
Photo 6. View of existing bridge footings at Tarantula Ditch Bridge (#56C0103).

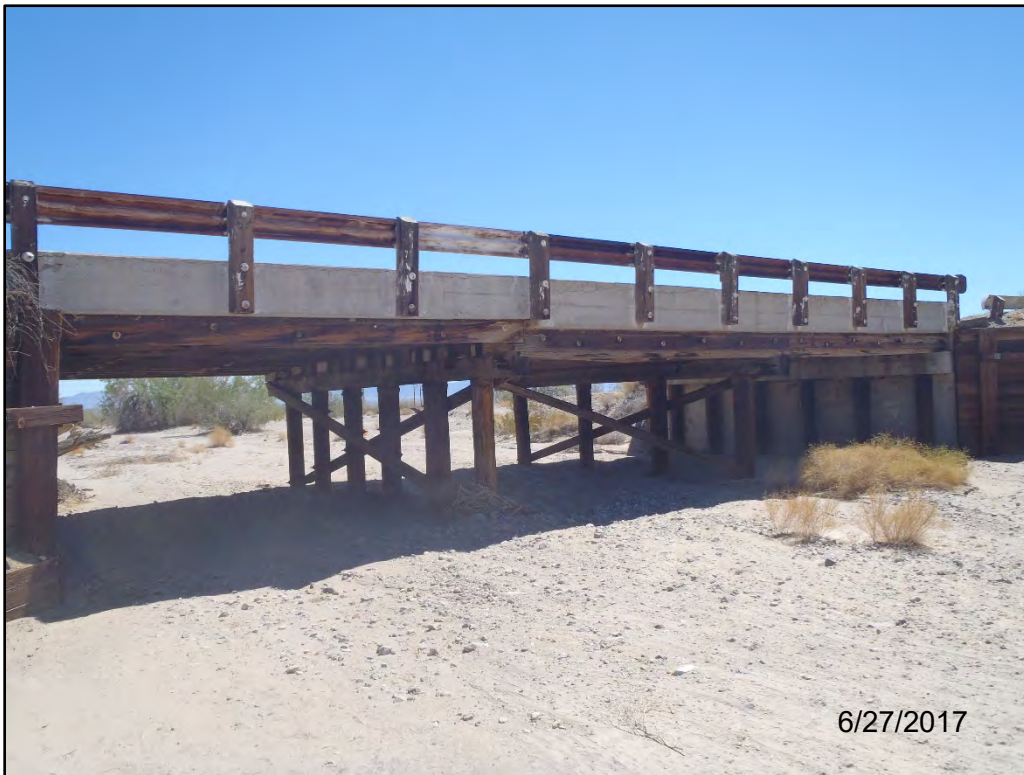
Photo 7. View of Sutro Ditch Bridge (#56C0104).

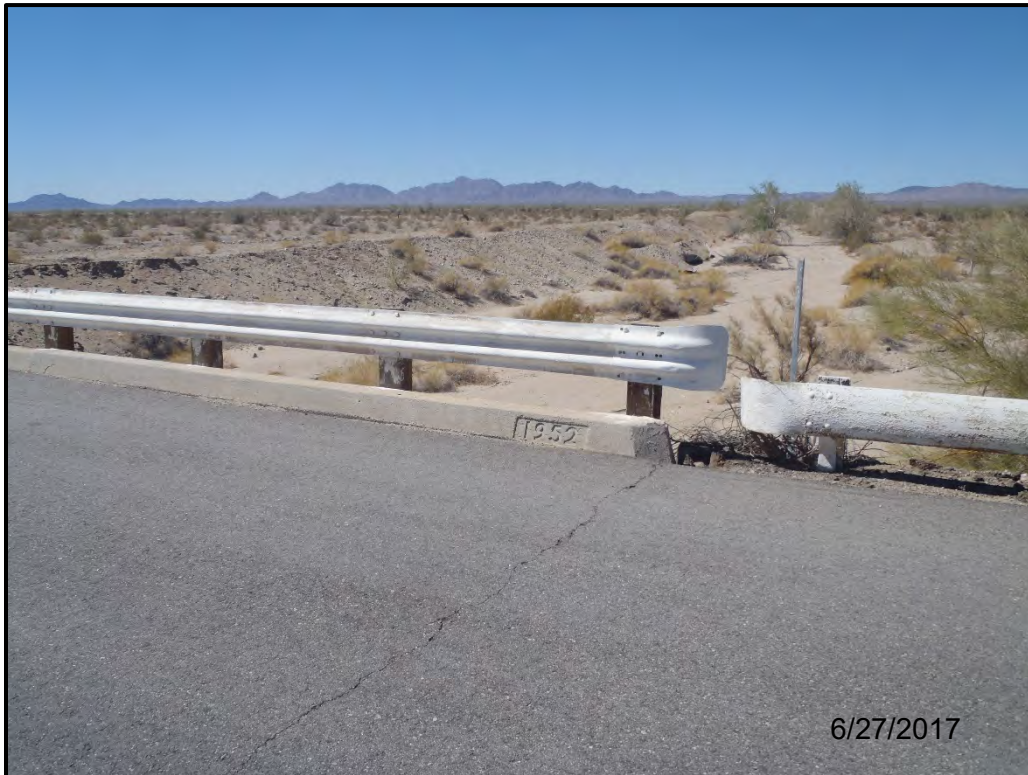
Photo 9. View downstream of the Acari Ditch Bridge (#56C0108).

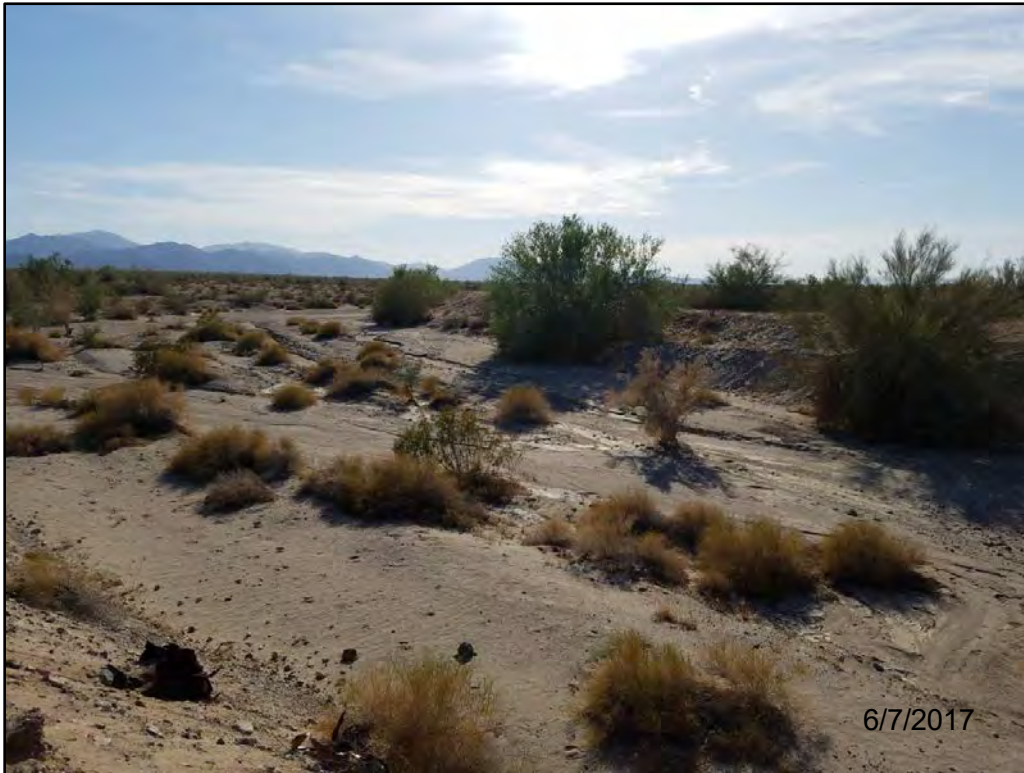
Photo 11. View of vegetated portions of the desert wash from Acari Ditch Bridge (#56C0108). Diversion dikes are present in and along the banks of the wash. Facing west.
