Memorandum

Date: March 28, 2020
File No: (Riv-Chuckwalla Valley Rd-Local)
(Dist. 8 – FPN BRLO-
5956[239][227][226][225])
Chuckwalla Valley Road Bridges Replacement
Project

Subject: Scenic Resources Evaluation and Visual Impact Assessment

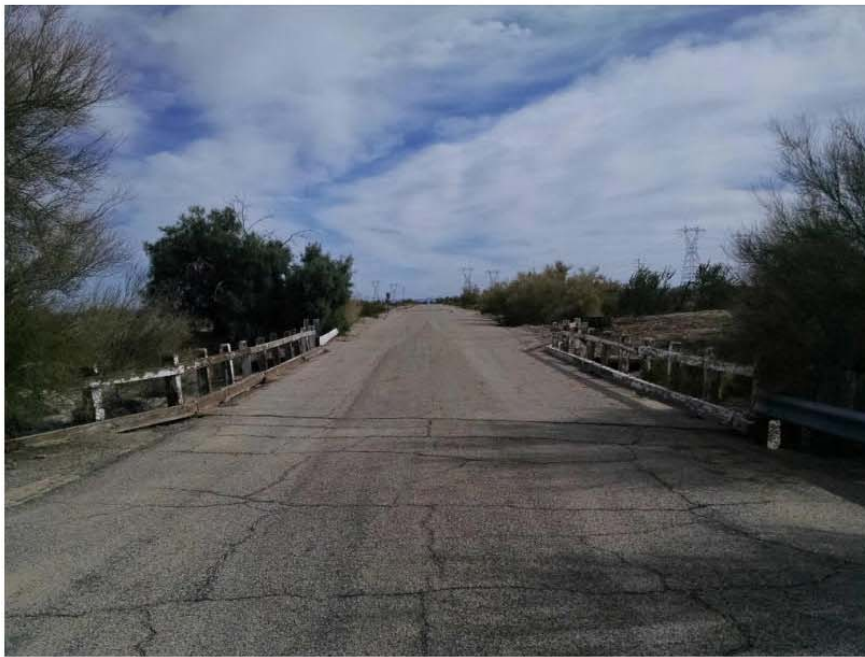
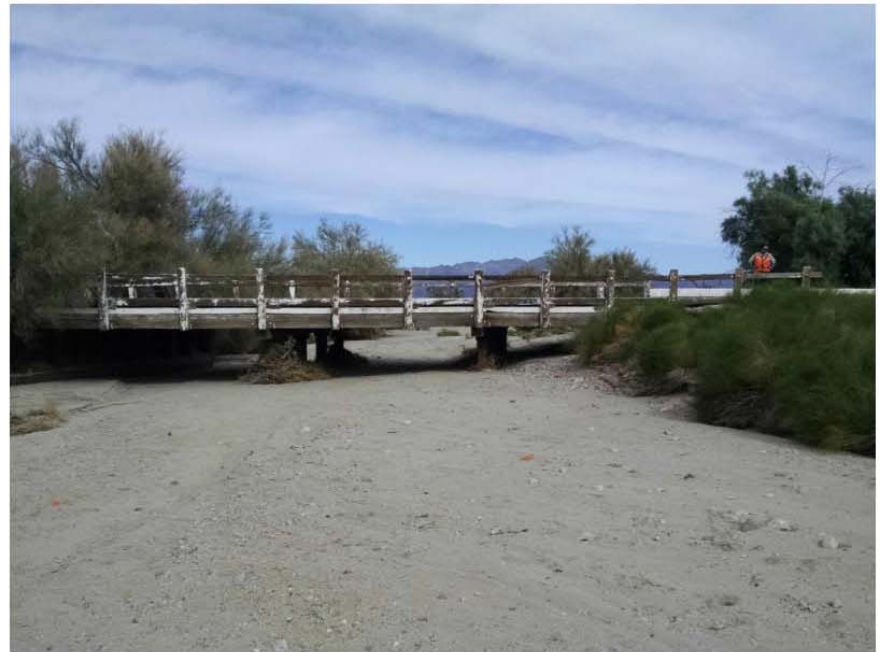
Figure 2. View from Bridge over Aztec Ditch

View Approaching Aztec Bridge

View from Aztec Ditch

Aztec Ditch Bridge is situated approximately 3 feet above the wash floor, supported by log piles treated with tar or creosote that are arranged against concrete abutments. The superstructure consists of a concrete deck covered with asphalt with timber posts lining the sides of the deck which support the metal guardrails. The structure appears to be in good condition. (See Figure 2. View from Bridge over Aztec Ditch).

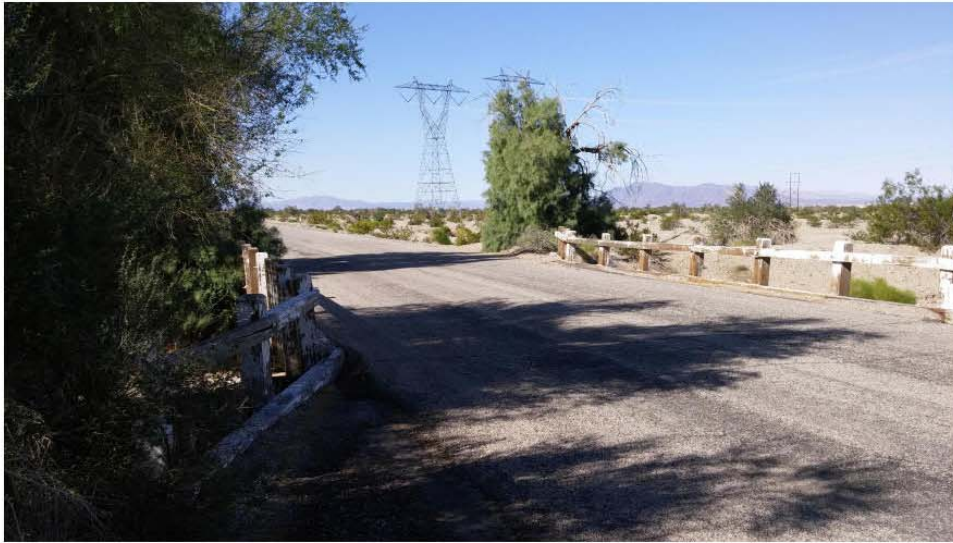
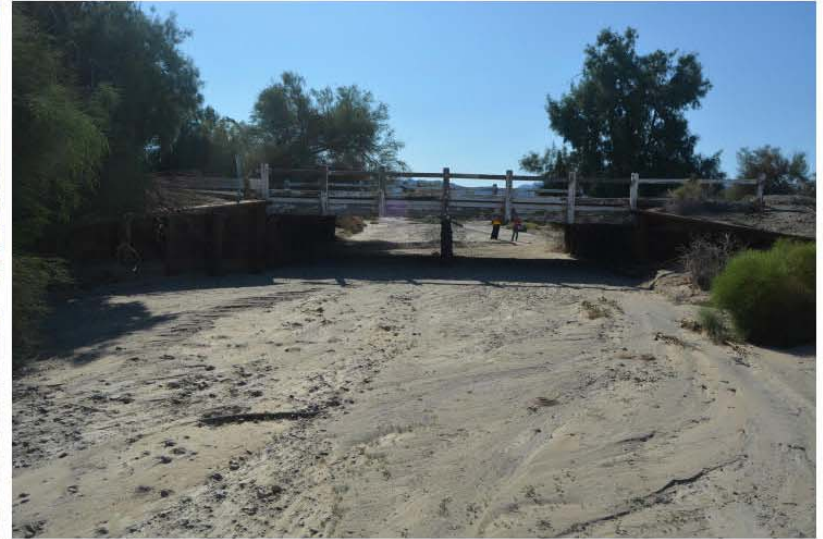
Figure 3. View from Bridge over Tarantula Ditch

View from Tarantula Bridge

View from Tarantula Ditch

Tarantula Ditch Bridge is situated approximately 3 feet above the wash floor, supported by log piles treated with tar or creosote arranged against timber abutments. The superstructure consists of a laminated wood and concrete deck, with timber posts lining the deck that support timber guardrails. The structure appears to be in good condition with some checks and staining in the wood. (See Figure 3. View from Bridge over Tarantula Ditch).

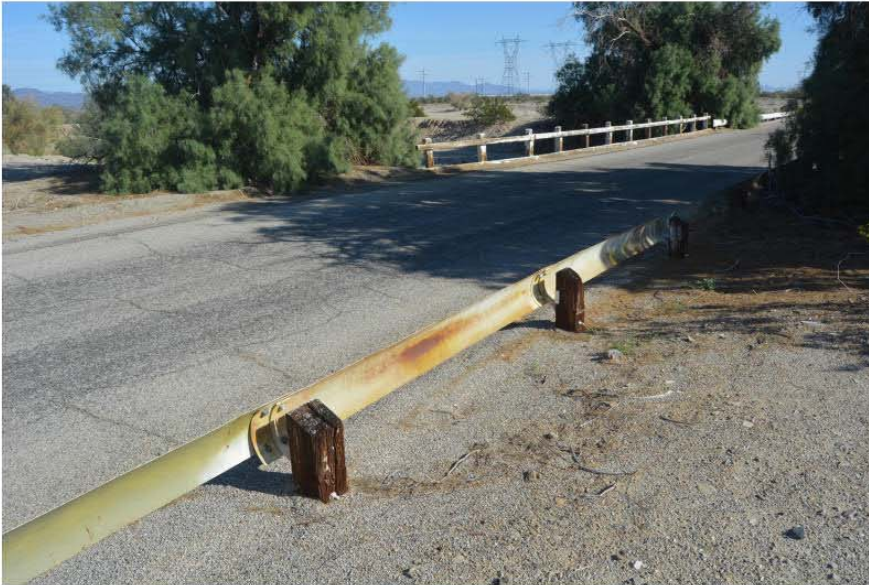
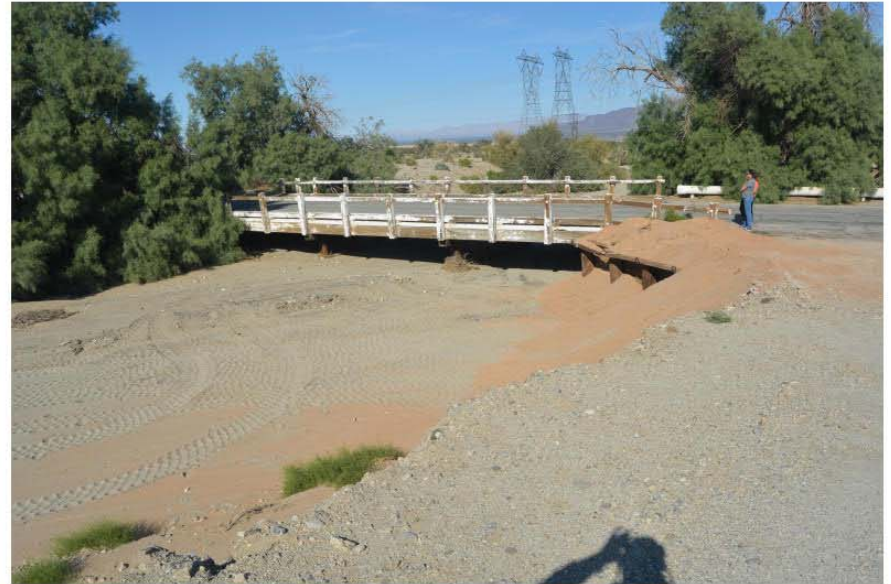
Figure 4. View from Bridge over Sutro Ditch

View from Sutro Bridge

View from Sutro Ditch

Sutro Ditch Bridge is situated approximately 3 feet above the wash floor, supported by log piles treated with tar or creosote arranged against timber abutments. The superstructure consists of a laminated wood and concrete deck, with timber posts lining the deck that support timber guardrails. Metal guardrails on wooden posts also lead to the bridge at the road approaches. The structure appears to be in good condition with some checks and staining in the wood. (See Figure 4. View from Bridge over Sutro Ditch).

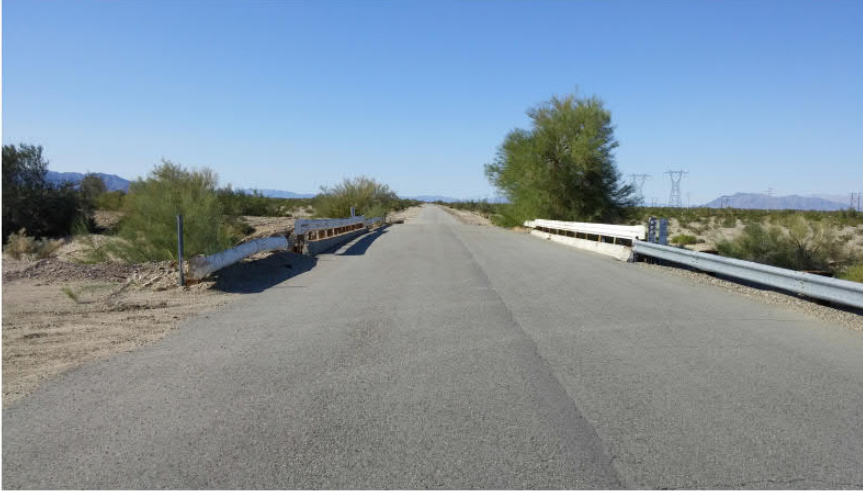
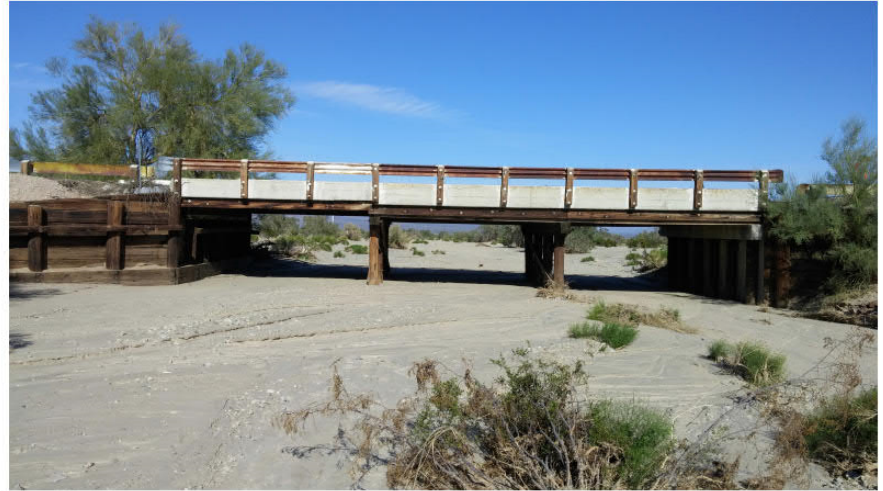
Figure 5. View from Bridge over Acari Ditch

View from Acari Bridge

View from Acari Ditch

Acari Ditch Bridge is situated approximately 7 feet above the wash floor, supported by redwood log piles treated with tar or creosote arranged against concrete abutments. The superstructure consists of a concrete deck covered with asphalt, with timber posts lining the deck that supports metal guardrails. Metal guardrails on wooden posts also lead to the bridge at the road approaches. The structure appears to be in good condition. (See Figure 5. View from Bridge over Acari Ditch).
