Chuckwalla Valley Road Bridge over Aztec Ditch (State Br. No. 56C0102)

Appendix H. Site Photographs for the Chuckwalla Valley Road Bridges (#56C0102, #56C0103, #56C0104, and #56C0108)

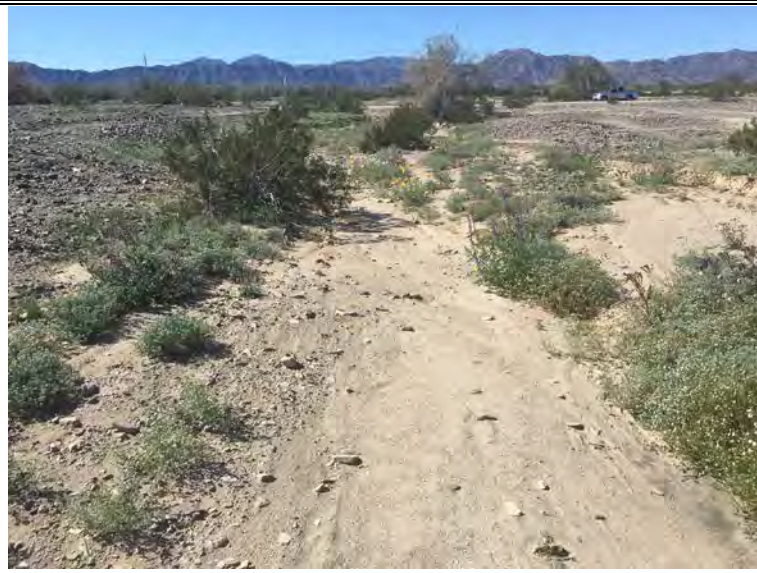
Photograph: 1-2

Comment: Looking downstream at Feature 1-6 where flows are conveyed from Chuckwalla Valley Road, but recent presumably routine grading had bermed the side of the road at the feature's origin.

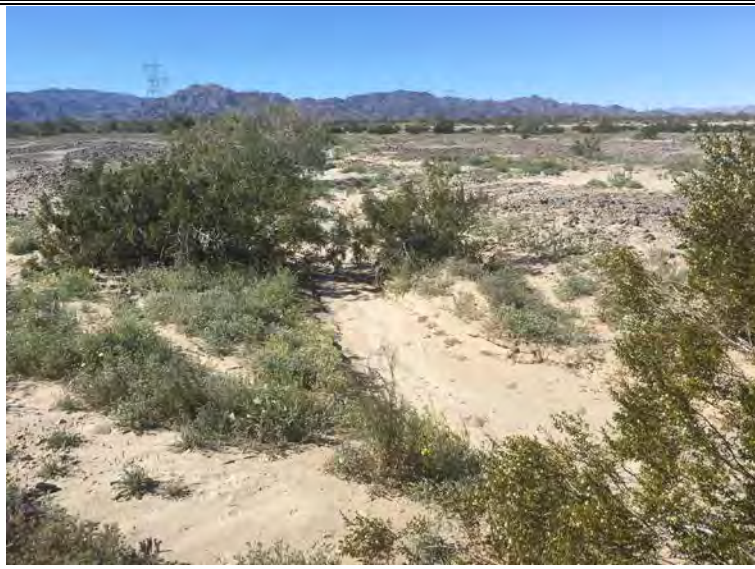
Photograph: 1-4

Comment: Looking upstream at Feature 1-2 (Aztec Ditch from the bridge on Chuckwalla Valley Road.

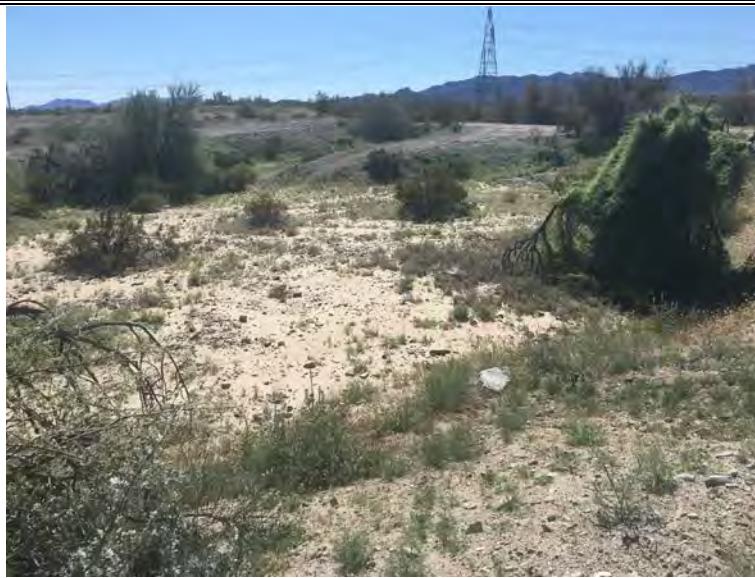
Photograph: 1-6

Comment: Area where flow from Feature 1-3 terminates, taken from the diversion dike.

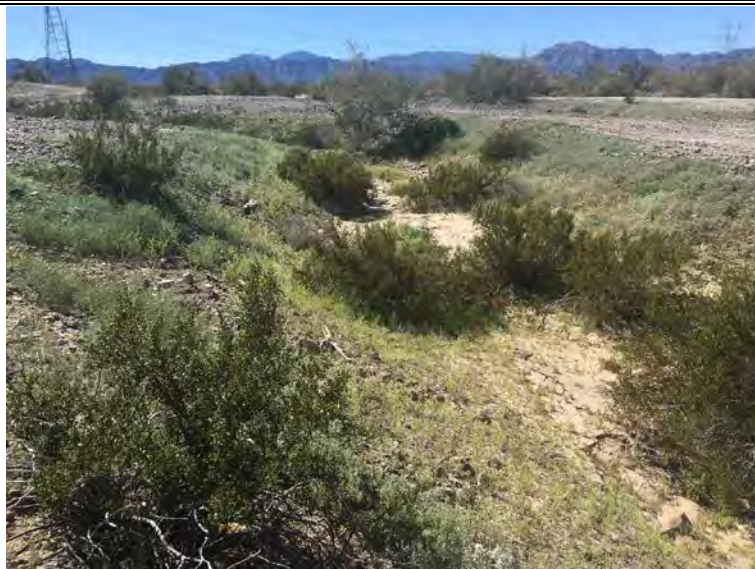
Photograph: 1-8

Comment: Looking upstream at Feature 1-4 from its confluence with Feature 1-3 near Chuckwalla Valley Road.

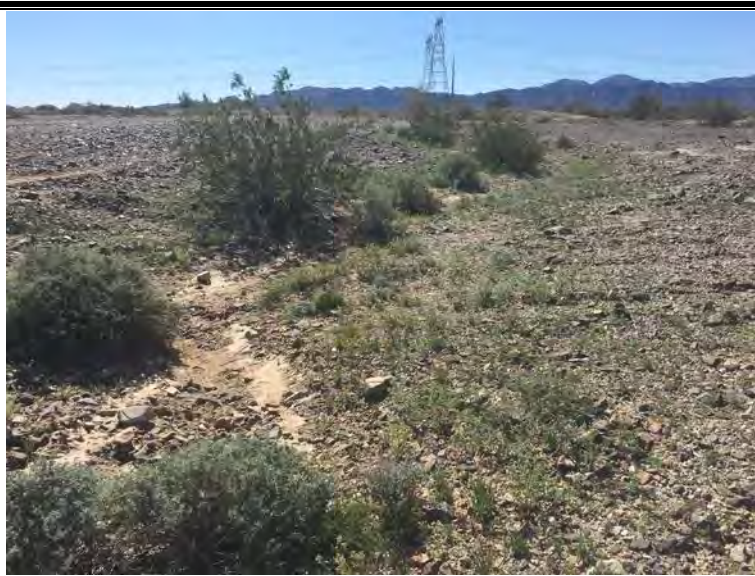
Photograph: 1-9

Comment: Looking downstream at the origin of Feature 1-5 along the south side of Chuckwalla Valley Road.

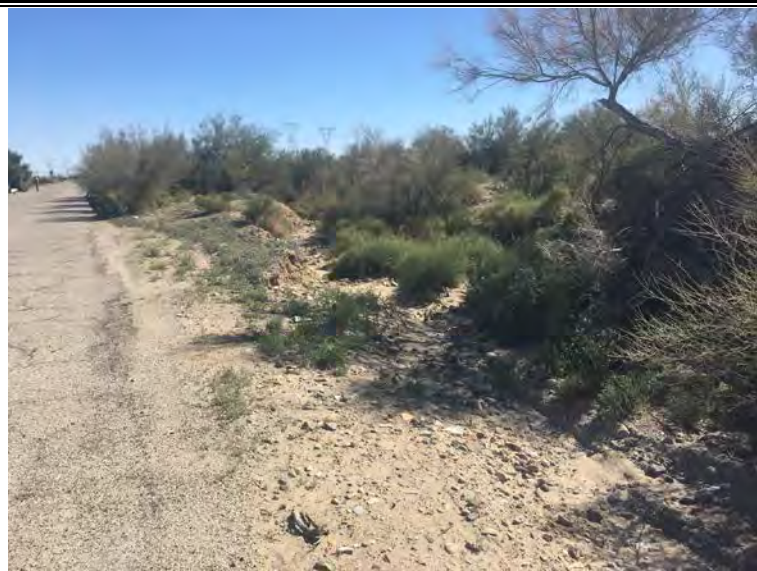
Photograph: 1-10

Comment: Looking downstream at one of the low flow channels within Feature 1-2 (Aztec Ditch).

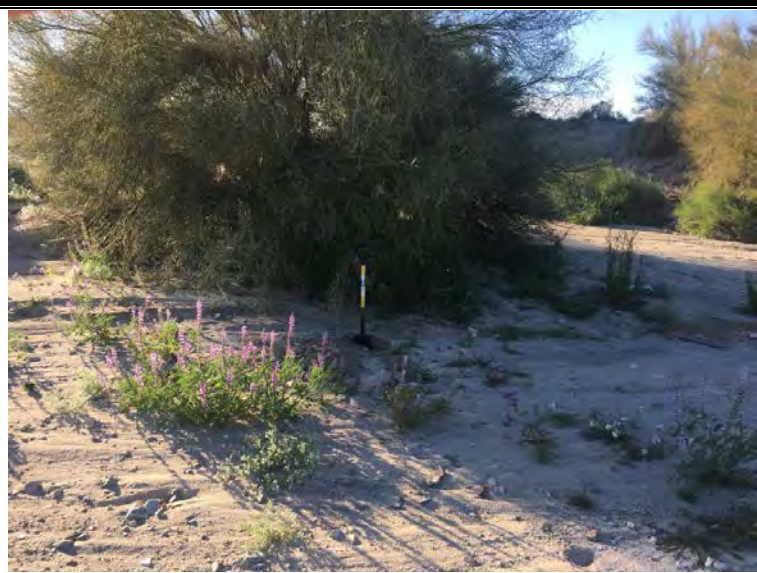
Photograph: 1-11
Photo Date: 02-19-2019
Location: Feature 2-1
Direction: Southeast
Comment: Looking upstream at Feature 2-1.

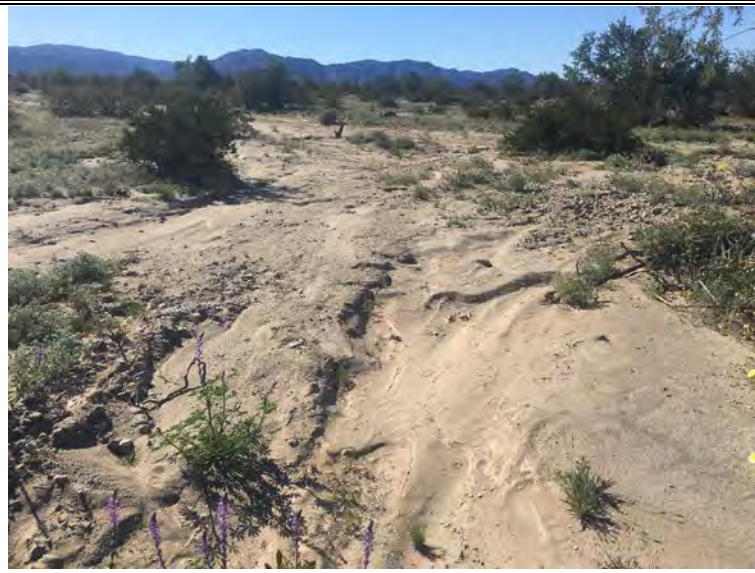
Photograph: 1-13
Photo Date: 02-19-2019
Location: Feature 2-2
Direction: Northwest
Comment: Looking at low point along the Chuckwalla Valley Road where Feature 2-2 terminates.

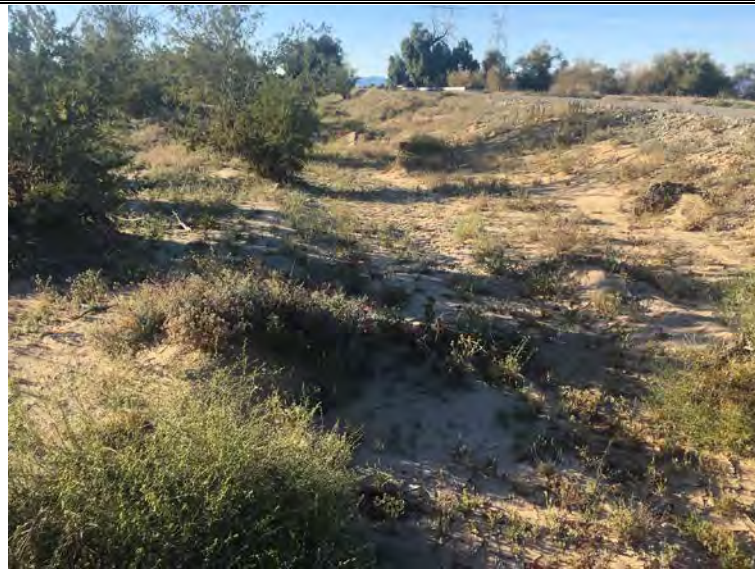
Photograph: 1-14
Photo Date: 02-19-2019
Location: Feature 2-2
Direction: Southwest
Comment: Looking upstream at Feature 2-2 from the diversion dike that splits Feature 2-2 from Feature 2-3.

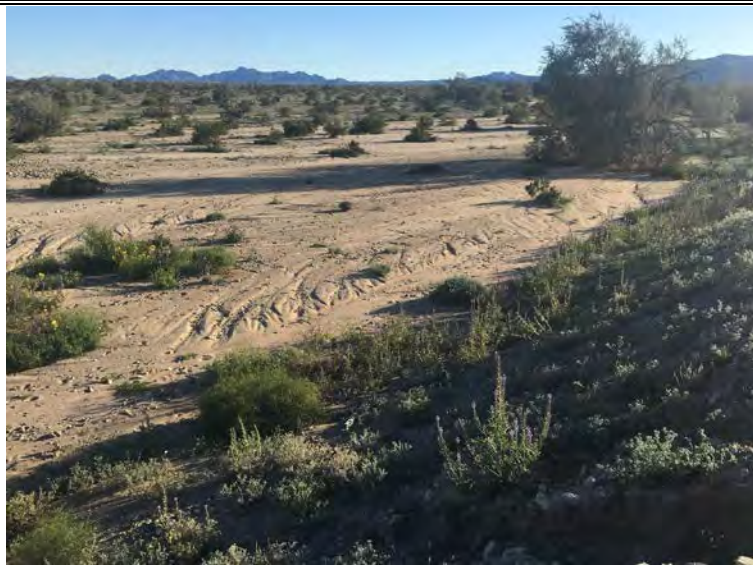
Photograph: 1-15
Photo Date: 02-19-2019
Location: Feature 2-3
Direction: Northeast
Comment: Looking downstream at one of the low flow channels within Feature 2-3.

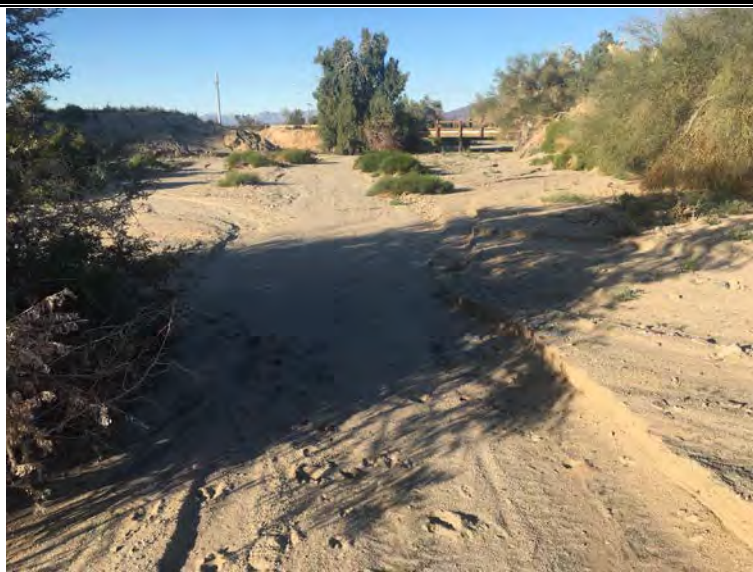
Photograph: 1-16
Photo Date: 02-19-2019
Location: Feature 2-3
Direction: Northwest
Comment: Looking upstream at Feature 2-3.

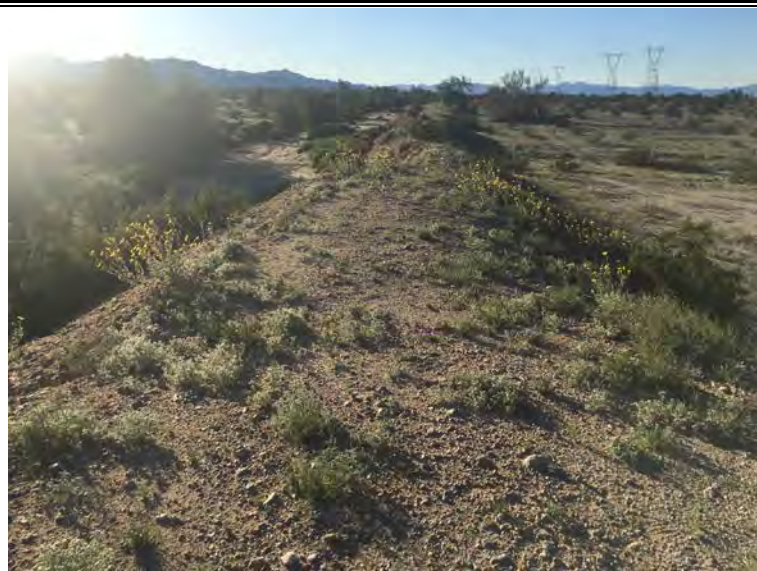
Photograph: 1-17
Photo Date: 02-19-2019
Location: Feature 2-3
Direction: West
Comment: View of the man-made diversion dike, taken from the top of the diversion dike along the west side of Feature 2-3.

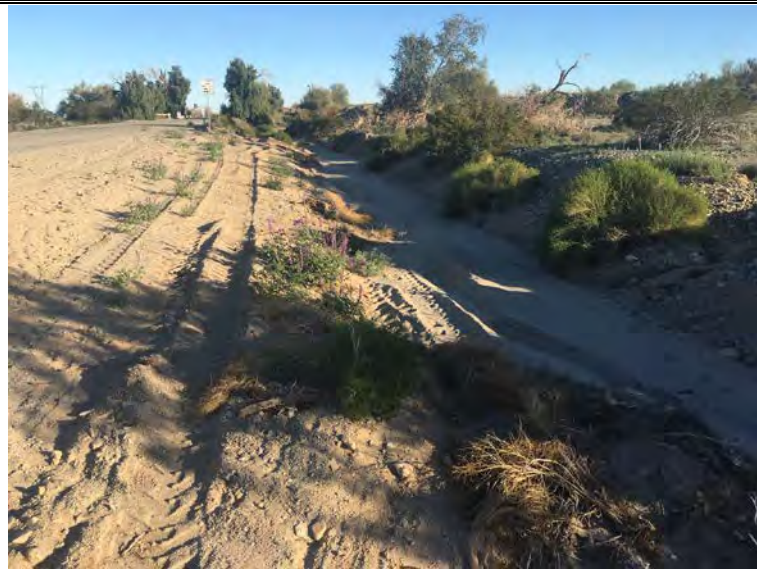
Photograph: 1-19
Photo Date: 02-19-2019
Location: Feature 2-4
Direction: South
Comment: Looking upstream at Feature 2-4 from where the feature flows into Feature 2-7.

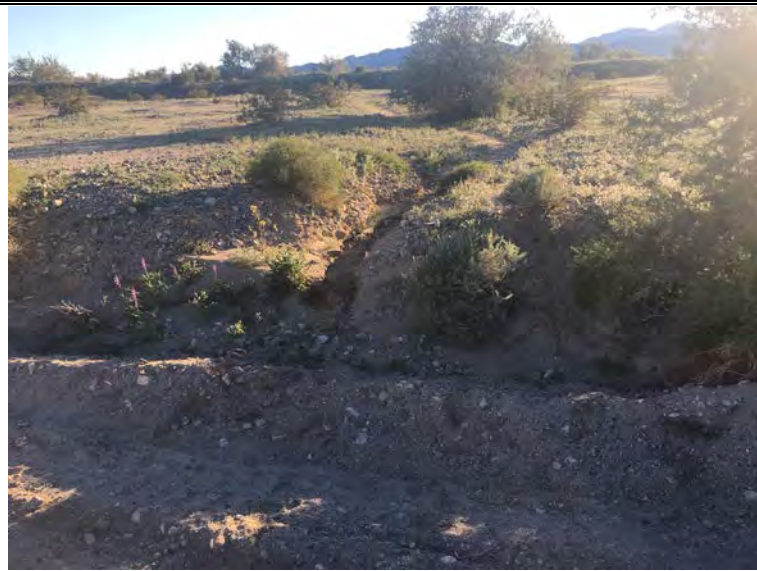
Photograph: 1-20
Photo Date: 02-19-2019
Location: Feature 2-5
Direction: Southwest
Comment: Looking upstream at Feature 2-5 from where the feature flows into Feature 2-7.

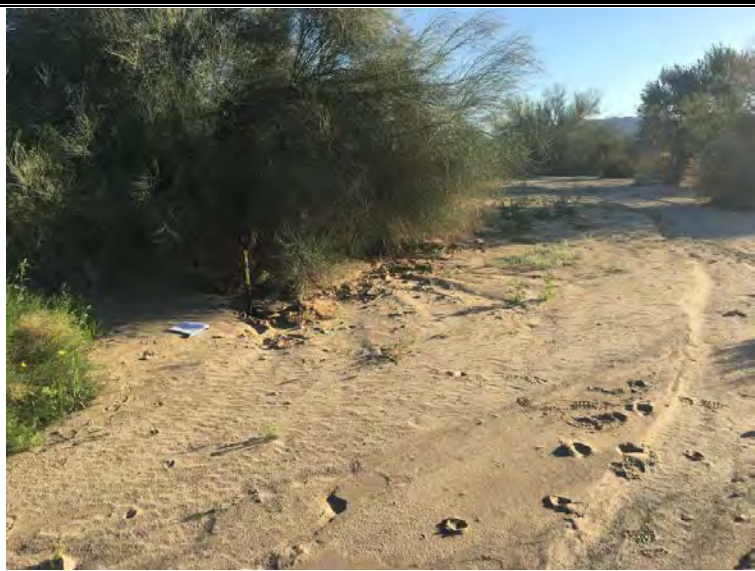
Photograph: 2-1
Photo Date: 02-27-2019
Location: Feature 3-1 and Feature 3-2
Direction: Southwest
Comment: Looking upstream at Feature 3-1 and Feature 3-2 from their confluence along Chuckwalla Valley Road.

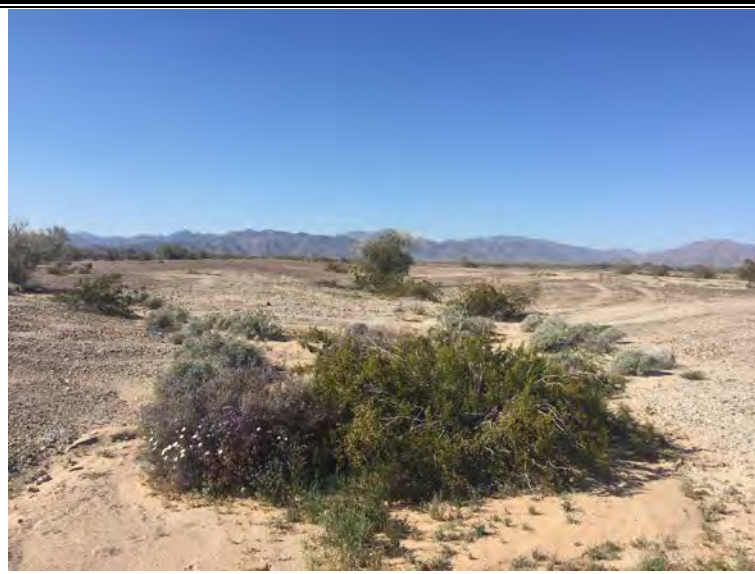
Photograph: 2-2
Photo Date: 02-27-2019
Location: Feature 3-2
Direction: Northeast
Comment: Looking downstream at Feature 3-2.

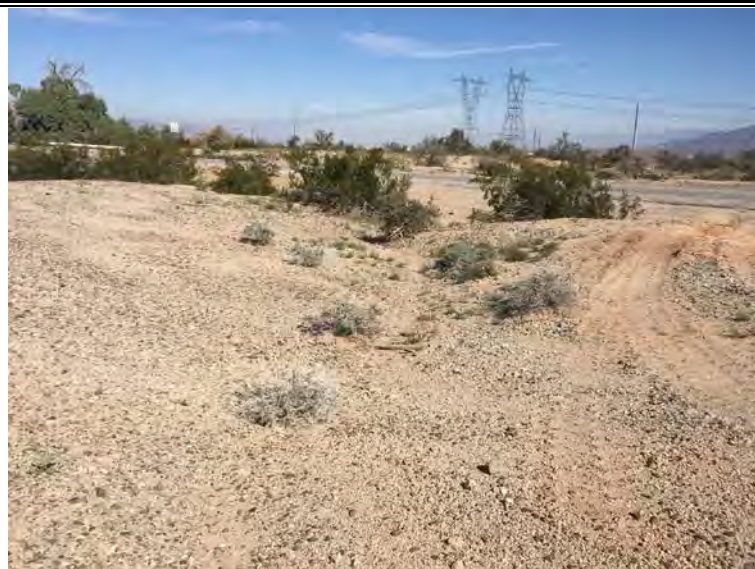
Photograph: 2-5
Photo Date: 02-27-2019
Location: Feature 3-4
Direction: South
Comment: Looking upstream at Feature 3-4 from its confluence with Feature 3-5.

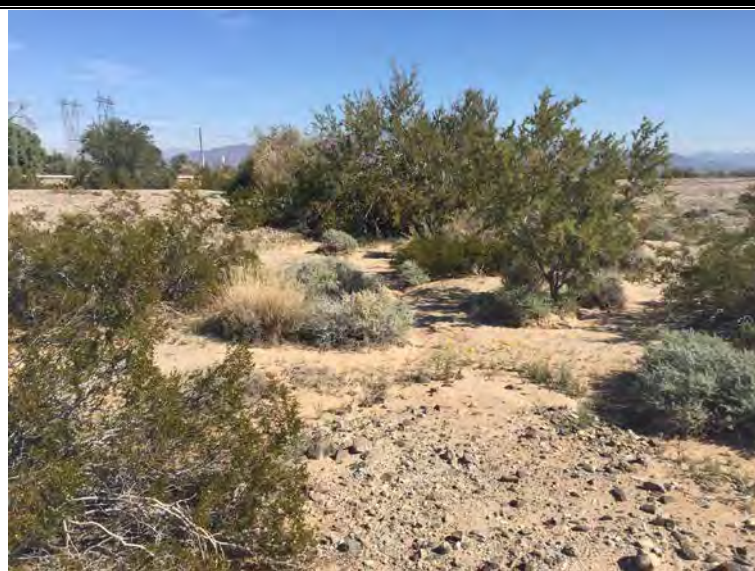
Photograph: 2-7
Photo Date: 02-27-2019
Location: Feature 3-5
Direction: South
Comment: Looking upstream at Feature 3-5 from its terminus at a low point along Chuckwalla Valley Road.

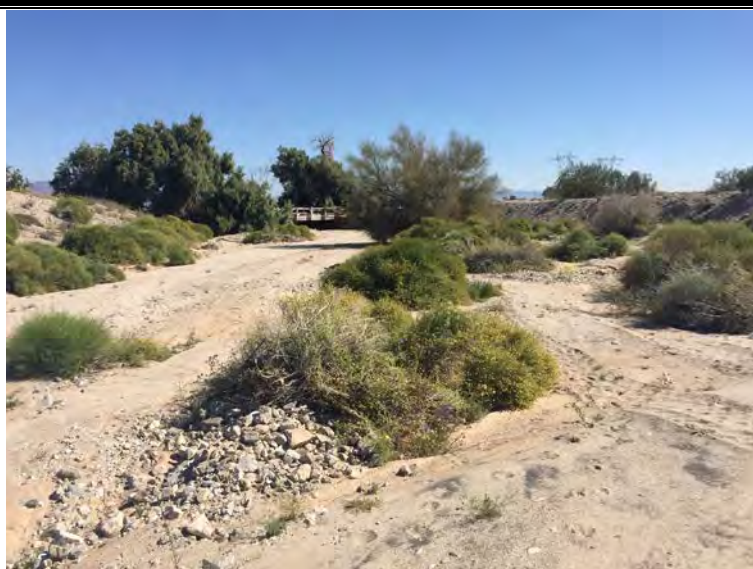
Photograph: 2-10
Photo Date: 02-27-2019
Location: Feature 3-8
Direction: Northeast
Comment: Looking downstream at Feature 3-8 from the top of the diversion dike on the east side of the channel.

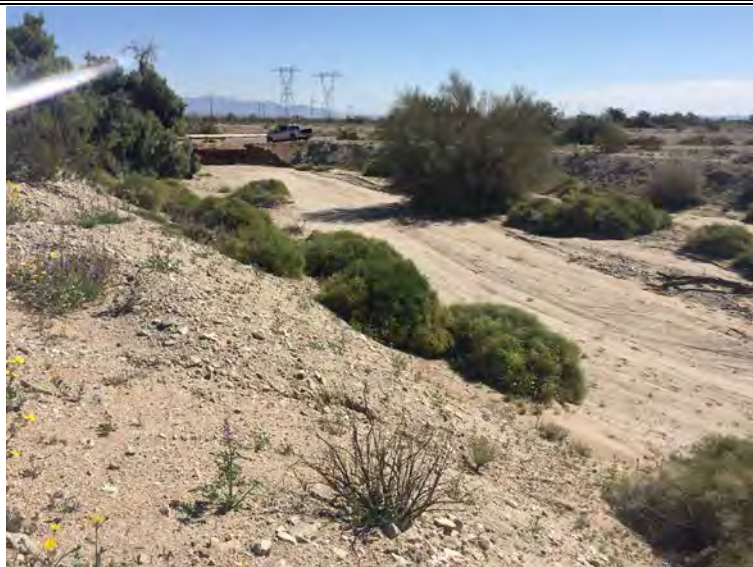
Photograph: 2-11
Photo Date: 02-27-2019
Location: Feature 3-7
Direction: Southeast
Comment: Looking downstream at Feature 3-7 flowing towards Feature 3-8 near the bridge.

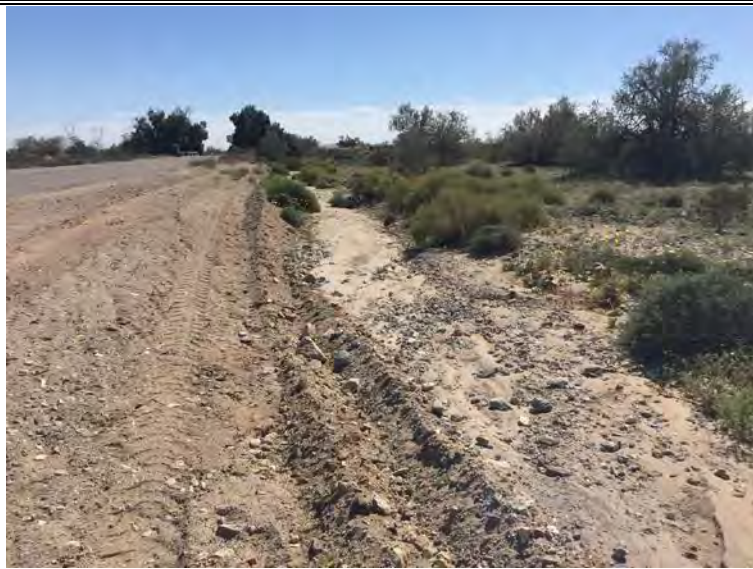
Photograph: 2-15

Comment: Looking downstream at Feature 3-9 from where it runs over old asphalt. It runs parallel to Chuckwalla Valley Road.

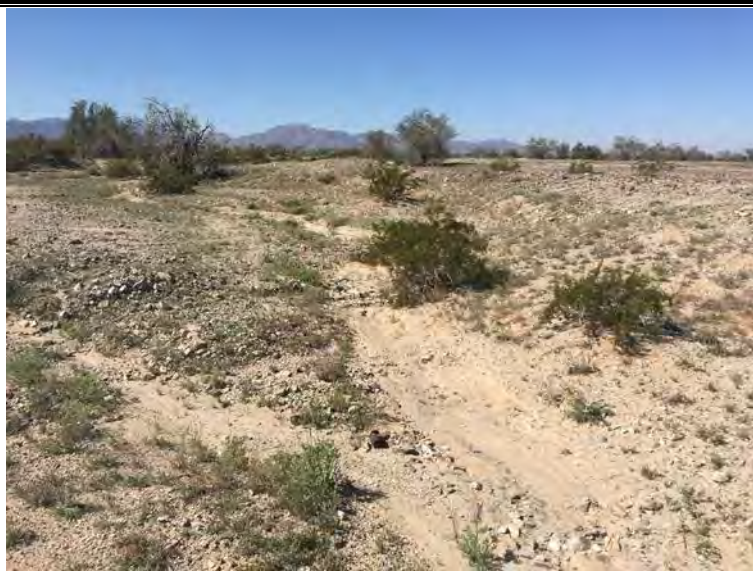
Photograph: 2-18
Photo Date: 02-27-2019
Location: Feature 3-8
Direction: Southwest
Comment: Looking upstream at Feature 3-8 from where the diversion dike meets Chuckwalla Valley Road.

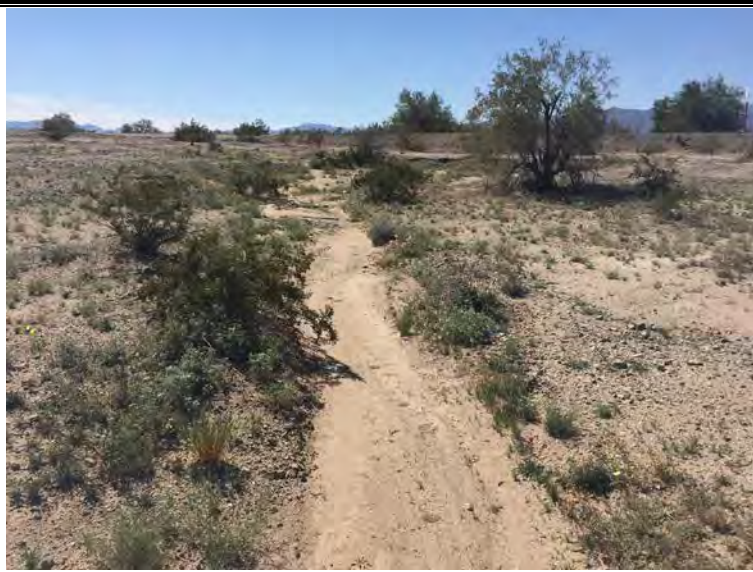
Photograph: 2-20
Photo Date: 02-27-2019
Location: Feature 3-8
Direction: North
Comment: Looking downstream at Feature 3-8 from the diversion dike along the east side of Chuckwalla Valley Road.

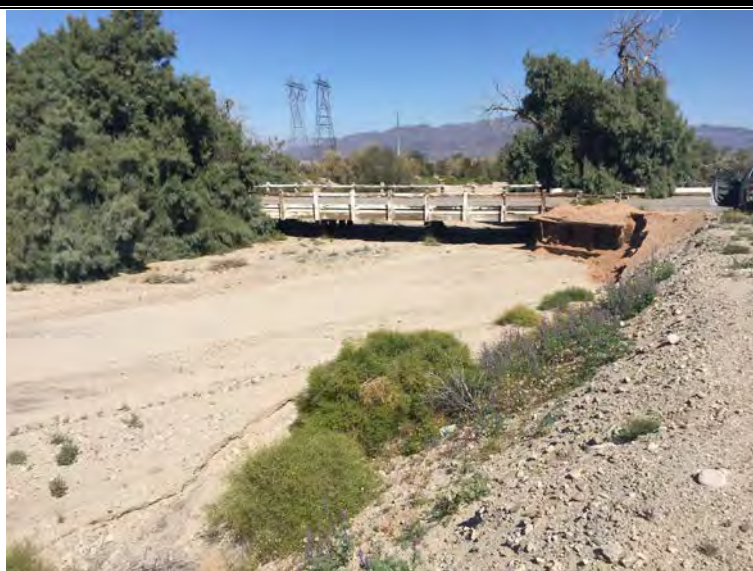
Photograph: 2-21
Photo Date: 02-27-2019
Location: Feature 3-8
Direction: Southwest
Comment: Looking upstream at Feature 3-8 from the diversion dike along the east side of the channel.

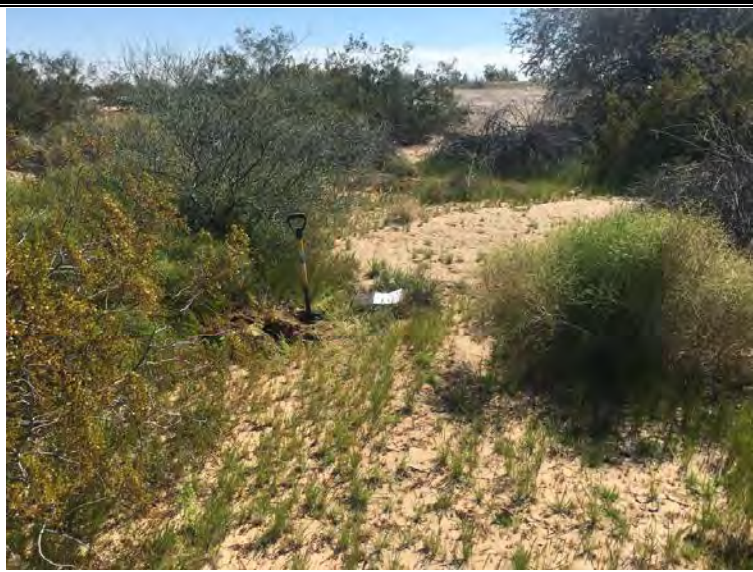
Photograph: 2-47
Photo Date: 02-27-2019
Location: Feature 3-5
Direction: South
Comment: Looking at SP 1 within the low point displaying soil cracks at the terminus of Feature 3-5.

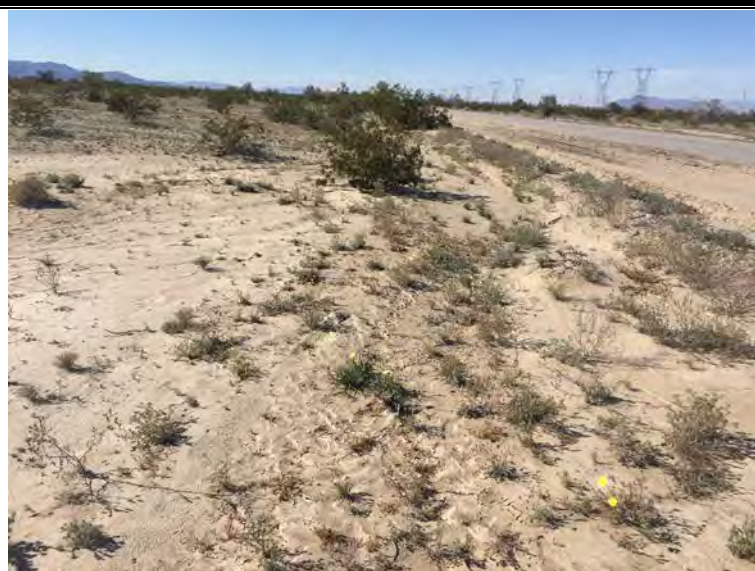
Photograph: 2-30
Photo Date: 02-27-2019
Location: Feature 4-5
Direction: Northwest
Comment: Looking upstream at Feature 4-5 from the area containing soil cracks where the feature terminates.

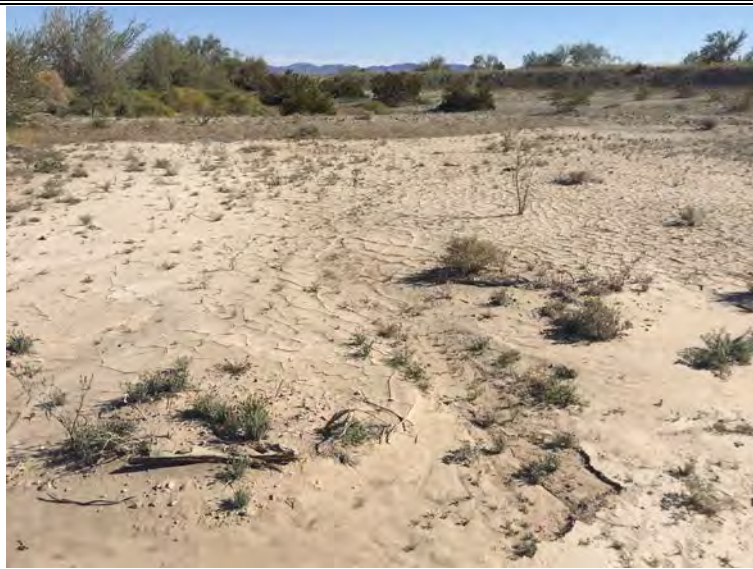
Photograph: 2-31
Photo Date: 02-27-2019
Location: Feature 4-5
Direction: South
Comment: Area containing soils cracks where Feature 4-5 terminates.

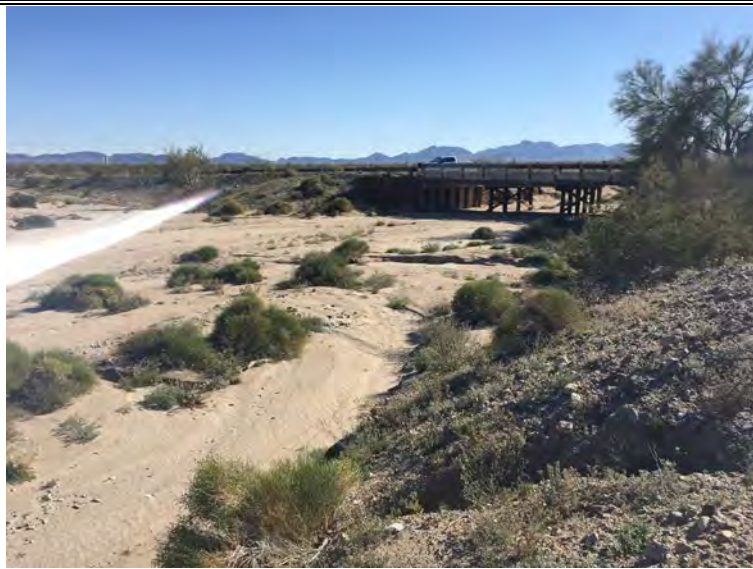
Photograph: 2-34

Comment: Looking upstream at Feature 4-4 from the diversion dike along the west side of the channel.

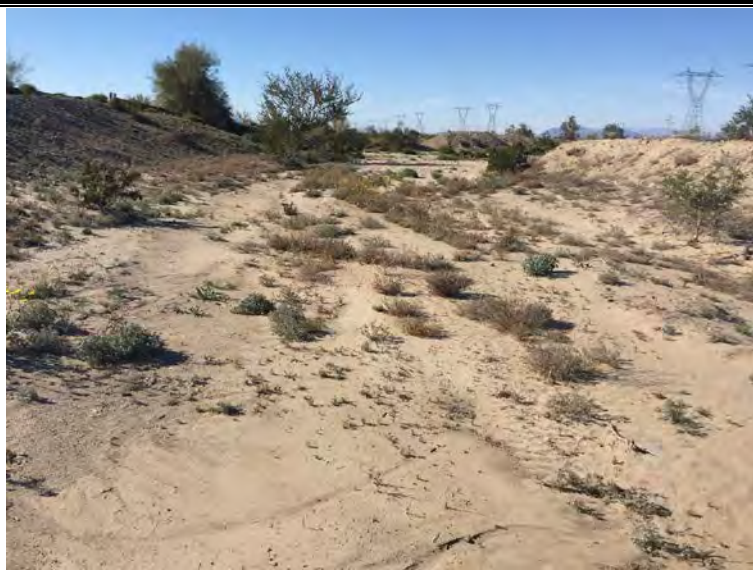
Photograph: 2-36

Comment: Low point where water sits, but does not exhibit flow or hydrophytic vegetation, looking towards Feature 4-4.

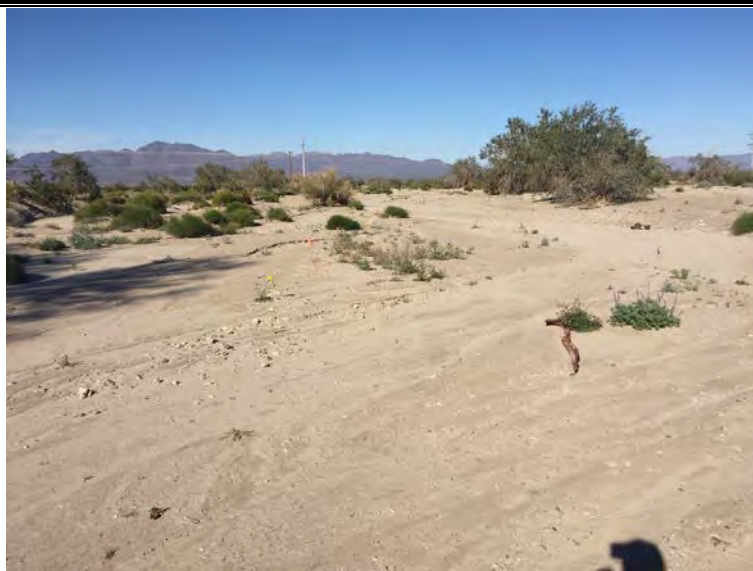
Photograph: 2-38

Comment: Looking downstream at Feature 4-4.

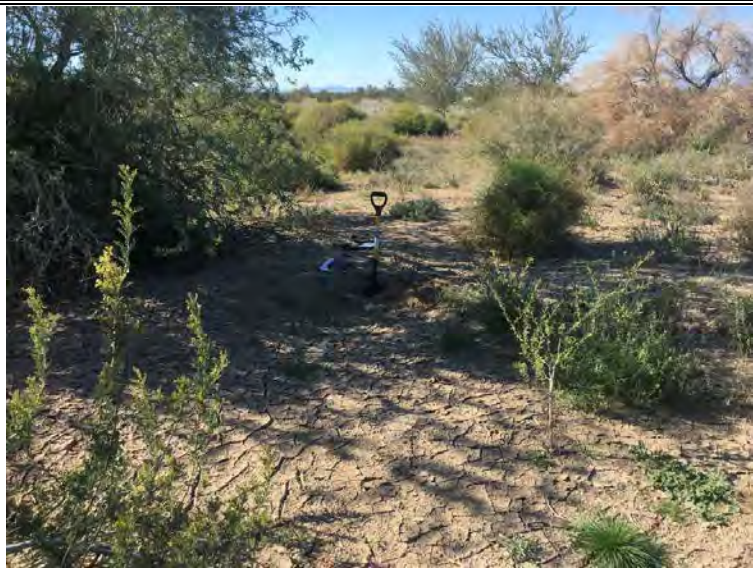
Photograph: 2-49

Comment: Looking at SP 3 within area containing soil cracks to the west of the western diversion dike, south of Chuckwalla Valley Road.

Remarks: Pit w/ln low spot of cracked soil area.

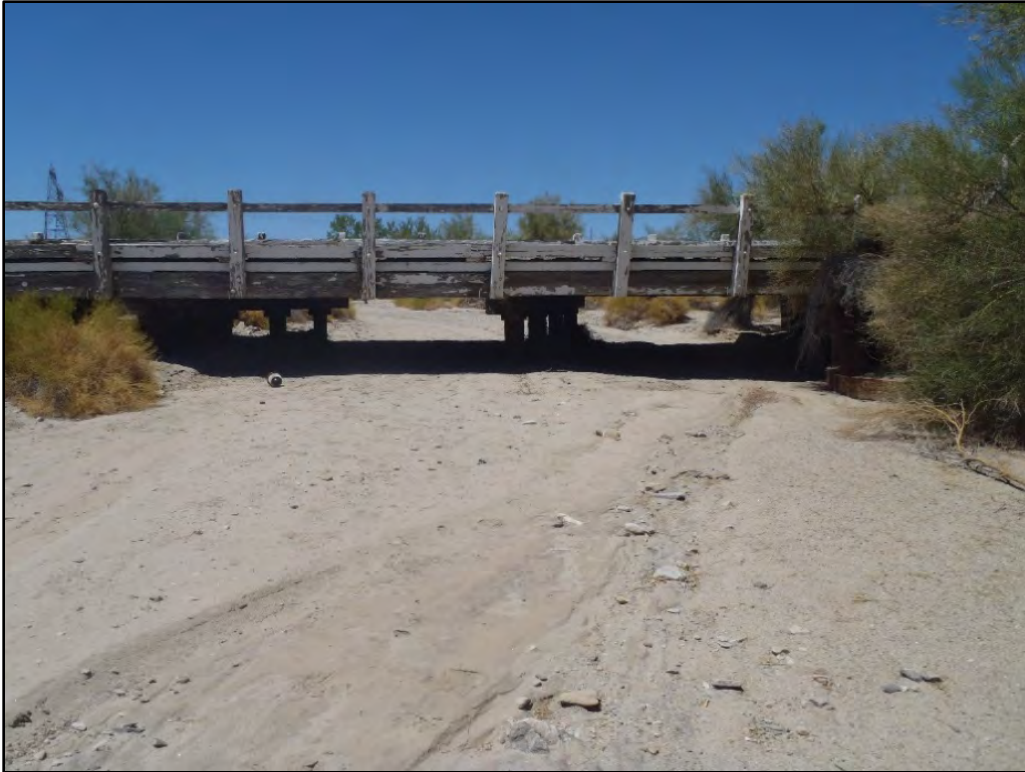
Photo 1. View southwest of Aztec Ditch Bridge (#56C0102) and the desert wash.

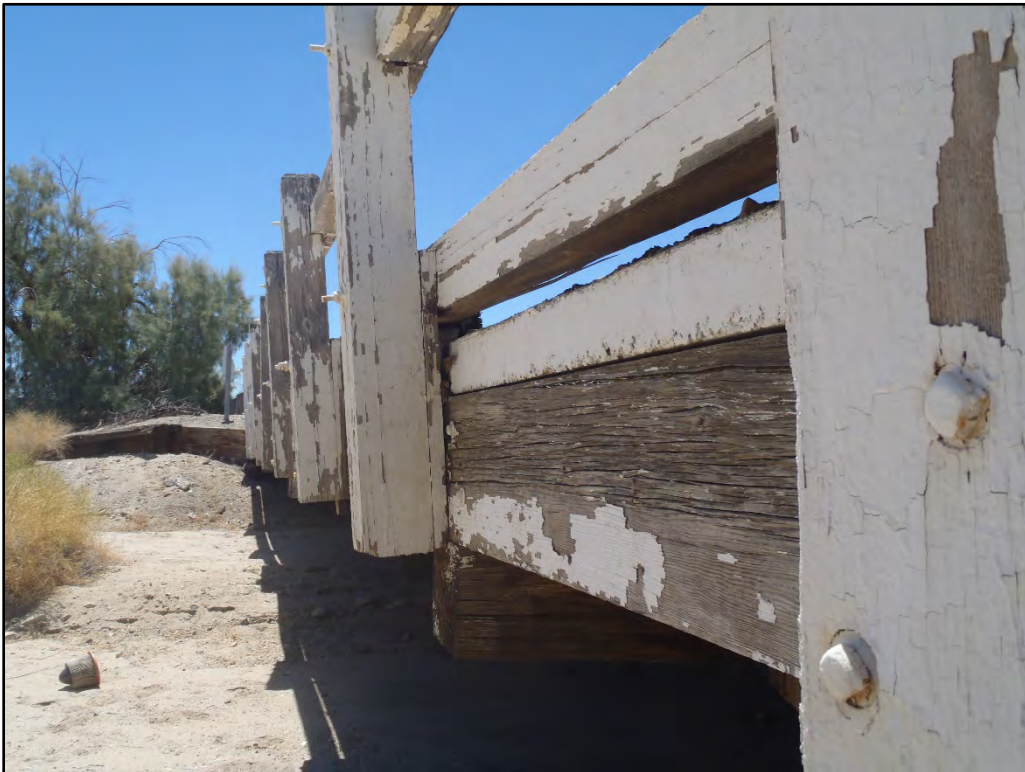
Photo 2. View of the timber bridge at Aztec Ditch.

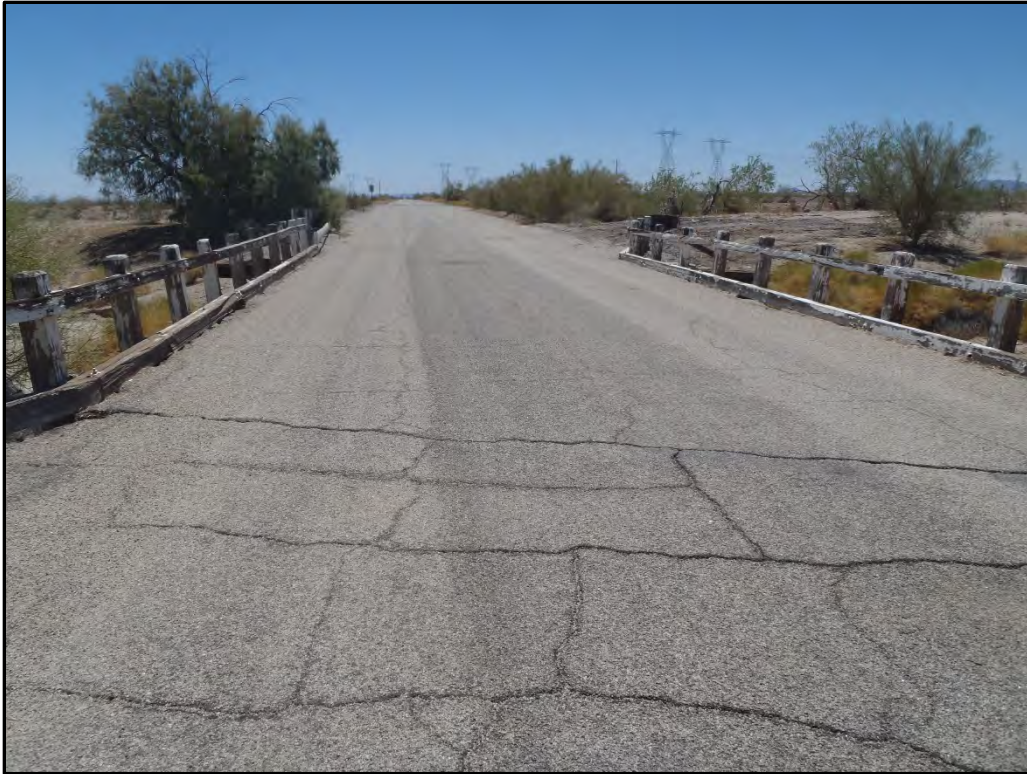
Photo 3. View of Chuckwalla Valley Road at Aztec Ditch Bridge (#56C0102).

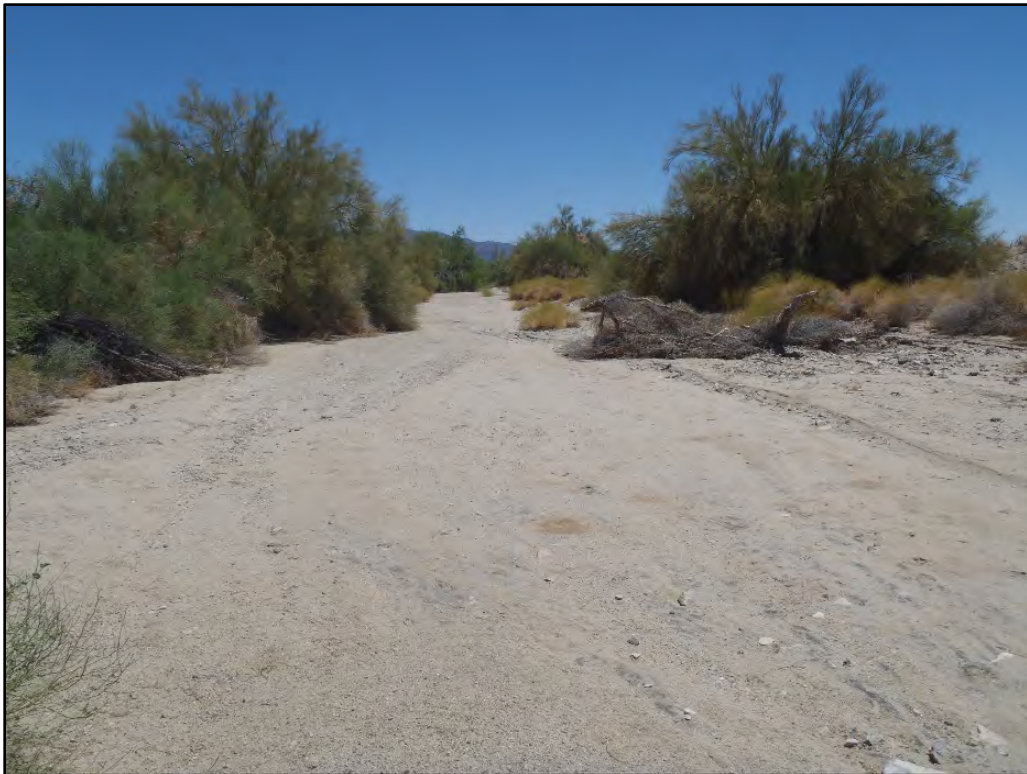
Photo 4. View north from Aztec Ditch Bridge (#56C0102) and the desert wash.

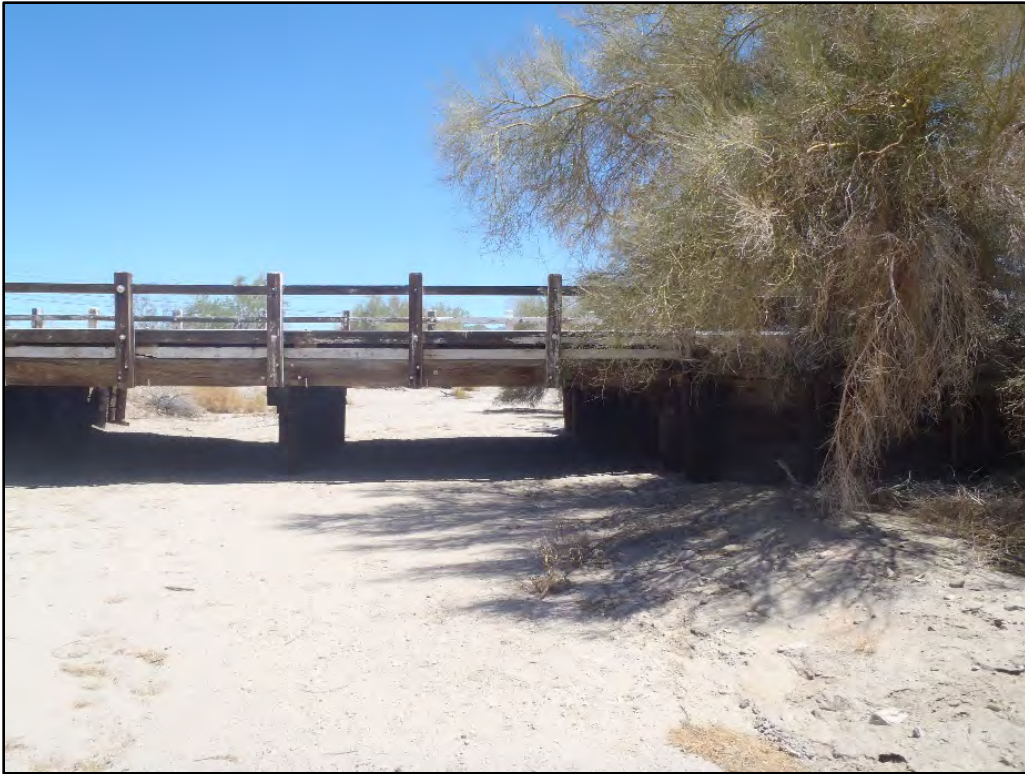
Photo 5. View southwest of Tarantula Ditch Bridge #56C0103) and the desert wash under the existing timber bridge.

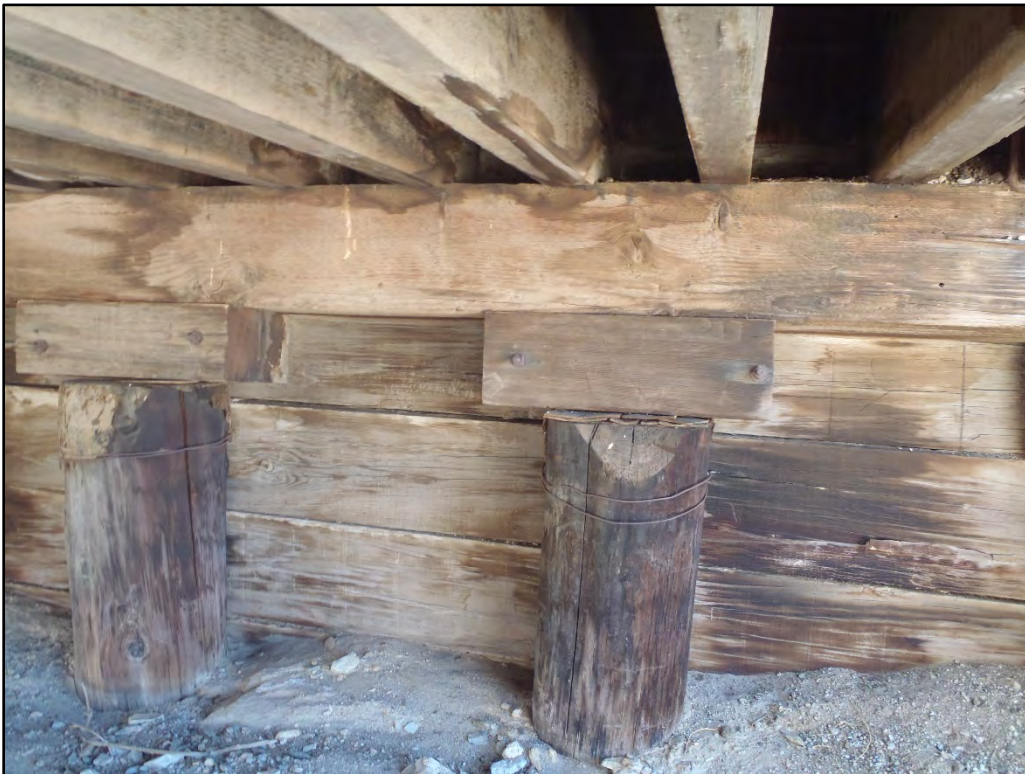
Photo 6. View of existing bridge footings at Tarantula Ditch Bridge (#56C0103).

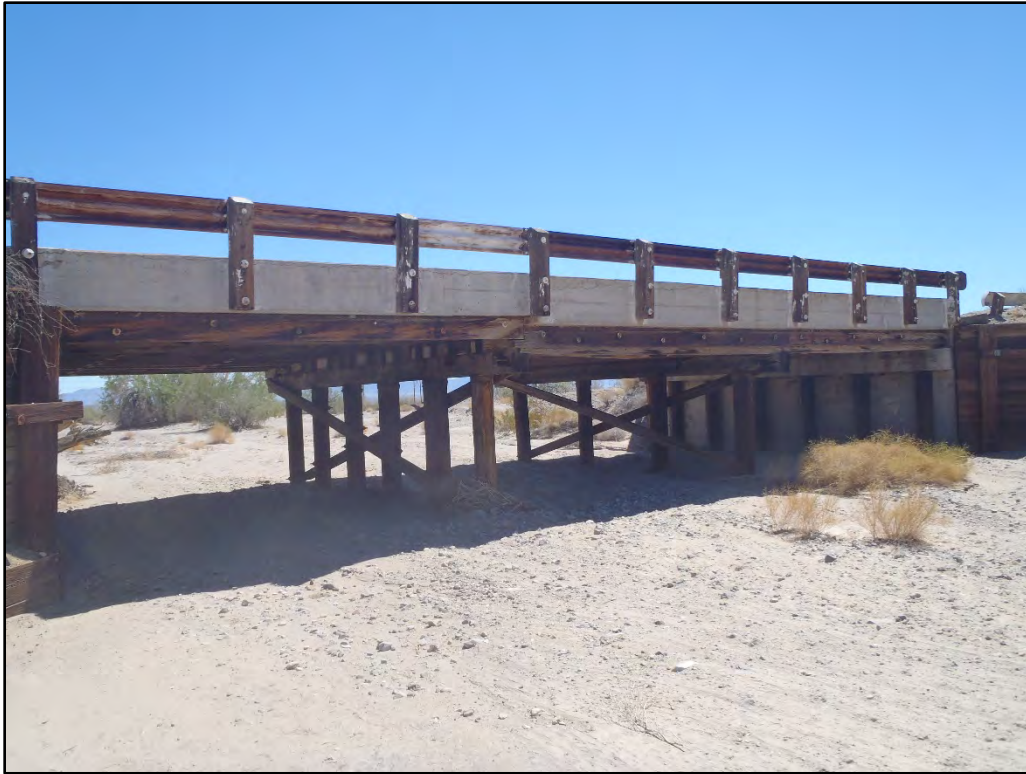
Photo 7. View of Sutro Ditch Bridge (#56C0104).

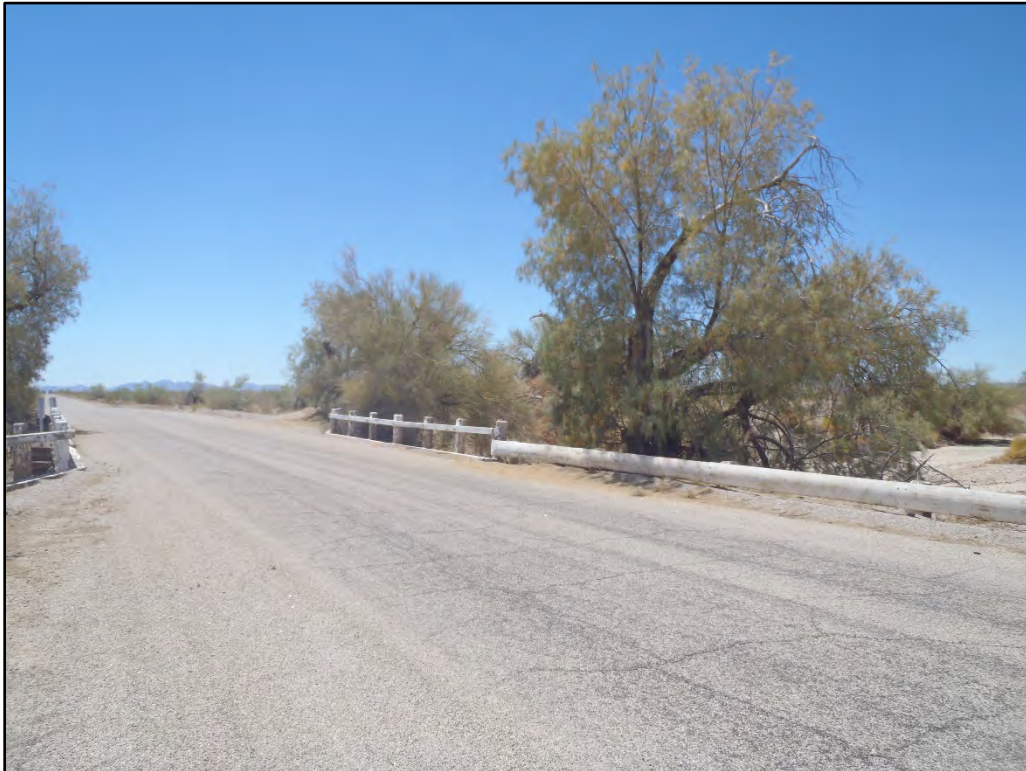
Photo 8. View of Chuckwalla Valley Road adjacent to Sutro Ditch Bridge (#56C0104).

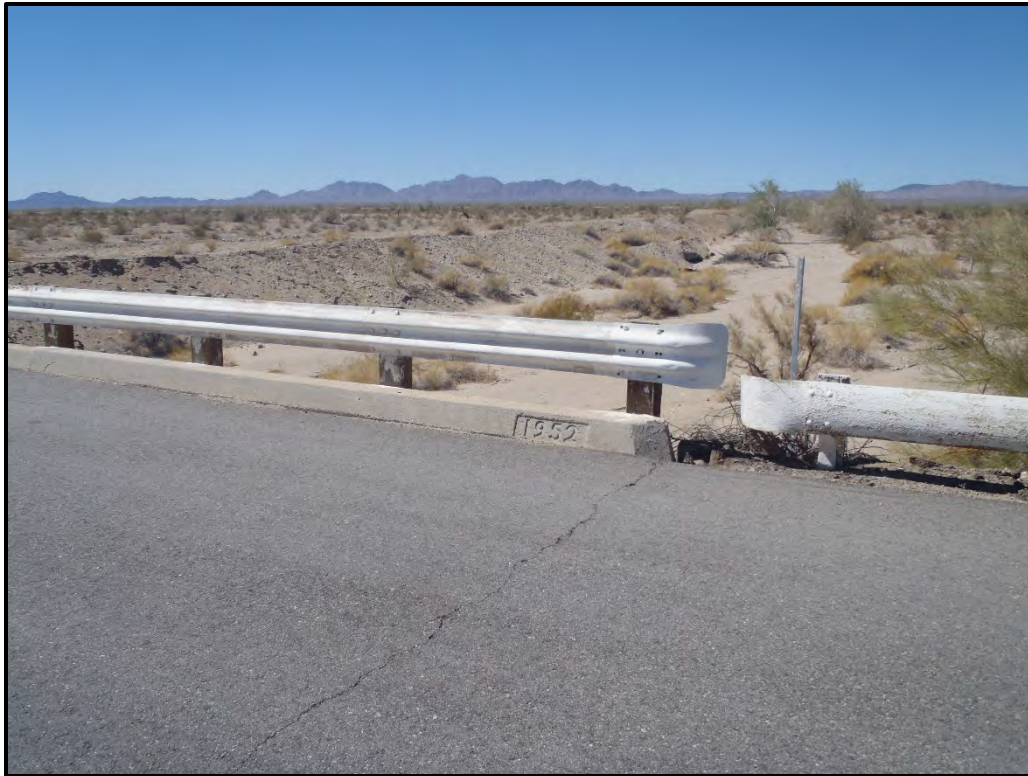
Photo 9. View downstream of the Acari Ditch Bridge (#56C0108).

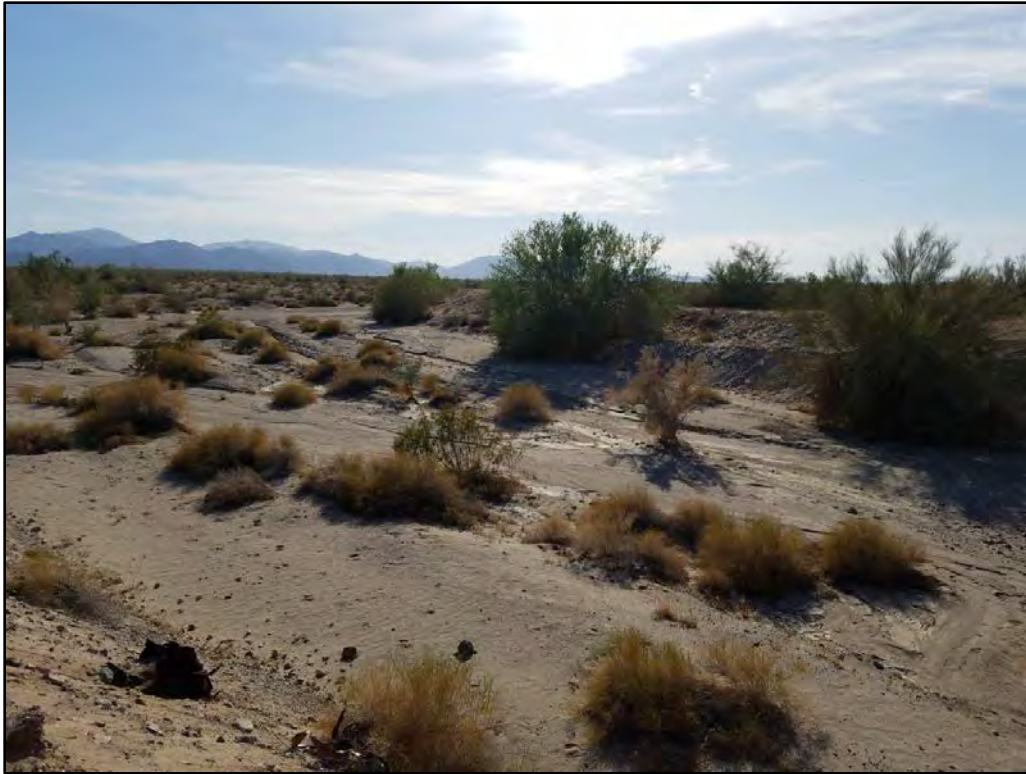
Photo 11. View of vegetated portions of the desert wash from Acari Ditch Bridge (#56C0108). Diversion dikes are present in along the banks of the wash. Facing west.
