Skyview Road Pedestrian Bridge Project

MSHCP Consistency Analysis

Riverside County
California

Discussion of Consistency with MSHCP Requirements

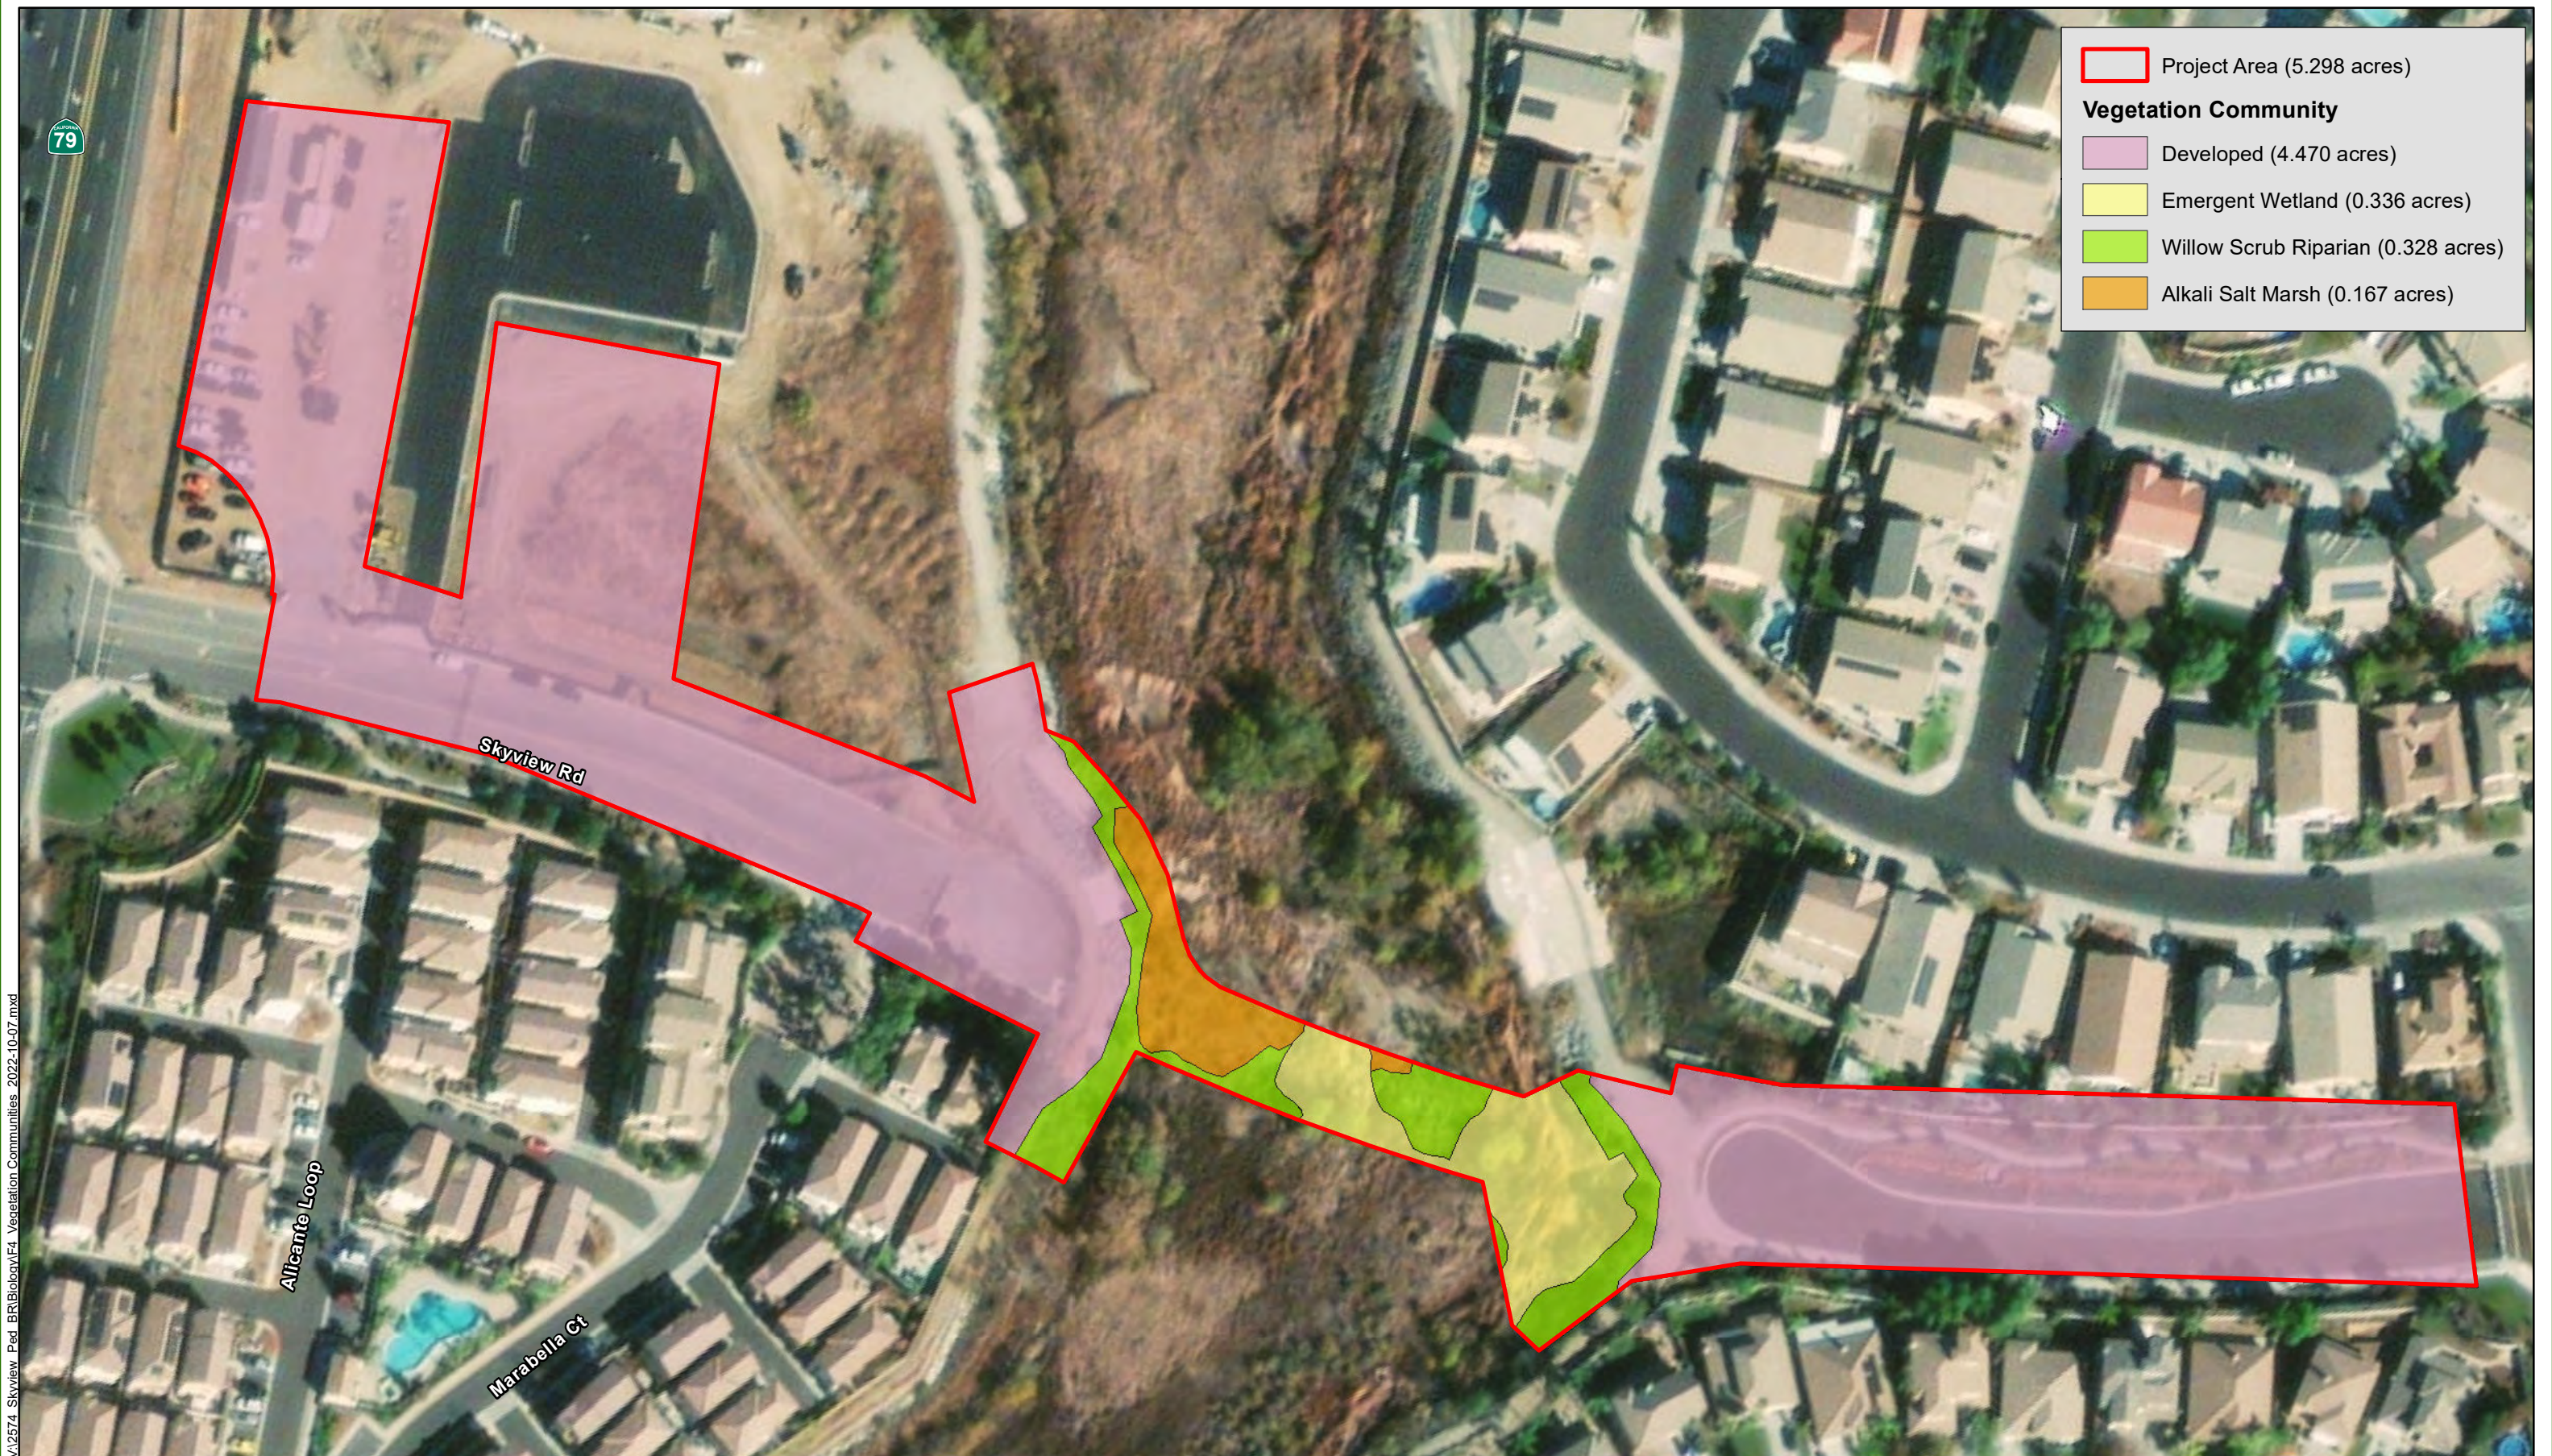
Figure 4
Vegetation Communities
 Skyview Road Pedestrian Bridge Project
 Winchester, Riverside County, California

| | Project Area (5.298 acres) |

Due to the presence of riparian habitat features as well as the various Additional Survey Needs and Procedures required for this Project, a Project-level vegetation map is required. Natural vegetation communities found within the Project area are limited to the French Valley Creek corridor, which includes emergent wetland (0.336 acres), willow riparian scrub (0.328 acres), and alkali salt marsh (0.167 acres). These natural plant communities were identified during biological surveys, mapped aerially, and are depicted in Appendix B – Figure 4. Vegetation Communities. Potential impacts to these sensitive communities can be viewed on Appendix B – Figure 5. Project Impacts. Sensitive habitat communities are discussed in more detail below.

Willow riparian scrub habitat within the French Valley Creek corridor consists of thickets of arroyo willow (*Salix lasiolepis*) and tamarisk (*Tamarix ramosissima*) with mule fat (*Baccharis salicifolia*) and various forb species found in more open areas of this habitat type. Approximately 0.328 acres of this habitat type are found along both levees and immediately upslope of emergent vegetation.

Alkali salt marsh habitat is found in portions of the French Valley Creek corridor that were re-graded in 2014 as part of a separate creek realignment project. This habitat type is thinly vegetated with mulefat, big saltbush (*Atriplex lentiformis*), and several species of annual halophytes. Approximately 0.167 acres of this habitat type are present within the Project area.

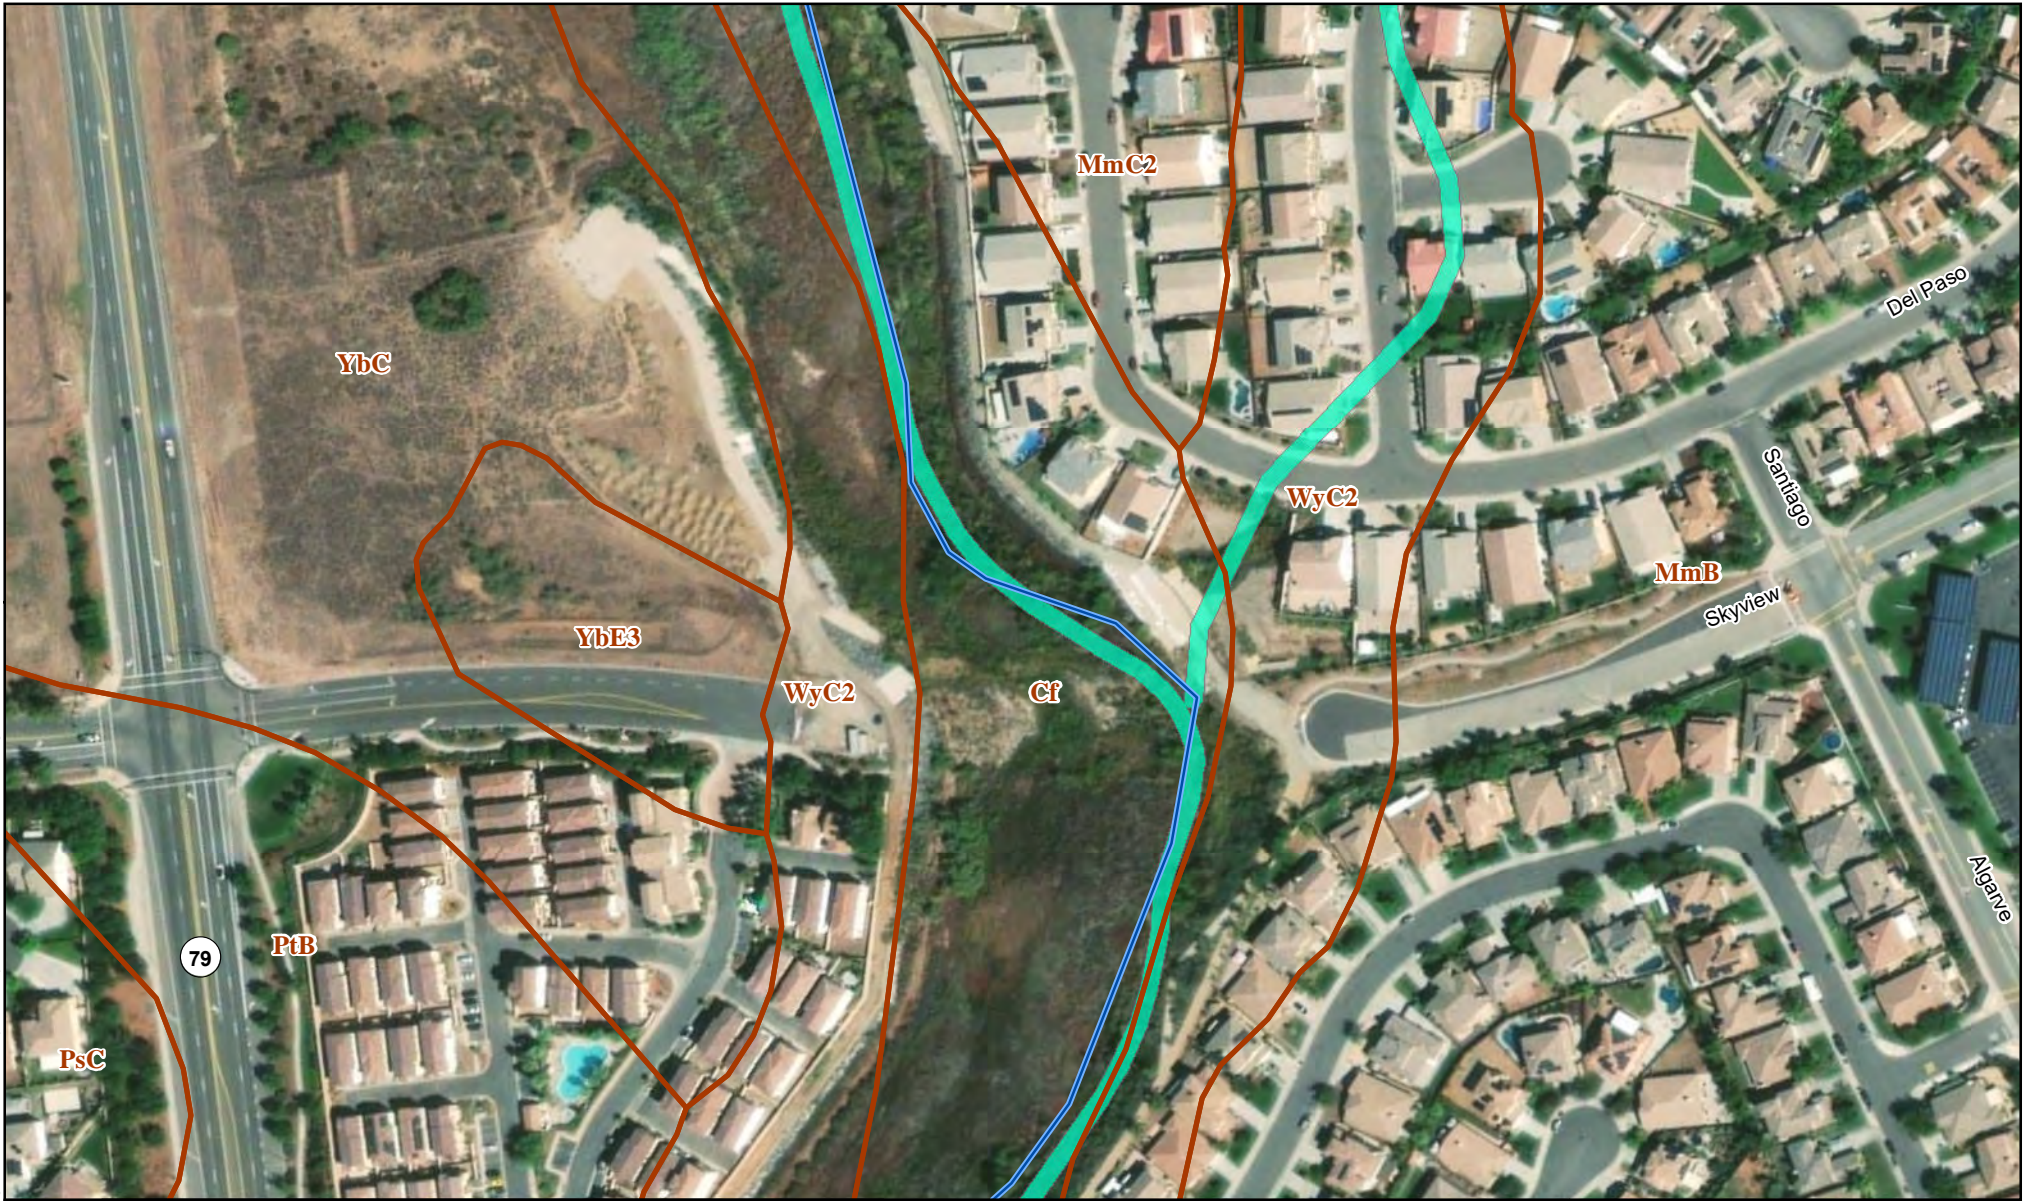
Skyview Road Pedestrian Bridge
Wetlands and Waterways
NHD, NWI, and Soils Map

- Stream (NHD)
- Riverine (NWI)
- Soil Unit (NRCS SSURGO)

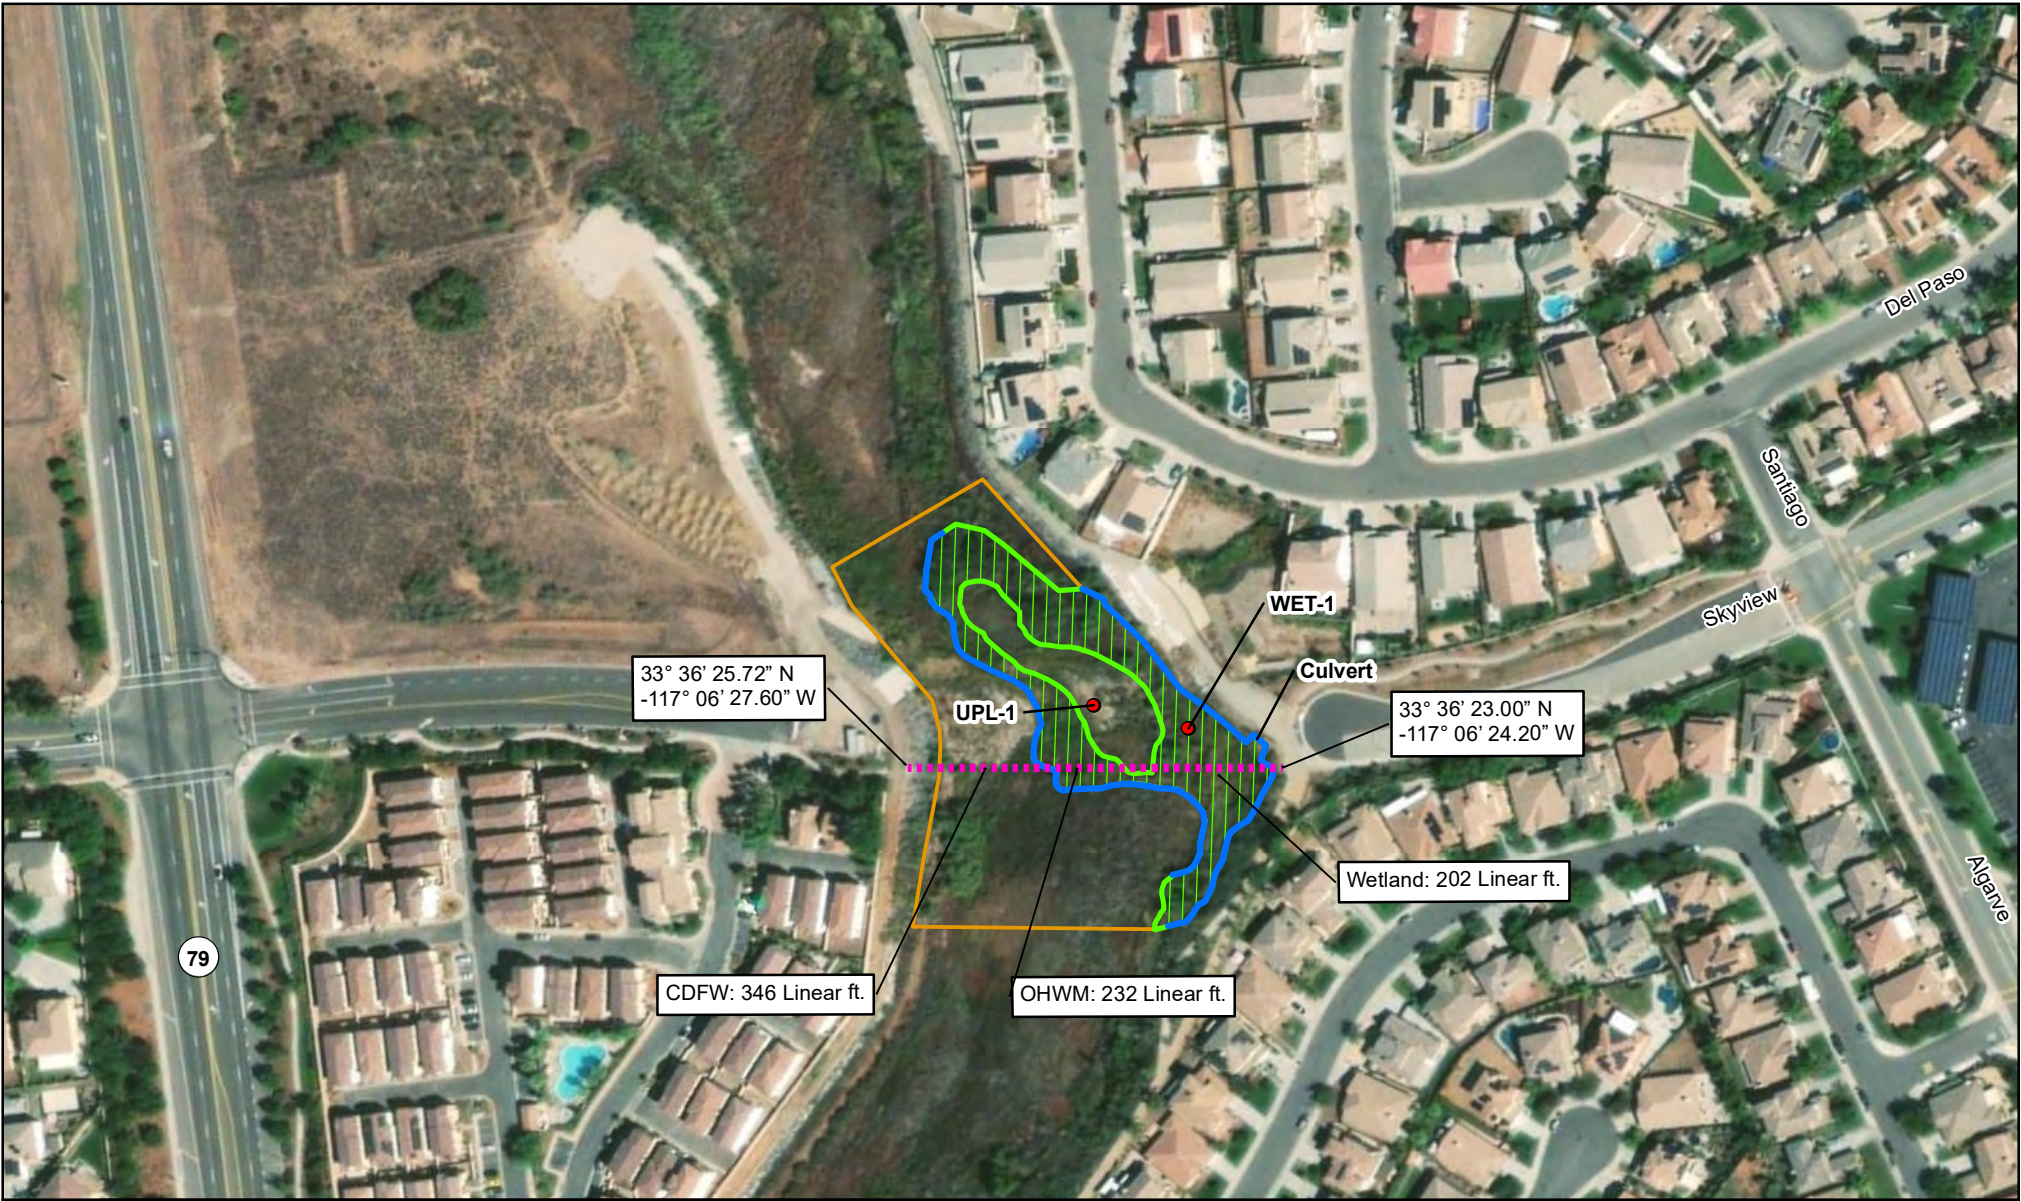
- Sample Point
- ▬ Pedestrian Bridge
- ▬ OHWM (Delineated)
- ▨ Wetland (Delineated)
- ▭ CDFW Jurisdiction (Project Survey Area)

Note: the linear feet measurements are at the approximate bridge location.

The field investigation identified an intermittent stream with an adjacent wetland complex within French Valley Creek. The wetland boundaries and the stream's OHWM were mapped aerially and are depicted in the *Wetland and Waterway Delineation Report* produced by Power Engineers, Inc. (Appendix D. Wetland and Waterway Delineation Report). CDFW jurisdictional habitats were delineated as the riparian/riverine resources found within the entire width of the channel.

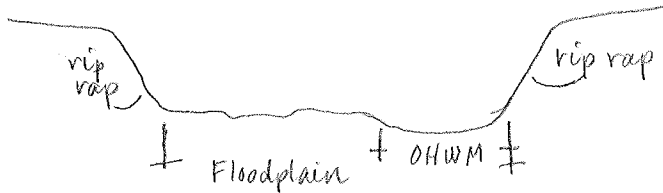
Cross section drawing:

OHWM

GPS point: 33.60067 -117.106872
