# **Skyview Road Pedestrian Bridge Project**

## **Determination of Biologically Equivalent or Superior Preservation Report**

Riverside County  
California

# DBESP Report

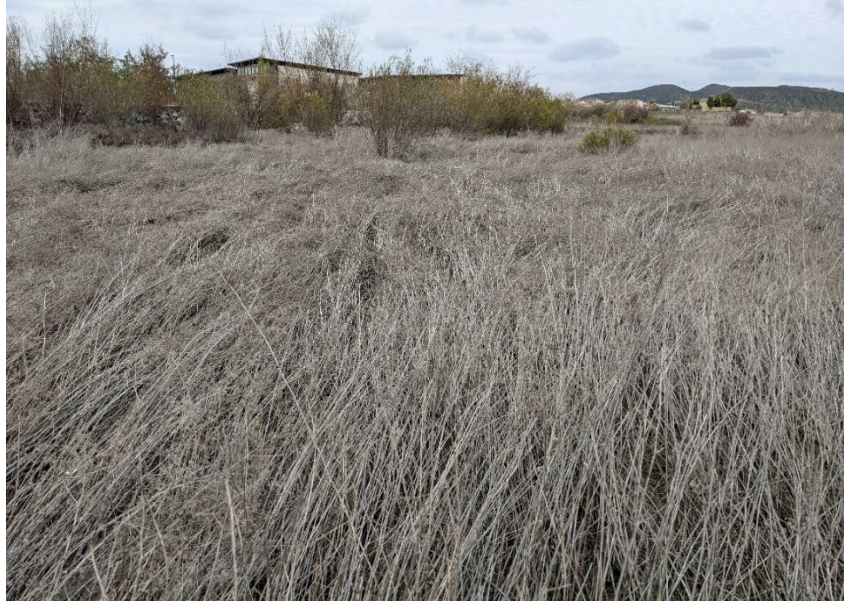
Representative Photograph 1. Representative photograph of the invasive broad-leafed pepperweed-dominated mitigation site (February 2022).

Off-site habitat mitigation would consist of a riparian/riverine habitat creation project at a site approximately 200 feet upstream of the proposed pedestrian bridge within French Valley Creek. The mitigation project would occur on APN 480-160-022, which is a parcel of land within the channel that is currently identified as an RCA MSHCP Conservation Easement. The site was selected during a site visit conducted on February 2, 2022 by Dokken biologists, a County environmental planner, and an RCA representative. The site was selected because of favorable channel hydrology and soil moisture, and a lack of existing habitat. This stretch of the creek has been channelized during development and construction of flood control levees, and currently is a narrow stream channel and a confined riparian area, unlike upstream and downstream, where riparian vegetation is broad and across the entire channel floor. The center of the site is currently dominated by broad-leafed pepperweed (*Lepidium latifolium*), an invasive species, and the northern edge of the site contains a line of tamarisk (*Tamarix ramosissima*) and tree tobacco (*Nicotiana glauca*), both of which are also invasive (Representative Photograph 1). Various natives such as alkali heath (*Frankenia salina*), mulefat (*Baccharis salicifolia*), willow (*Salix sp.*), and San Diego sunflower (*Bahiopsis laciniata*) are scattered adjacent to and throughout the site, but are limited by the widespread dominance of broad-leafed pepperweed. During site visits, adequate soil moisture was observed to support riparian plant species, including willows and

mulefat. In addition, the site contains patches of concentrated salt deposits, which suggests the site's potential to support the alkali salt marsh habitat type (Representative Photograph 2).

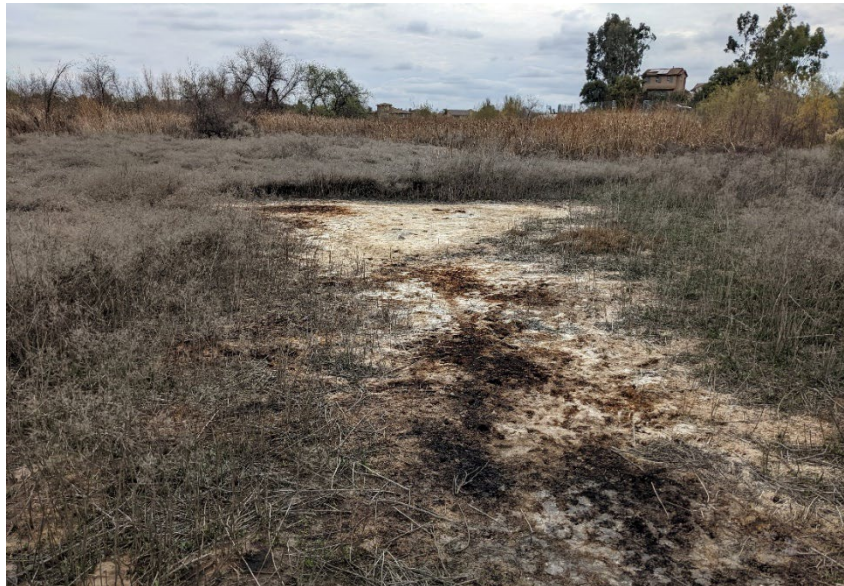
Representative Photograph 2. Representative photograph of salt deposits present at the proposed mitigation site (February 2022).

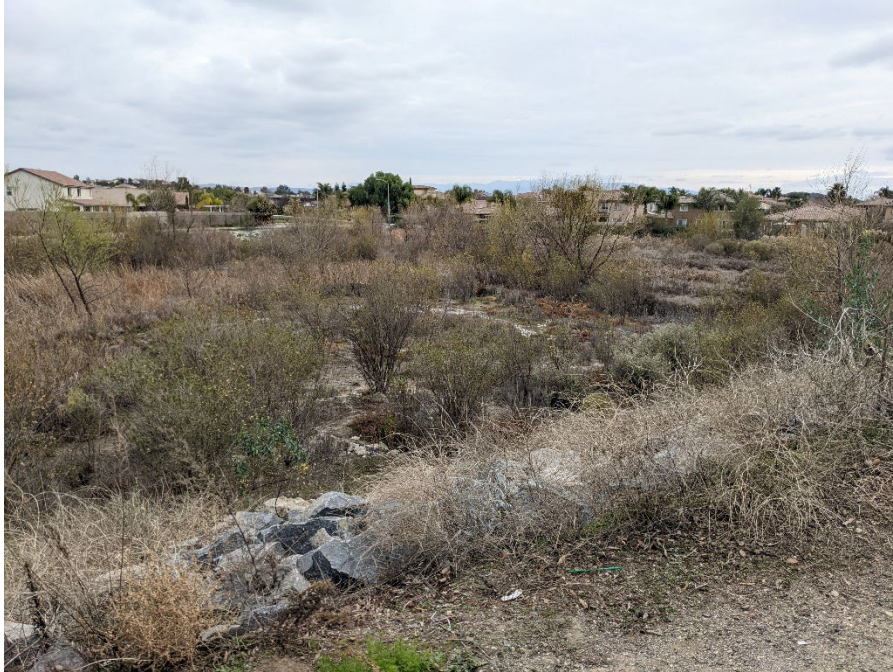
Representative Photograph 3. Representative photograph of the proposed Project site, taken from the west side of the channel on Skyview Road (February 2022).

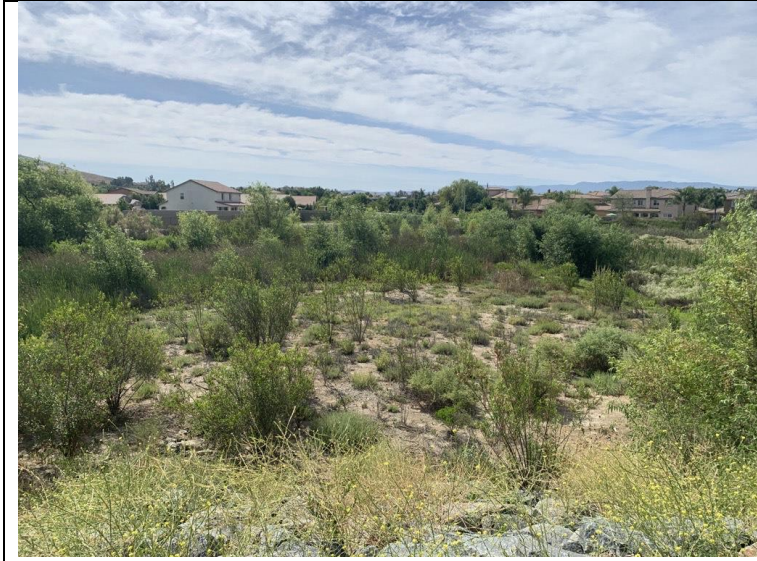
Photograph 1. View across the Warm Springs Valley/French Valley Channel showing proposed project area and riparian habitat (taken 6/1/2020; facing southeast).

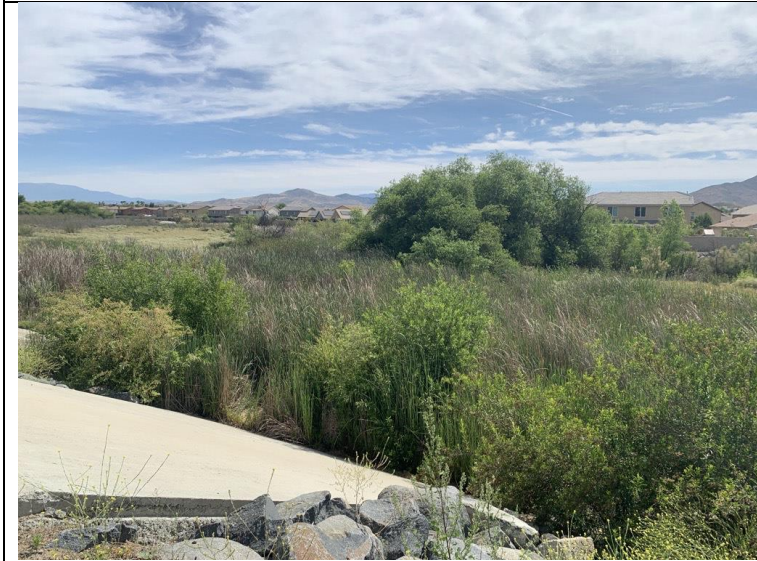
Photograph 2. View across the Warm Springs Valley/French Valley Channel north of proposed project area (taken 6/1/2020; facing northeast).

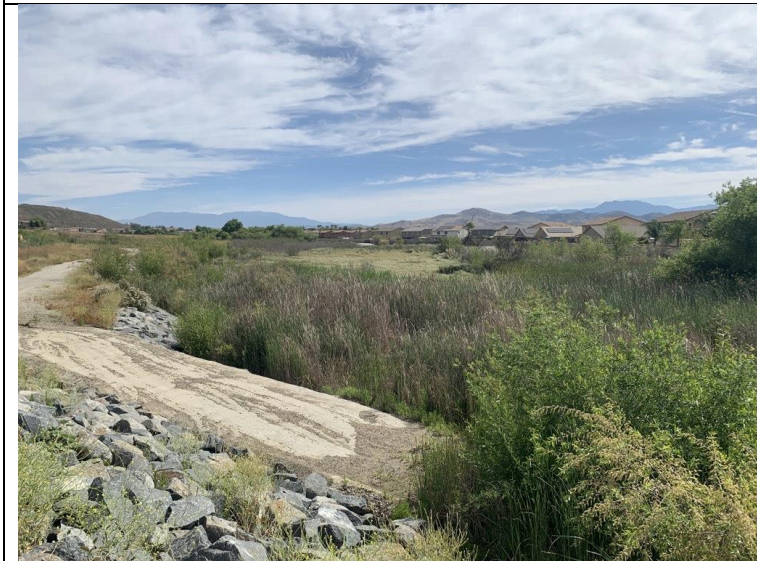
Photograph 3. View of riparian habitat upstream from the proposed project area (taken 6/1/2020; facing north).

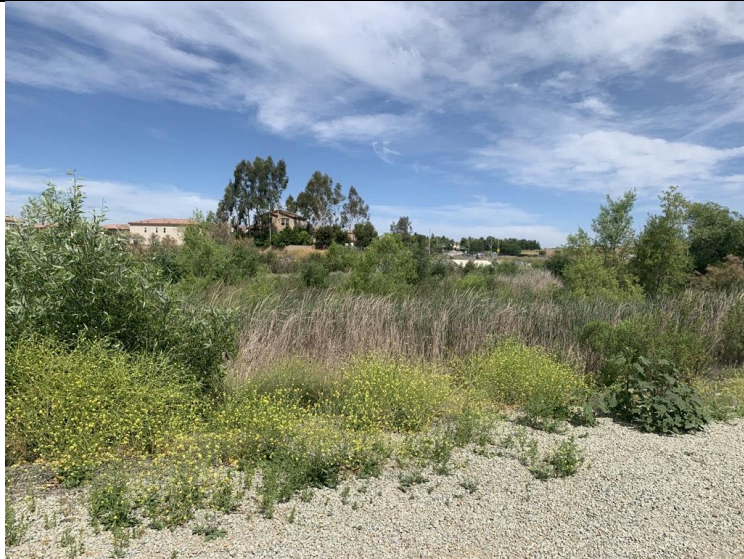
Photograph 4. View across the Warm Springs Valley/French Valley Channel showing proposed project area and riparian habitat (taken 6/1/2020; facing northwest).

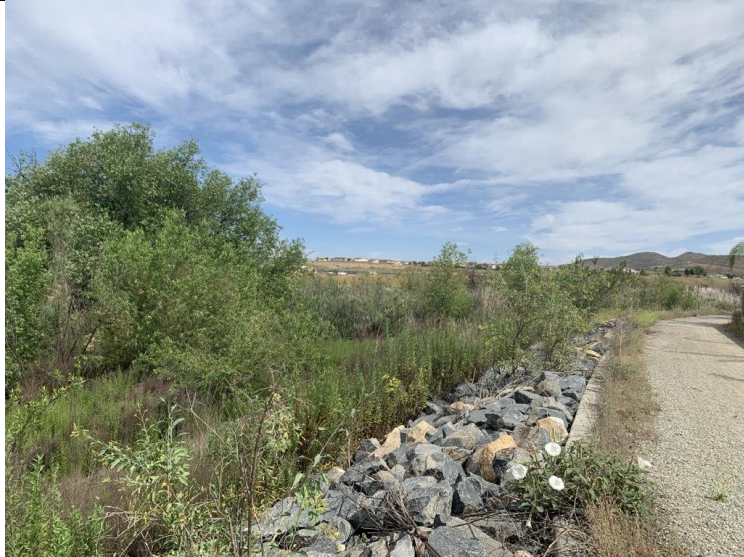
Photograph 5. View of riparian habitat upstream from the proposed project area (taken 6/1/2020; facing north).

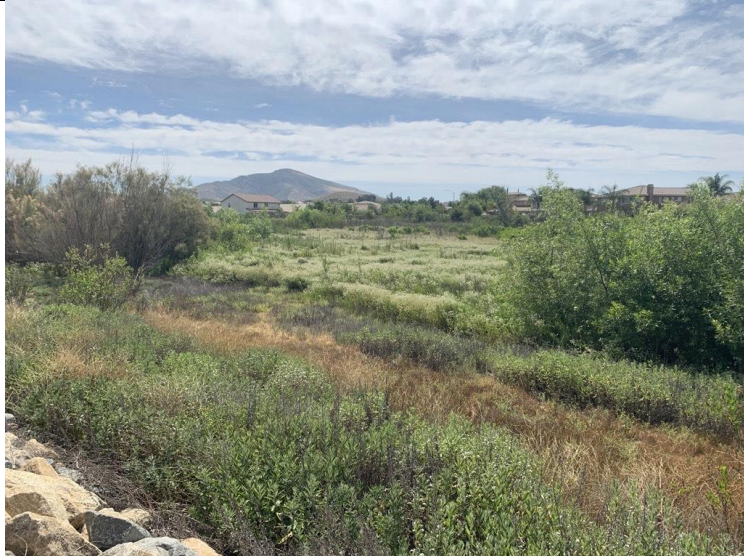
Photograph 6. View across the Warm Springs Valley/French Valley Channel showing proposed project area and riparian habitat (taken 6/1/2020; facing east).

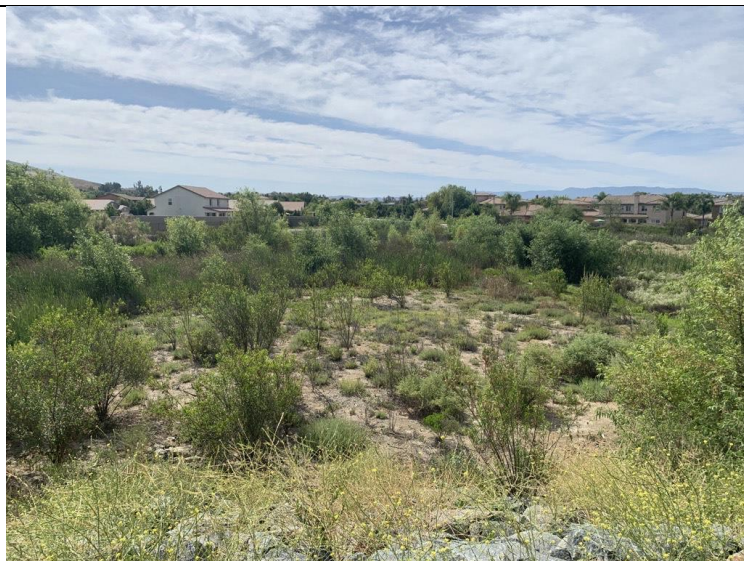
Photograph 1. View across the Warm Springs Valley/French Valley Channel showing proposed project area and riparian habitat (taken 6/1/2020; facing southeast).

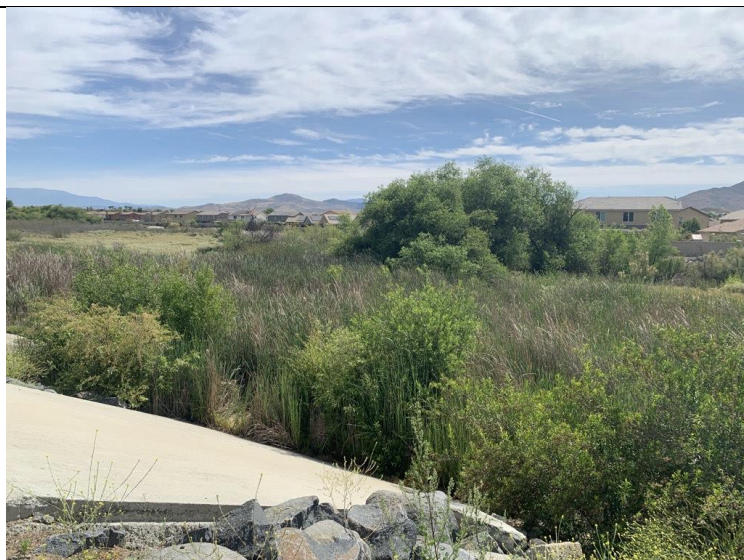
Photograph 2. View across the Warm Springs Valley/French Valley Channel north of proposed project area (taken 6/1/2020; facing northeast).

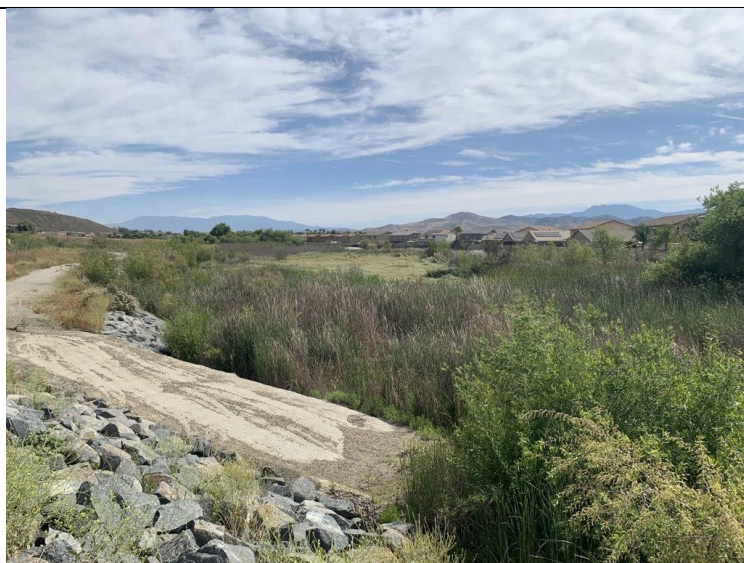
Photograph 3. View of riparian habitat upstream from the proposed project area (taken 6/1/2020; facing north).

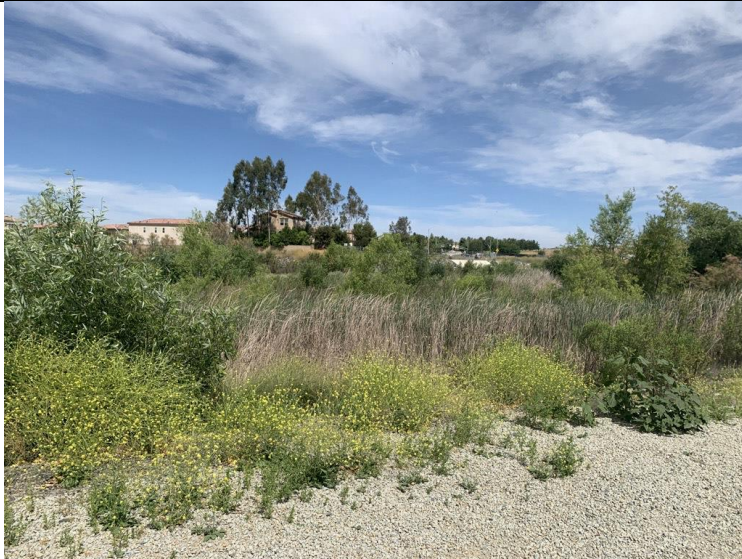
Photograph 4. View across the Warm Springs Valley/French Valley Channel showing proposed project area and riparian habitat (taken 6/1/2020; facing northwest).

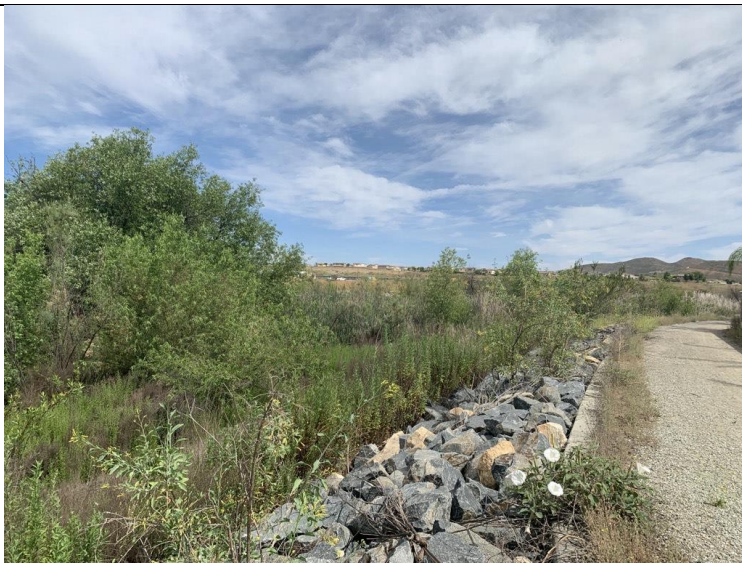
Photograph 5. View of riparian habitat upstream from the proposed project area (taken 6/1/2020; facing north).

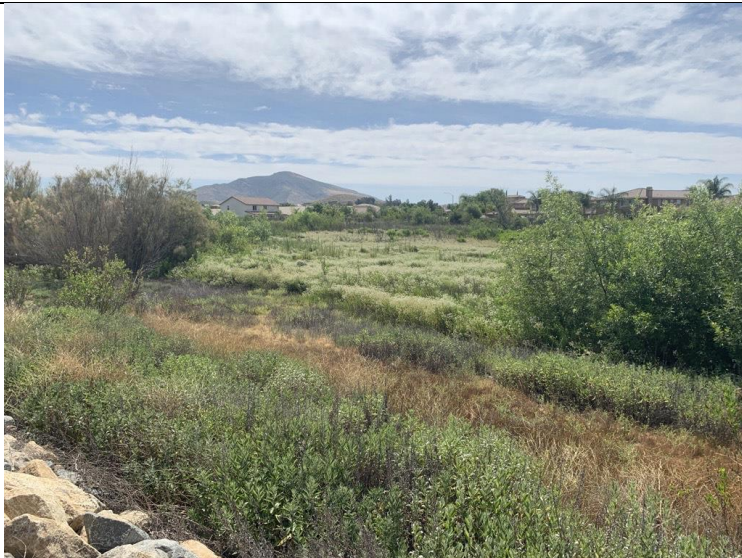
Photograph 6. View across the Warm Springs Valley/French Valley Channel showing proposed project area and riparian habitat (taken 6/1/2020; facing east).

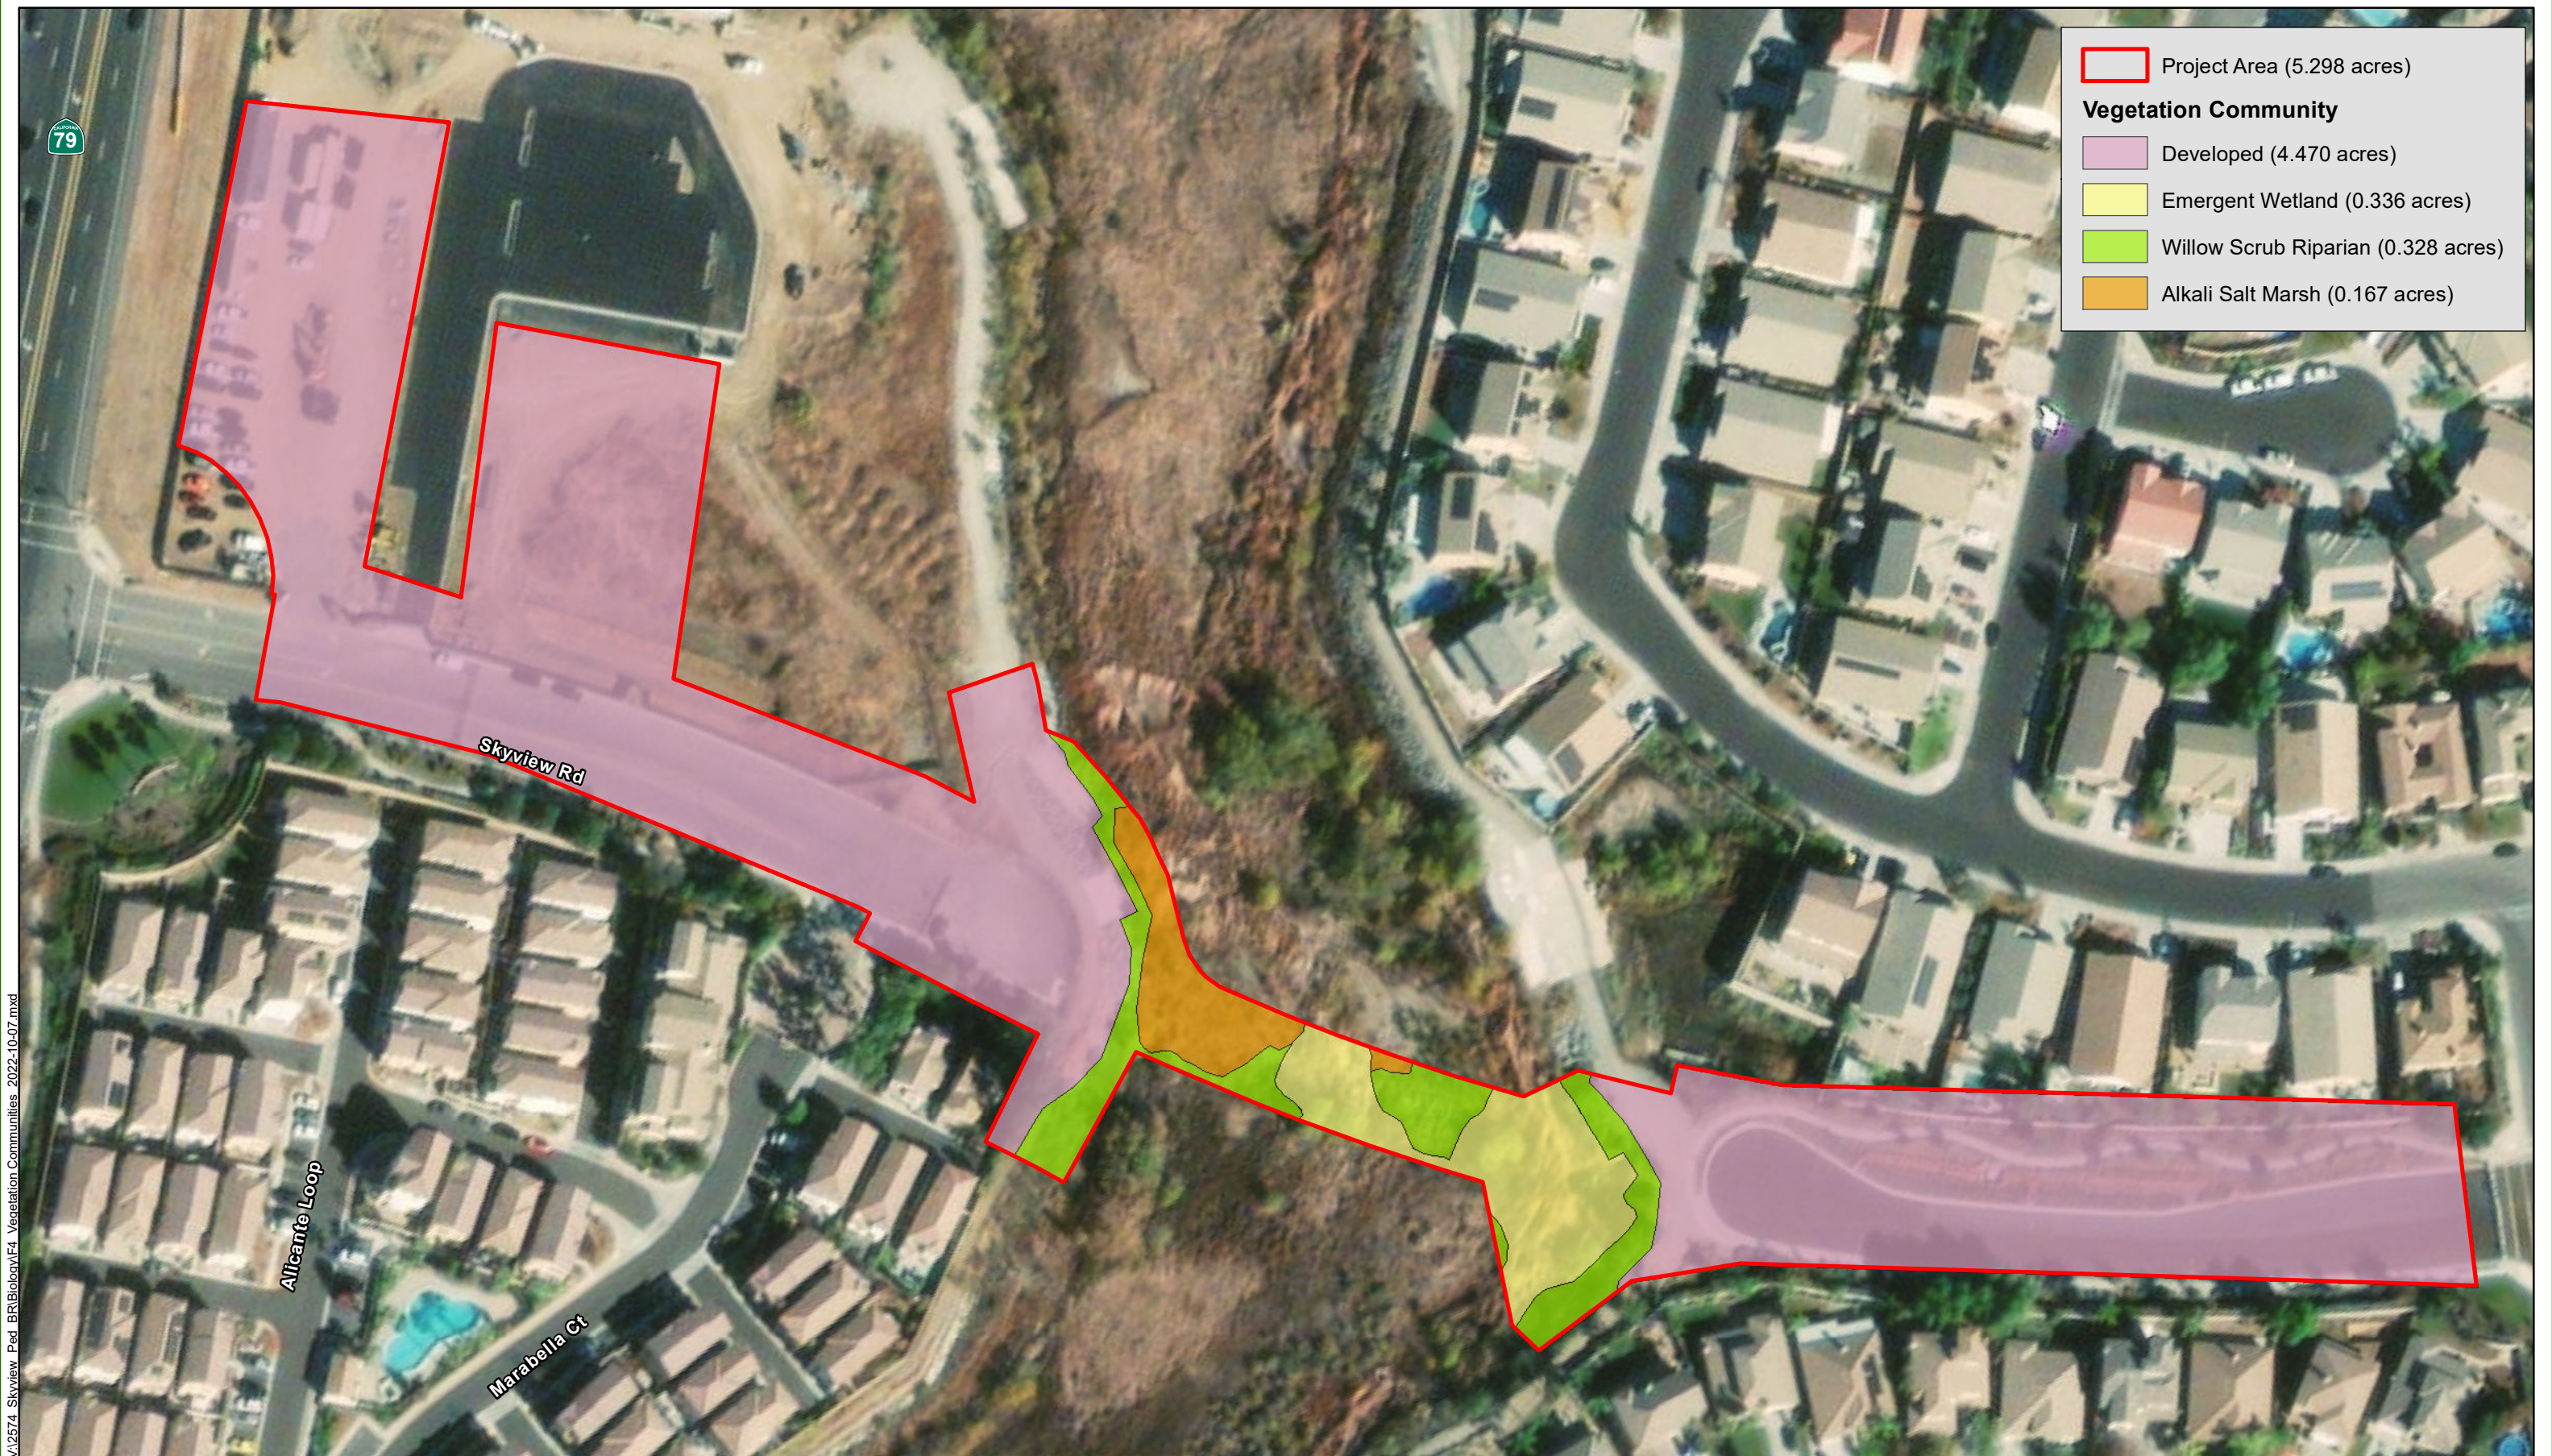
**Figure 4**  
**Vegetation Communities**  
 Skyview Road Pedestrian Bridge Project  
 Winchester, Riverside County, California

Project Area (5.298 acres)
<b>Vegetation Community</b>

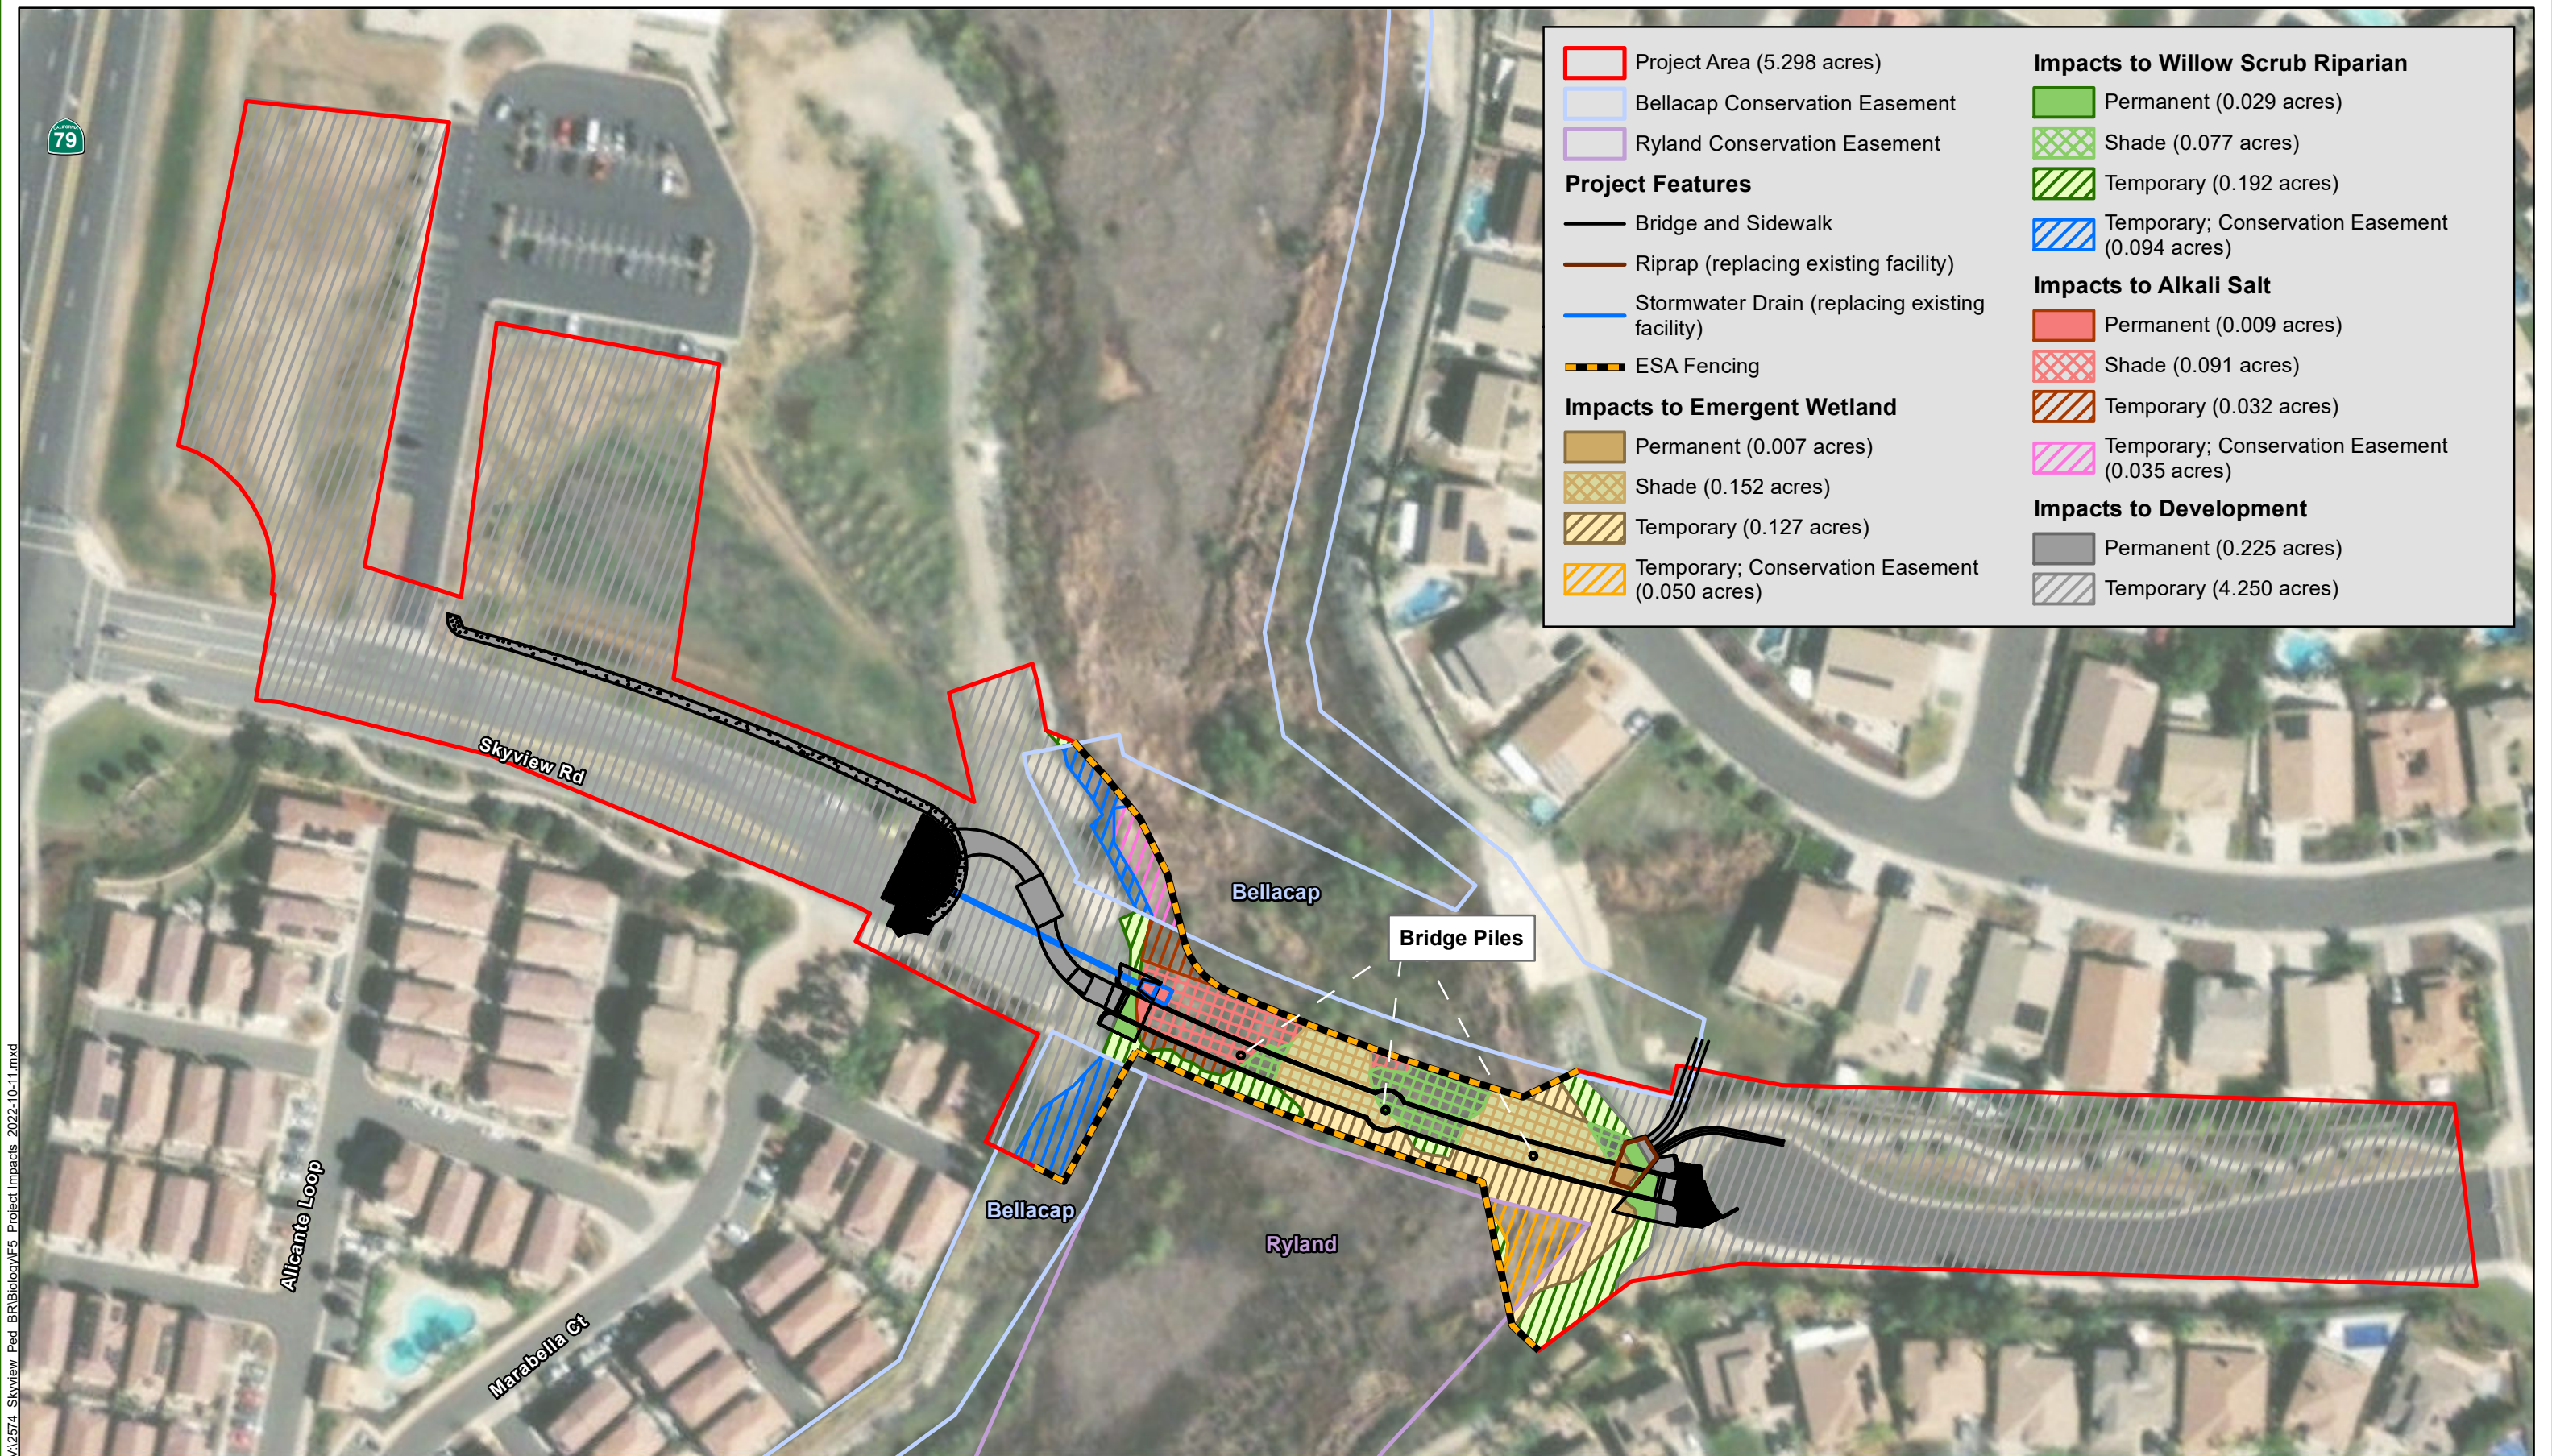
**Figure 5**  
**Project Impacts**  
 Skyview Road Pedestrian Bridge Project  
 Winchester, Riverside County, California

Project Area (5.298 acres)	<b>Impacts to Willow Scrub Riparian</b>
Bellacap Conservation Easement	Permanent (0.029 acres)
Ryland Conservation Easement	Shade (0.077 acres)
<b>Project Features</b>	Temporary (0.192 acres)
Bridge and Sidewalk	Temporary; Conservation Easement (0.094 acres)
Riprap (replacing existing facility)	<b>Impacts to Alkali Salt</b>
Stormwater Drain (replacing existing facility)	Permanent (0.009 acres)
ESA Fencing	Shade (0.091 acres)
<b>Impacts to Emergent Wetland</b>	Temporary (0.032 acres)
Permanent (0.007 acres)	Temporary; Conservation Easement (0.035 acres)
Shade (0.152 acres)	<b>Impacts to Development</b>
Temporary (0.127 acres)	Permanent (0.225 acres)
Temporary; Conservation Easement (0.050 acres)	Temporary (4.250 acres)

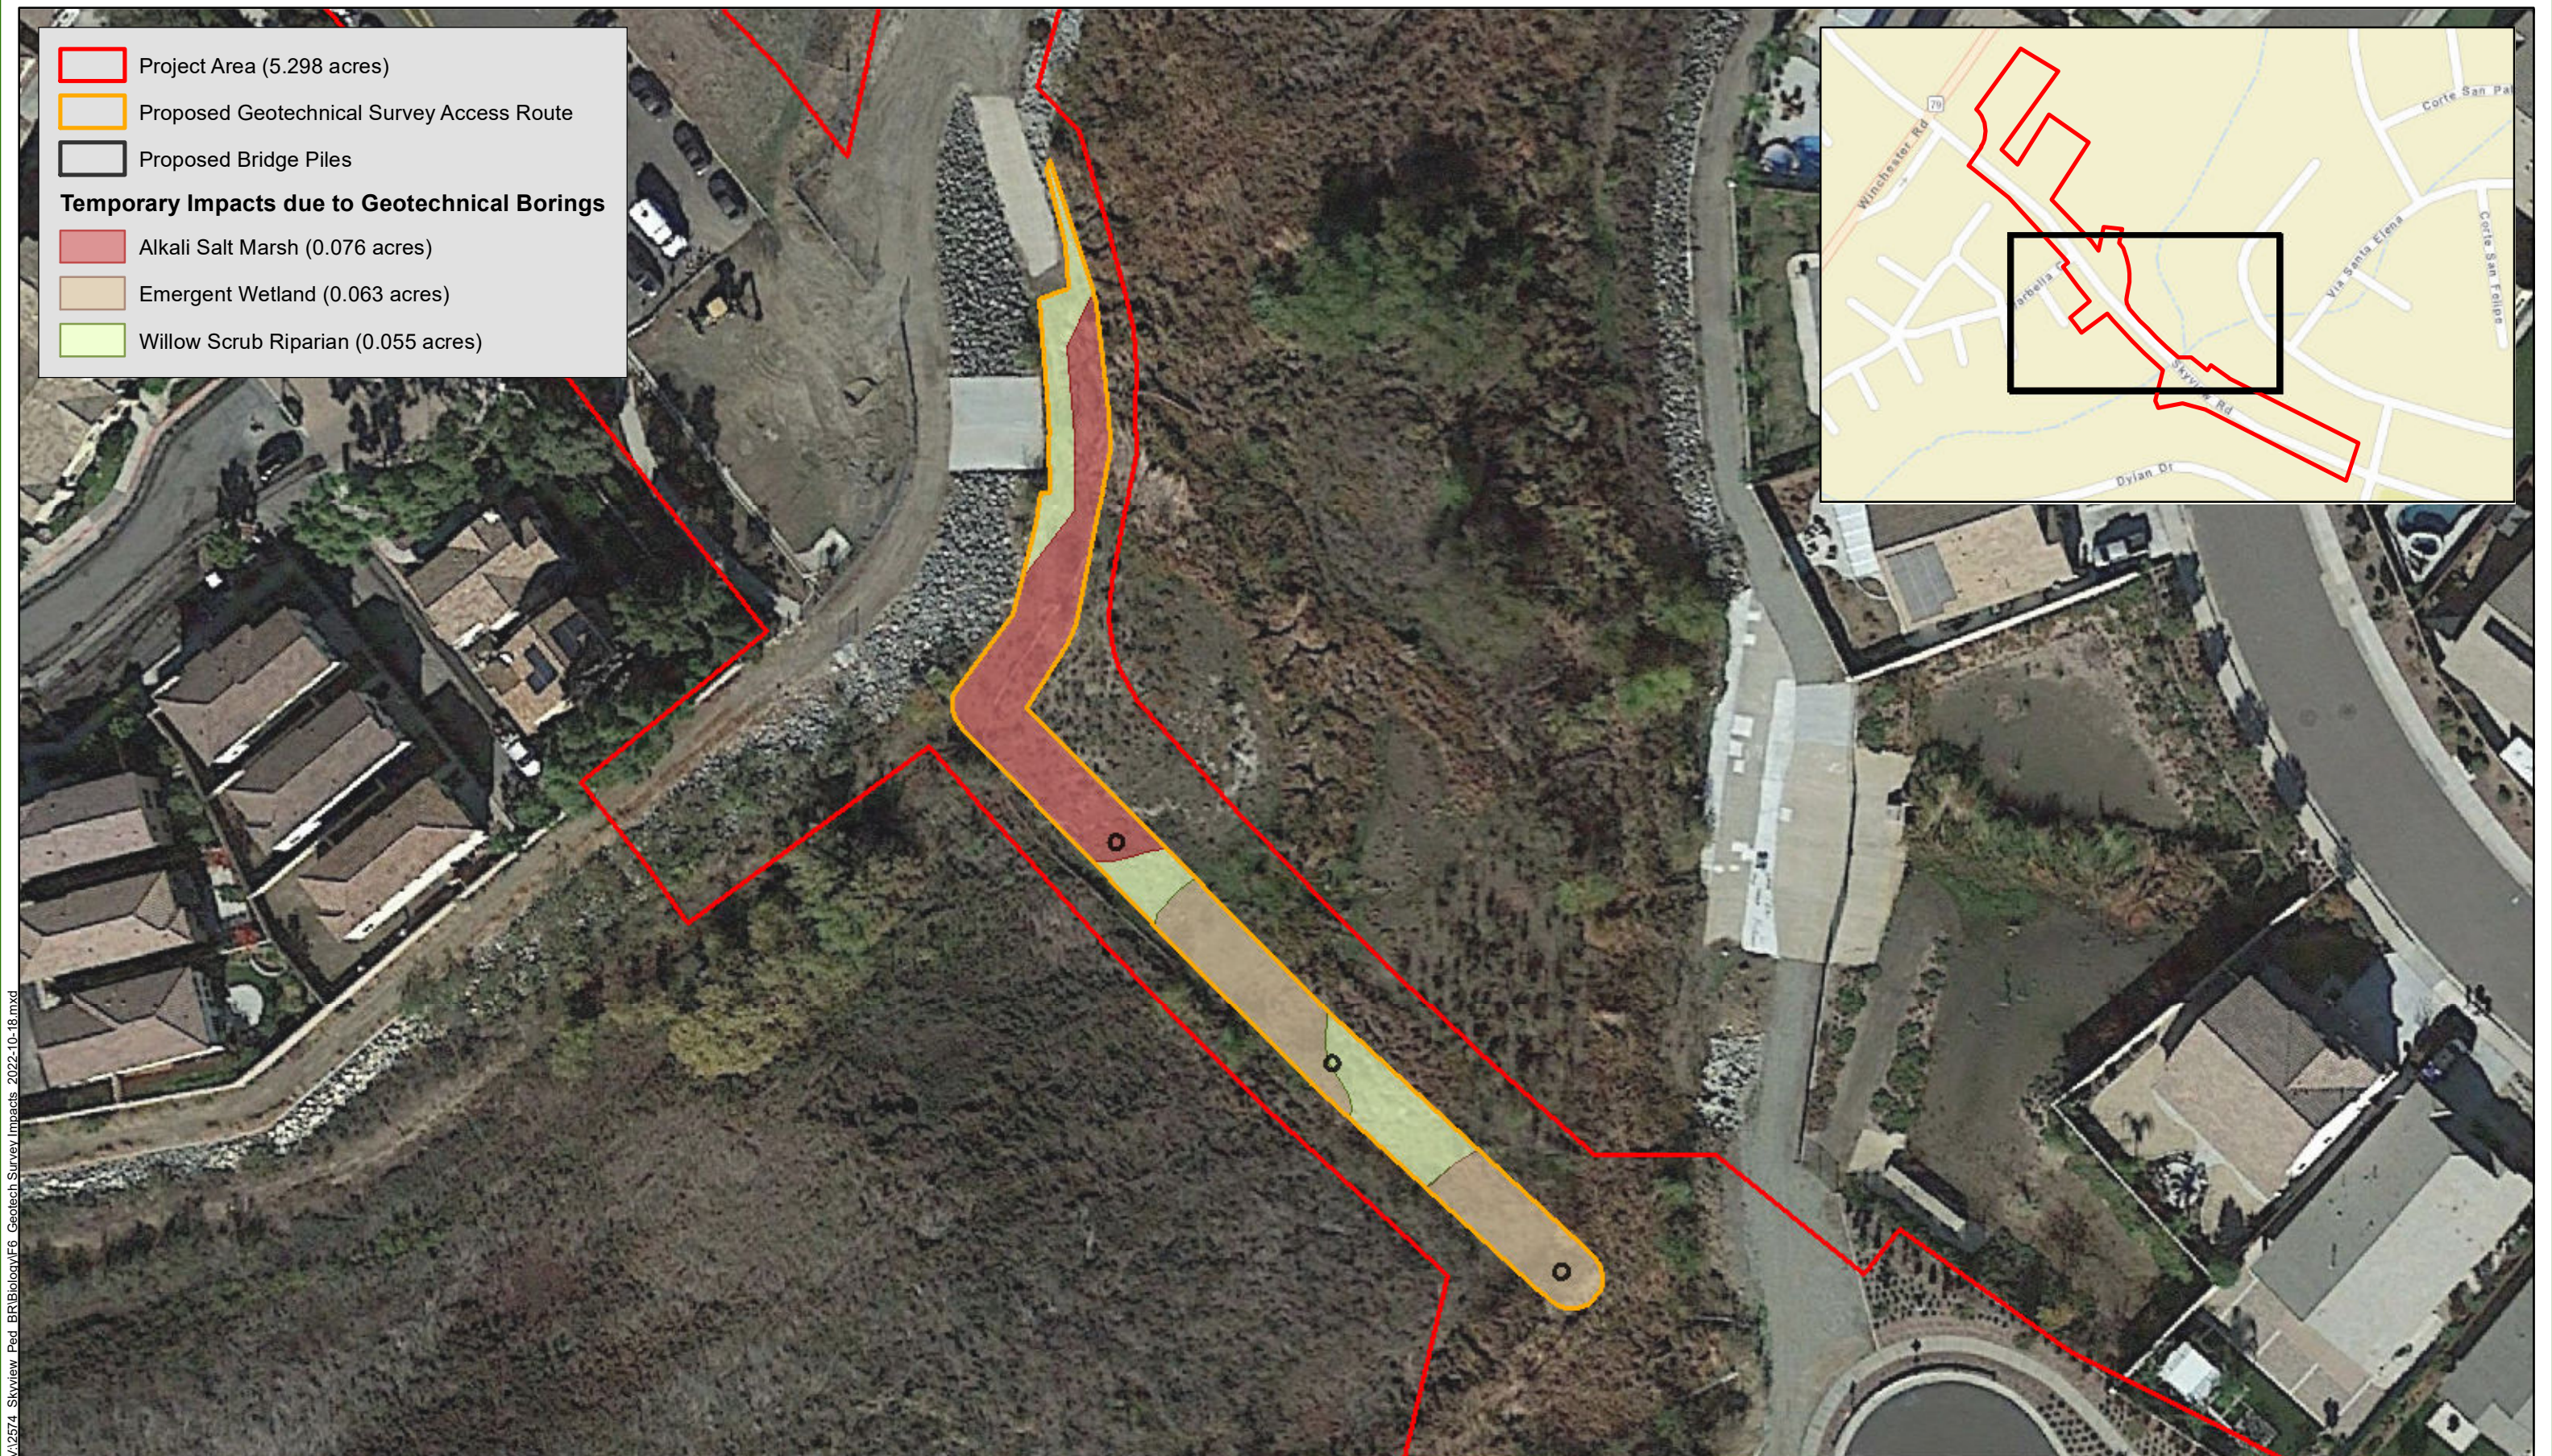
- Project Area (5.298 acres)
- Proposed Geotechnical Survey Access Route
- Proposed Bridge Piles
- Temporary Impacts due to Geotechnical Borings**
- Alkali Salt Marsh (0.076 acres)
- Emergent Wetland (0.063 acres)
- Willow Scrub Riparian (0.055 acres)
