# **Skyview Road Pedestrian Bridge Project**

## **Determination of Biologically Equivalent or Superior Preservation Report**

Riverside County  
California

# DBESP Report

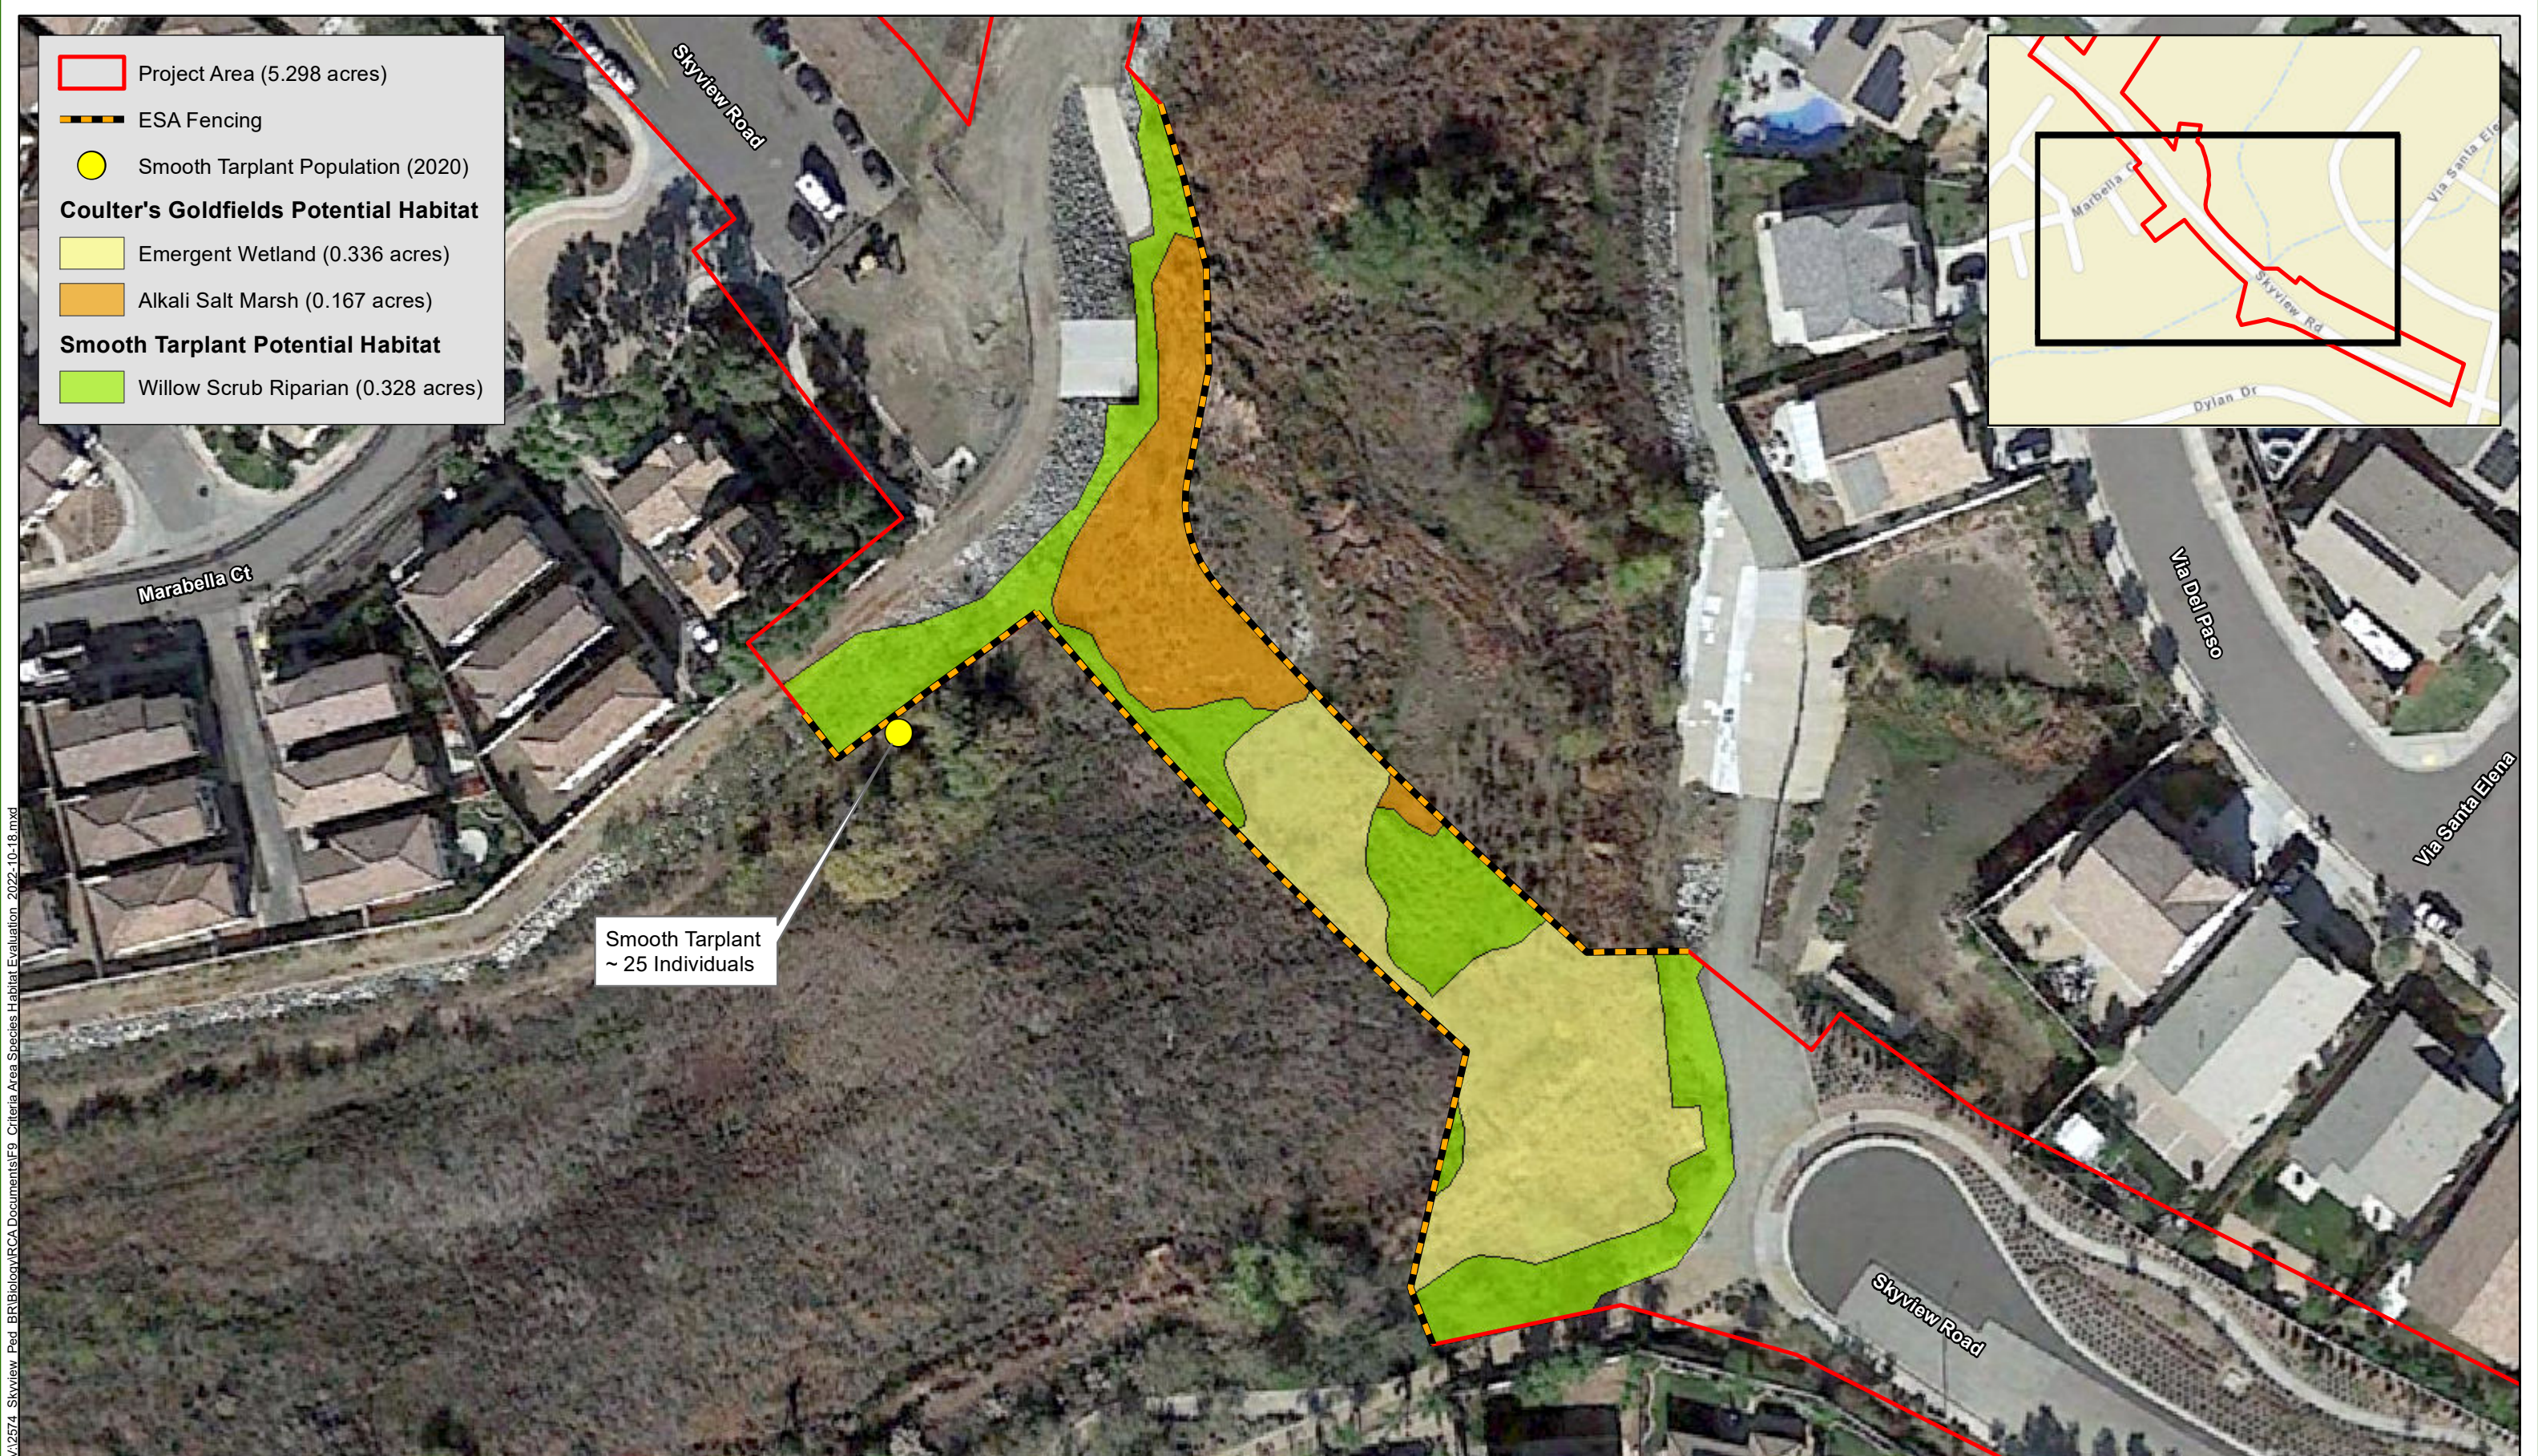
**Figure 9**  
**Criteria Area Plant Species: Habitat Evaluation**  
 Skyview Road Pedestrian Bridge Project  
 Winchester, Riverside County, California

- Project Area (5.298 acres)
- ESA Fencing
- Smooth Tarplant Population (2020)
- Coulter's Goldfields Potential Habitat**
- Emergent Wetland (0.336 acres)
- Alkali Salt Marsh (0.167 acres)
- Smooth Tarplant Potential Habitat**
- Willow Scrub Riparian (0.328 acres)

Smooth Tarplant  
~ 25 Individuals

One CASSA 4 species, Coulter's goldfields, has a high potential to occur within the Project area, and one CASSA 4 species, smooth tarplant, was observed just outside of the Project impact area during 2020 surveys. With the implementation of BIO-6 (below) and the other avoidance and minimization measures listed within Chapter 2.4, direct effects to these species will be avoided and minimized.

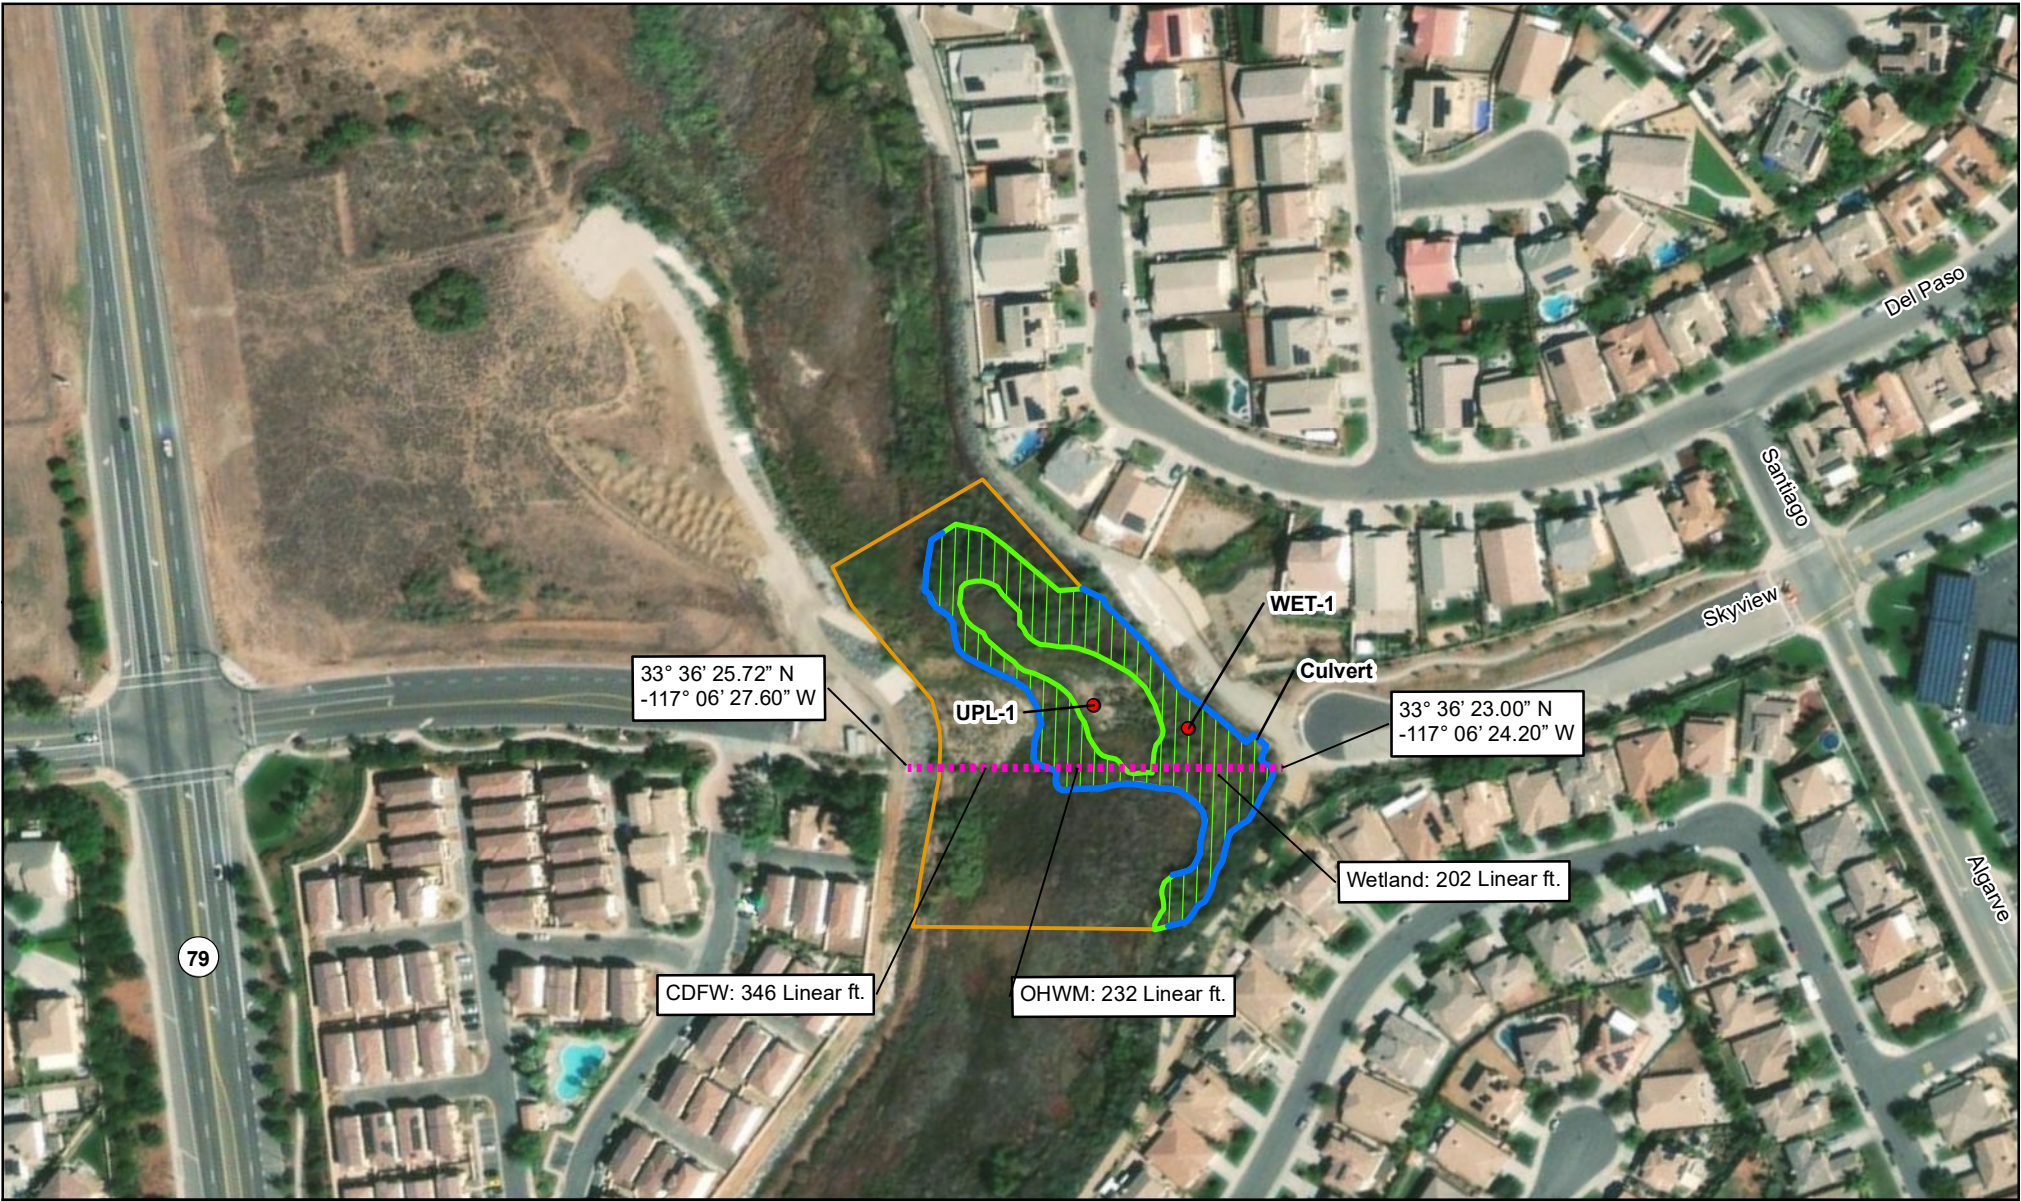
- Sample Point
- - - - - Pedestrian Bridge
- OHWM (Delineated)
- ▨ Wetland (Delineated)
- CDFW Jurisdiction (Project Survey Area)

**Note: the linear feet measurements are at the approximate bridge location.**

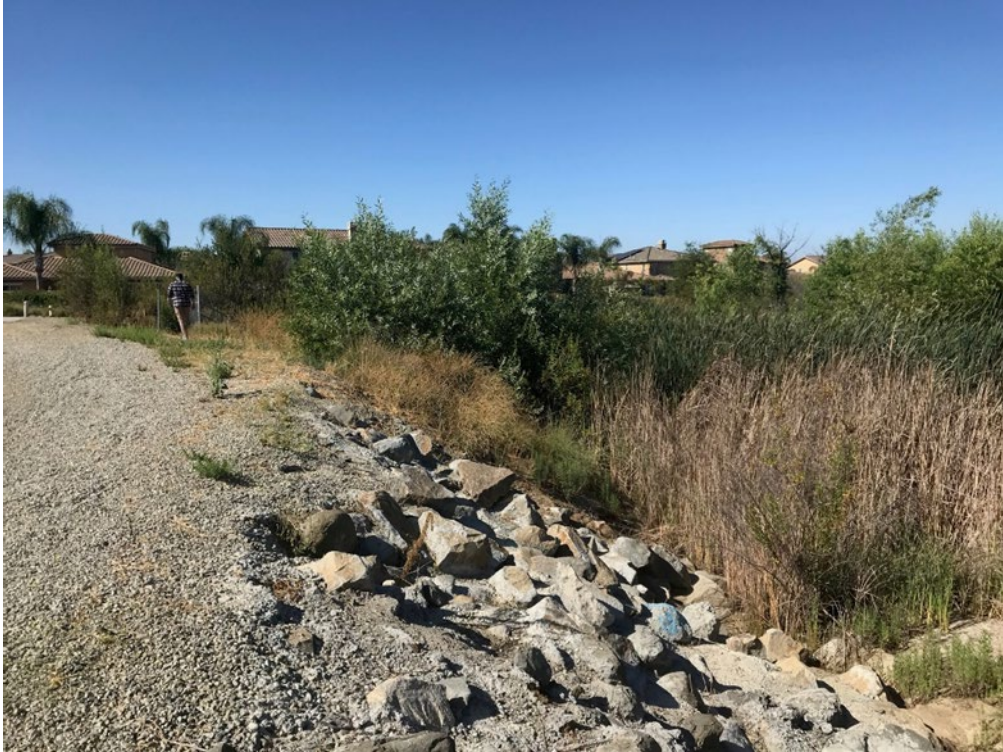
Photo Point 3: W1 Wetland on southeast end looking south

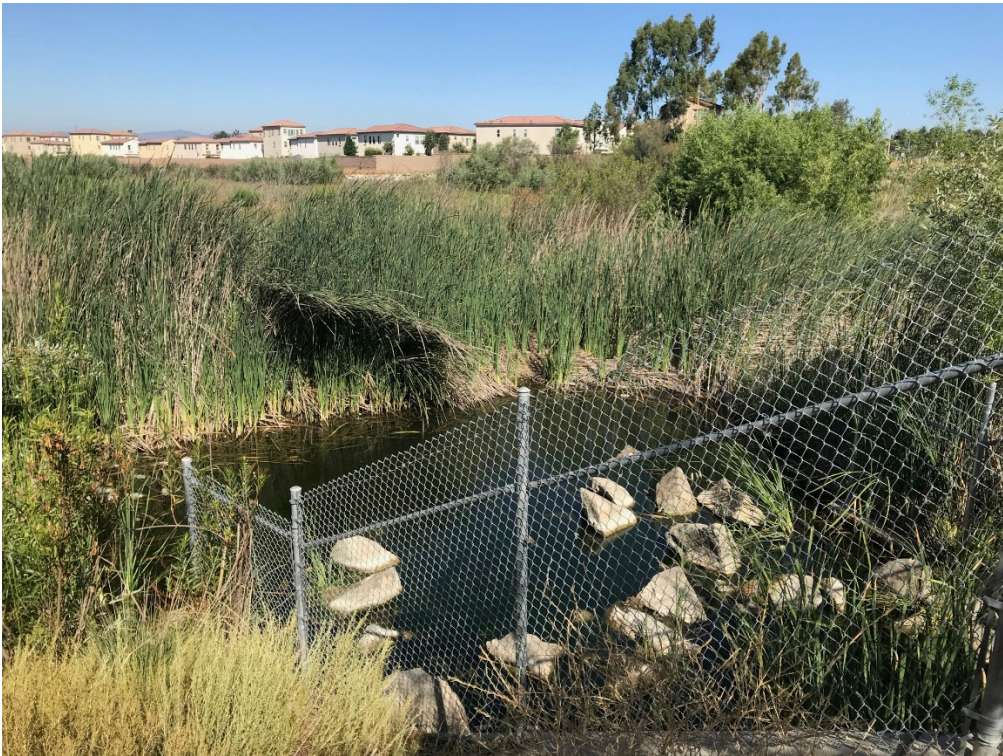
Photo Point 4: W1 Wetland on southeast end looking north

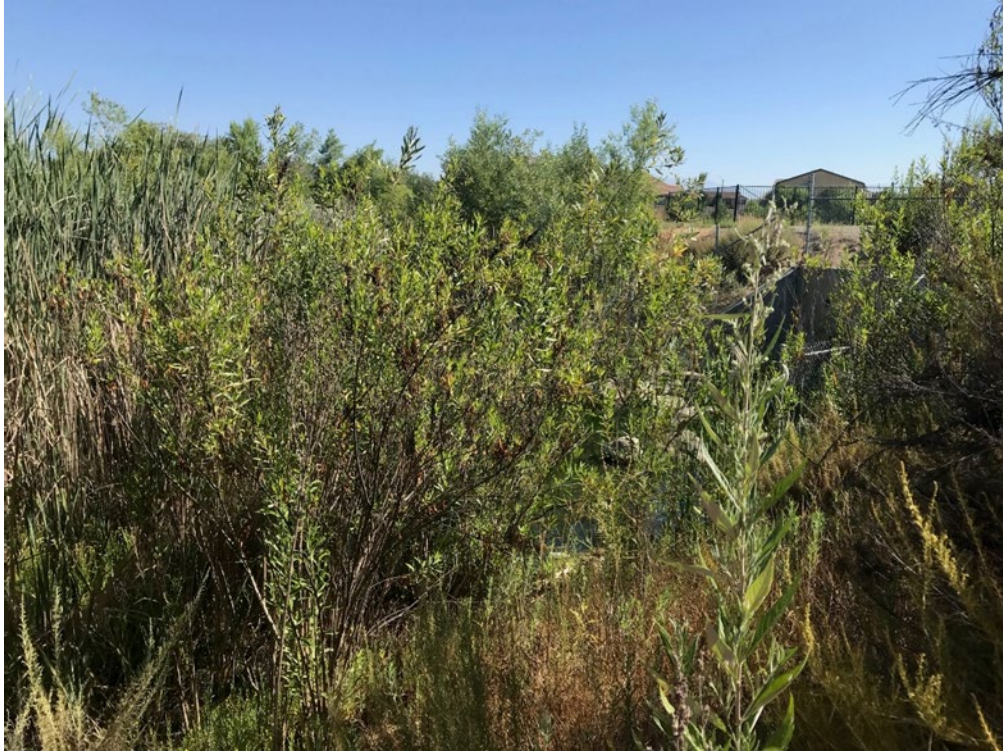
Photo Point 5: W1 Wetland on southeast end looking east

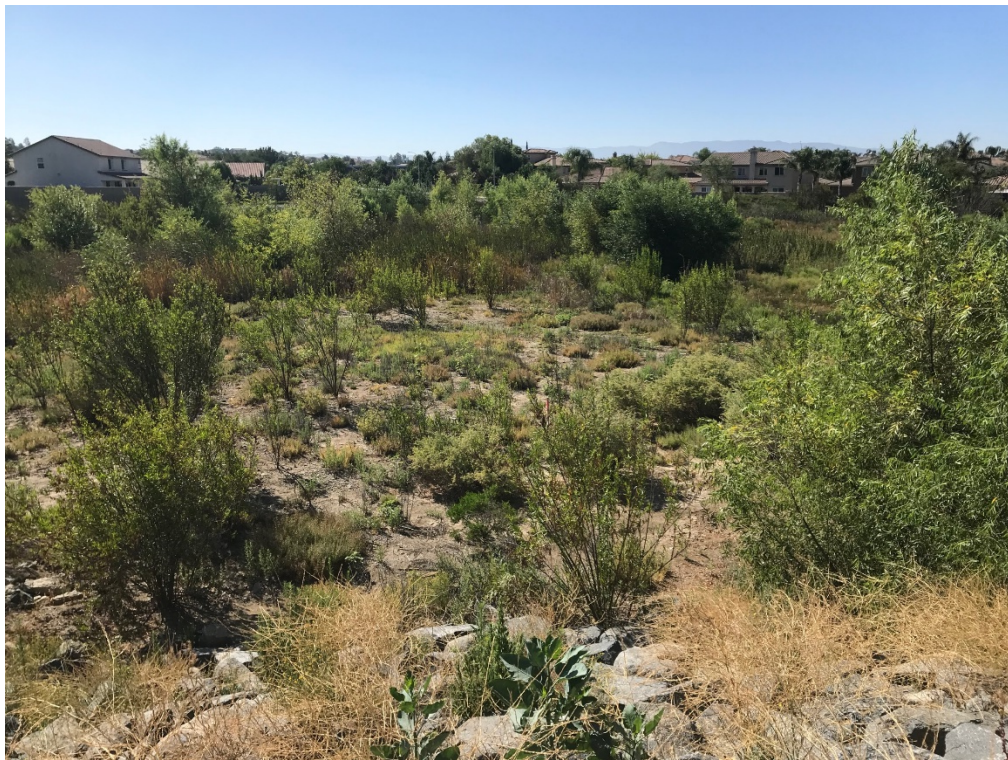
Photo Point 6: W1 Wetland and floodplain looking southeast

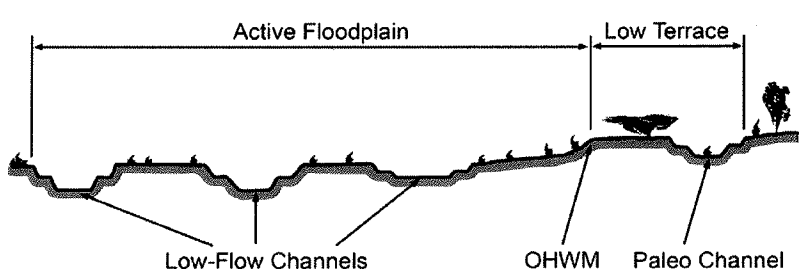
<b>Hydrogeomorphic Floodplain Units</b>

<b>Procedure for identifying and characterizing the floodplain units to assist in identifying the OHWM:</b> <ol style="list-style-type: none"> <li>1. Walk the channel and floodplain within the study area to get an impression of the geomorphology and vegetation present at the site.</li> <li>2. Select a representative cross section across the channel. Draw the cross section and label the floodplain units.</li> <li>3. Determine a point on the cross section that is characteristic of one of the hydrogeomorphic floodplain units.           <ol style="list-style-type: none"> <li>a) Record the floodplain unit and GPS position.</li> <li>b) Describe the sediment texture (using the Wentworth class size) and the vegetation characteristics of the floodplain unit.</li> <li>c) Identify any indicators present at the location.</li> </ol> </li> <li>4. Repeat for other points in different hydrogeomorphic floodplain units across the cross section.</li> <li>5. Identify the OHWM and record the indicators. Record the OHWM position via:           <table style="width: 100%; border: none; margin-top: 5px;"> <tr> <td style="width: 50%;"><input checked="" type="checkbox"/> Mapping on aerial photograph</td> <td style="width: 50%;"><input type="checkbox"/> GPS</td> </tr> <tr> <td><input type="checkbox"/> Digitized on computer</td> <td><input type="checkbox"/> Other:</td> </tr> </table> </li> </ol>		<input checked="" type="checkbox"/> Mapping on aerial photograph	<input type="checkbox"/> GPS	<input type="checkbox"/> Digitized on computer	<input type="checkbox"/> Other:
