AIRPORT BOULEVARD BRIDGE REPLACEMENT PROJECT

HAZARDOUS WASTE INITIAL SITE ASSESSMENT

AIRPORT BOULEVARD BRIDGE REPLACEMENT PROJECT Community of Thermal, Riverside County, California 08-RIV-County of Riverside

Federal Project Number: BRLS-5956(231)

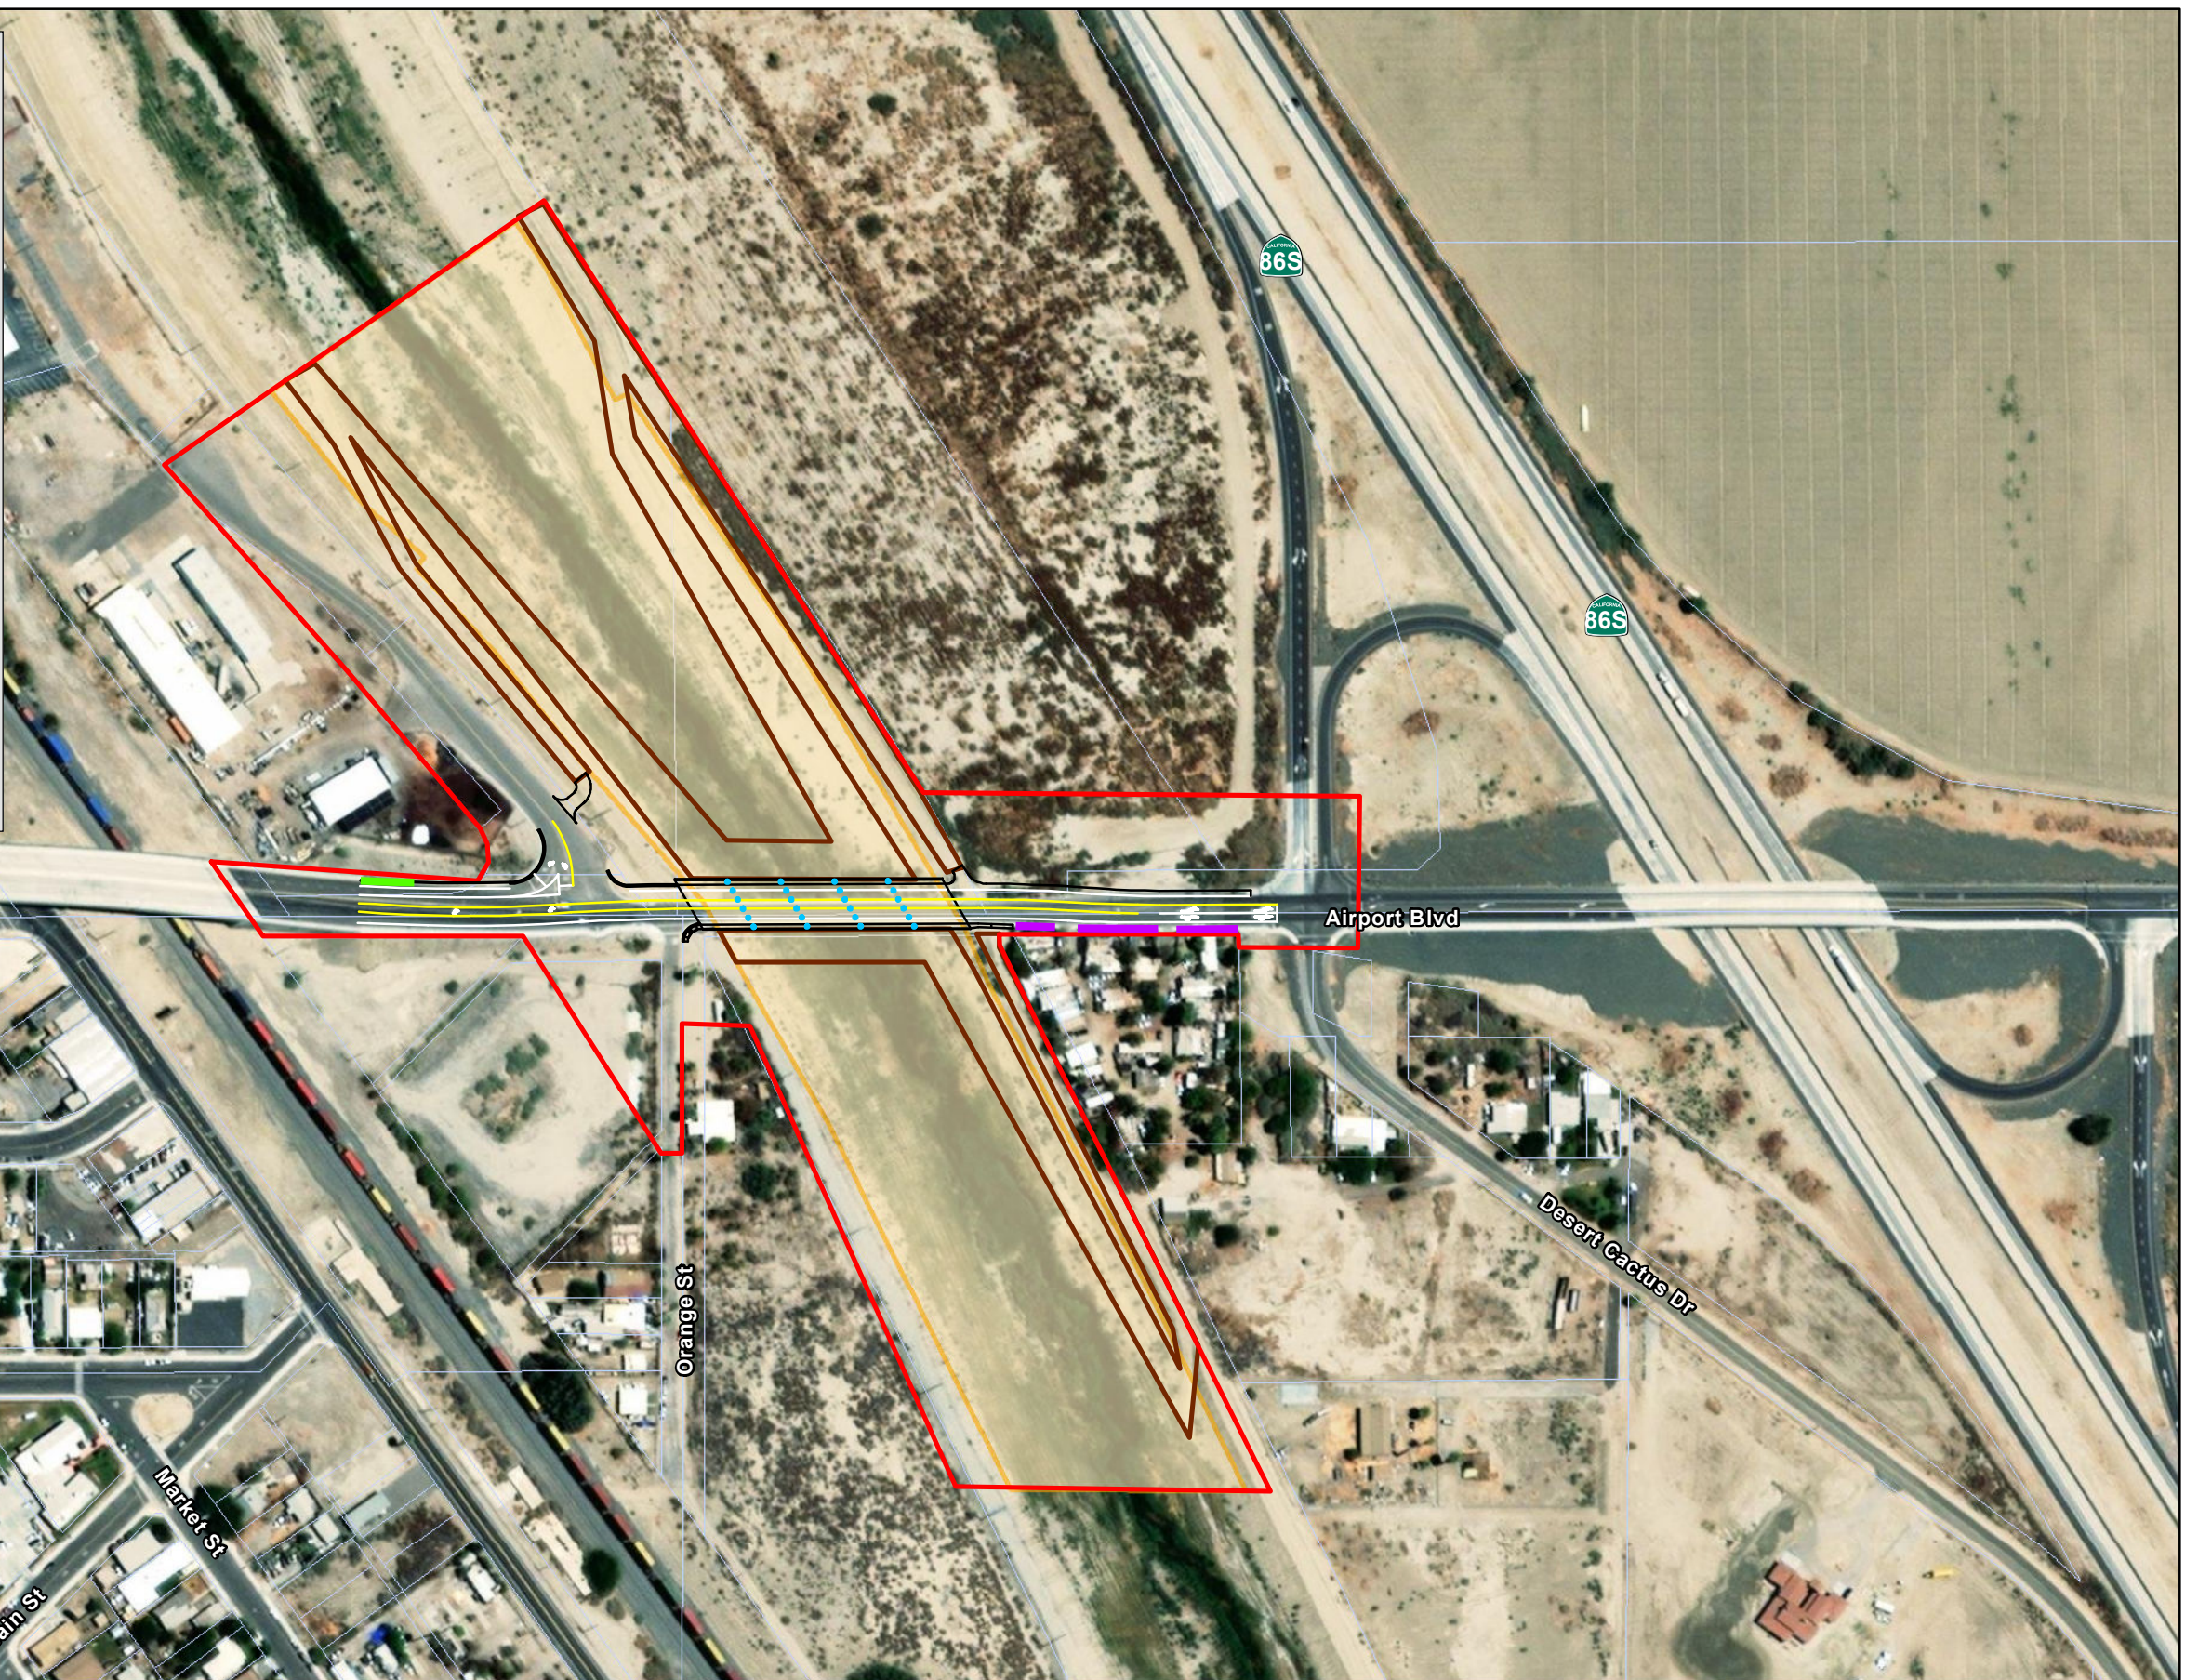
BRLS-5956(231)
Airport Boulevard Bridge Replacement Project
Thermal, Riverside County, California

- Project Area
- Existing CVWD Concrete Channel Lining
- Pavement Edges
- Metal Beam Guardrail
- Median Striping
- Lane Striping
- Retaining Wall
- Proposed Bridge Piers (0.003 acres)
- Access Roads
- Parcels

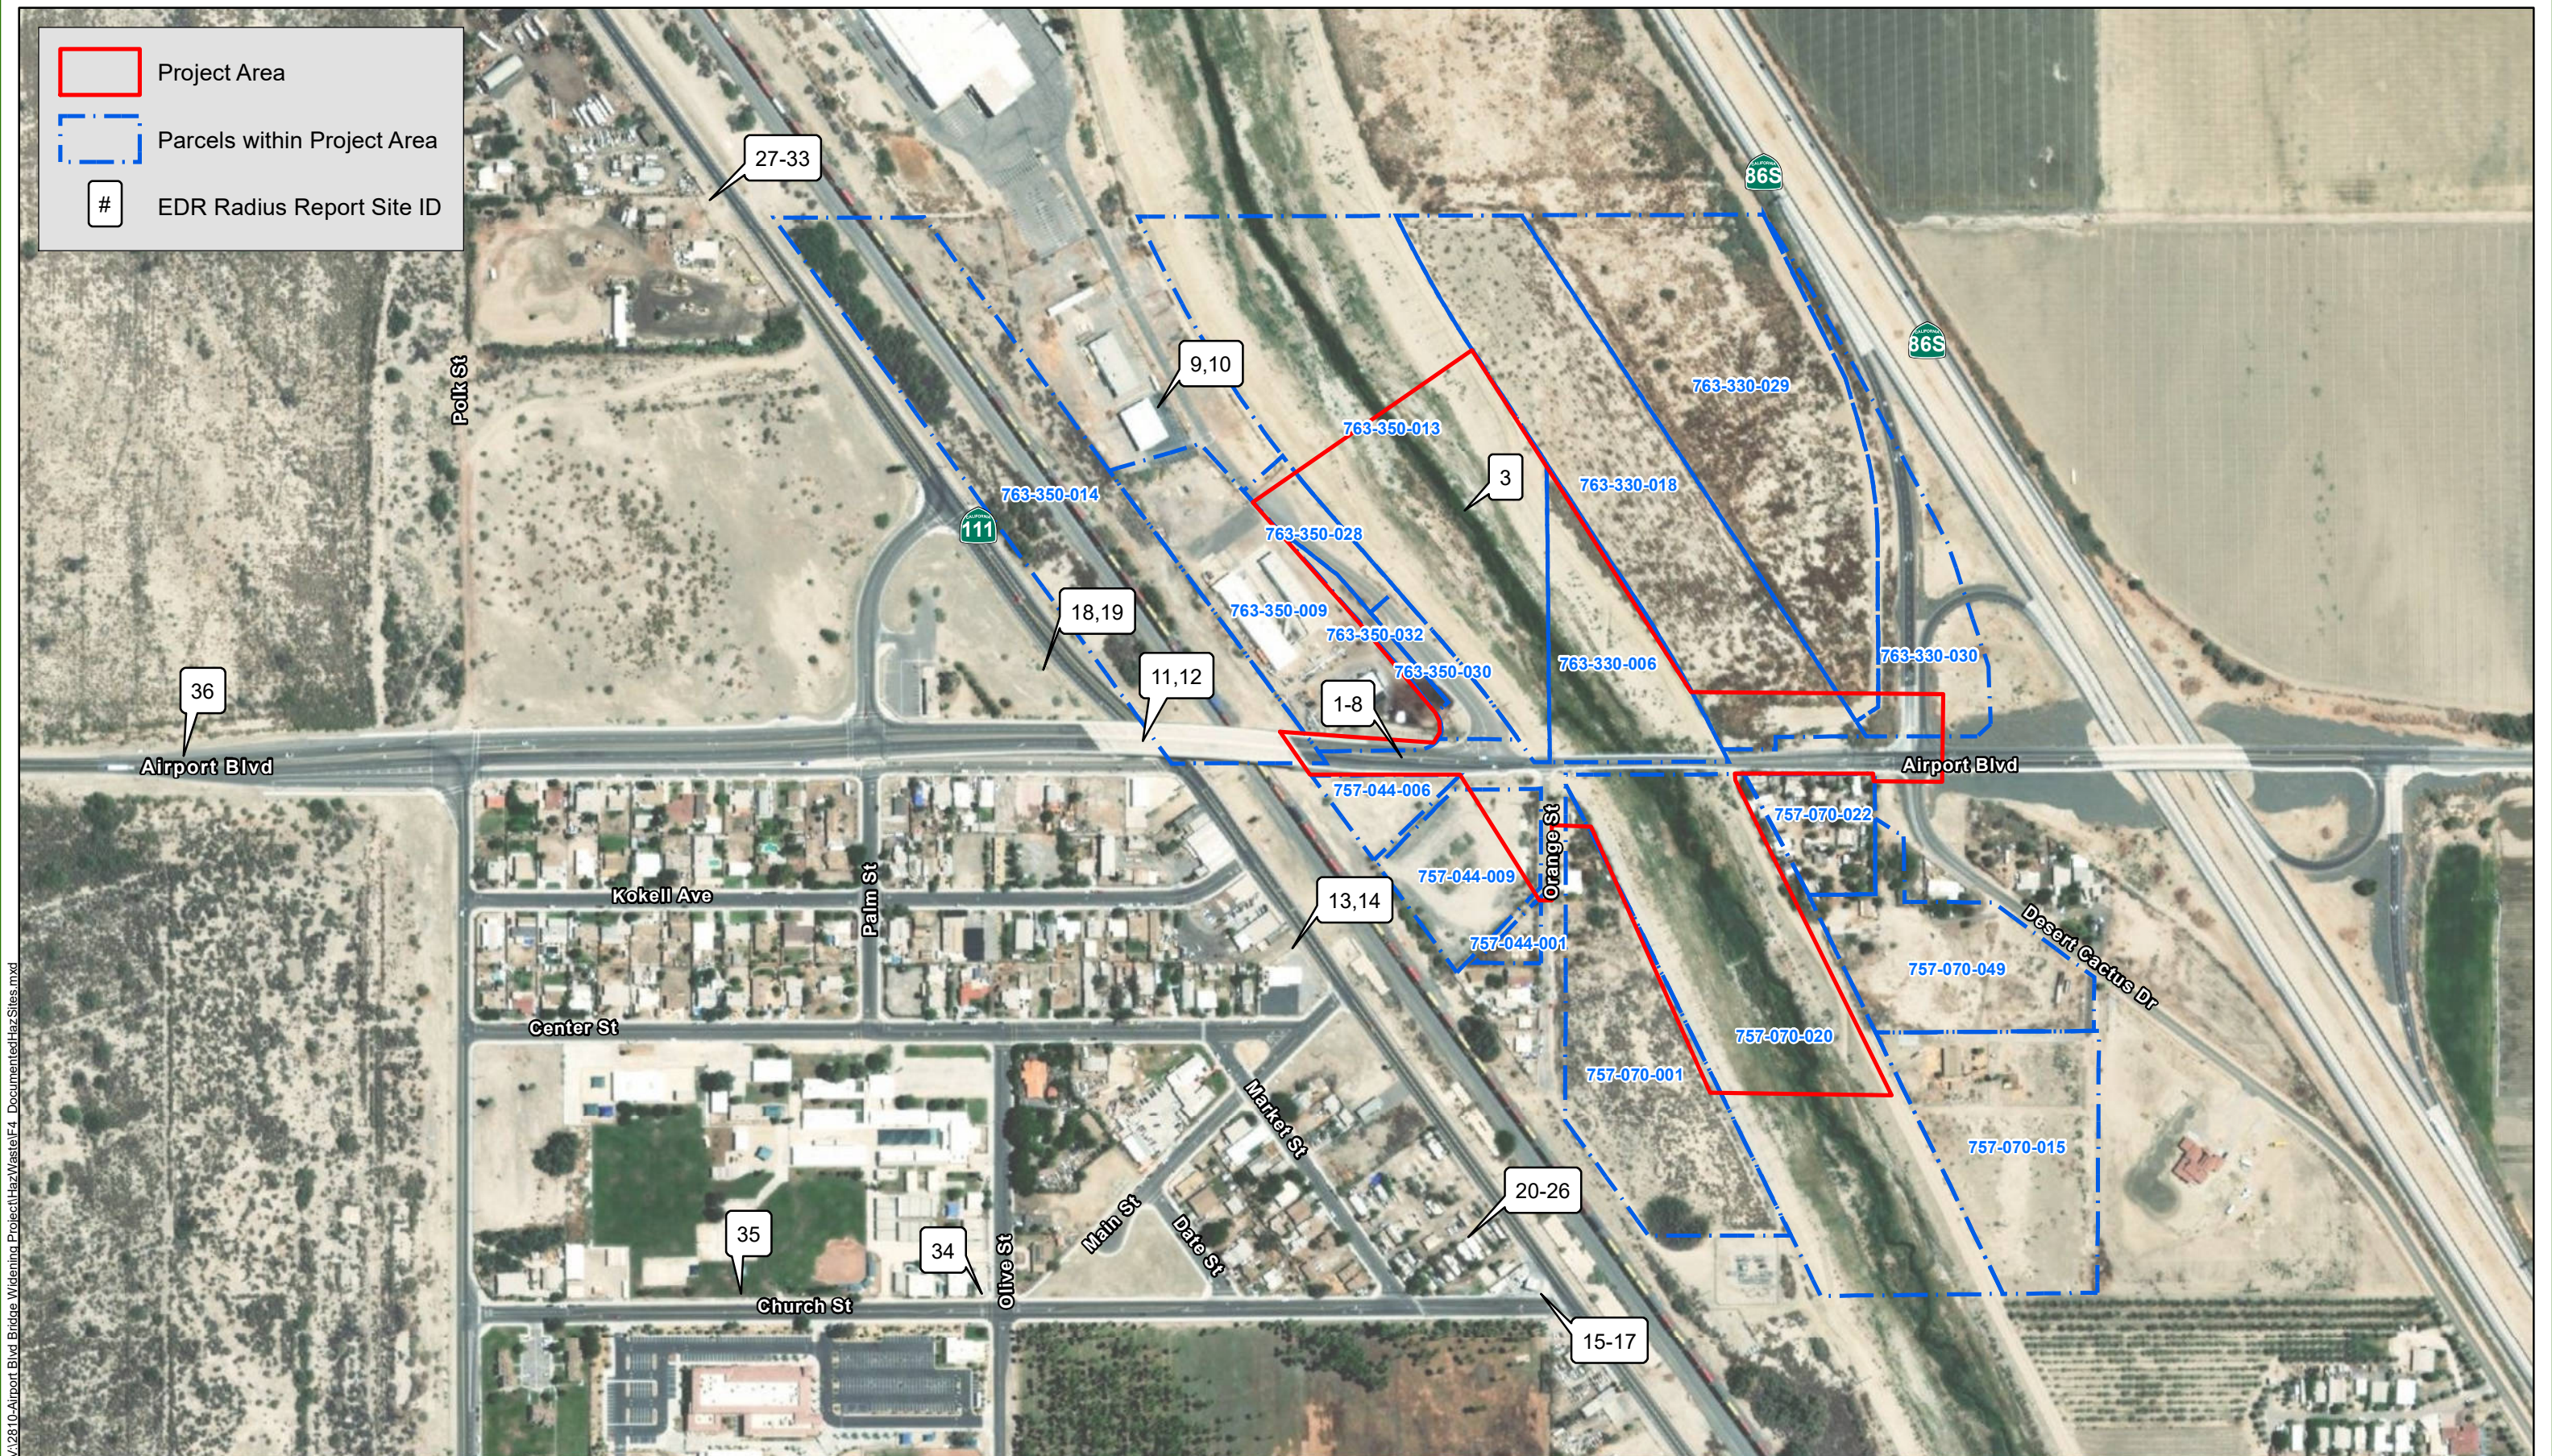
FIGURE 4
Documented Hazardous Waste Sites

Table 4.2 – EDR Sites within Project Area lists sites identified in the EDR Radius Report that are within the Project Area. These sites are also depicted in **Figure 4 – Documented Hazardous Waste Sites**.

Table 4.3 - EDR Sites within ½ mile of Project Area lists sites identified in the EDR Radius Report that are within ½ mile of the Project Area. These sites are also depicted in **Figure 4 – Documented Hazardous Waste Sites**:

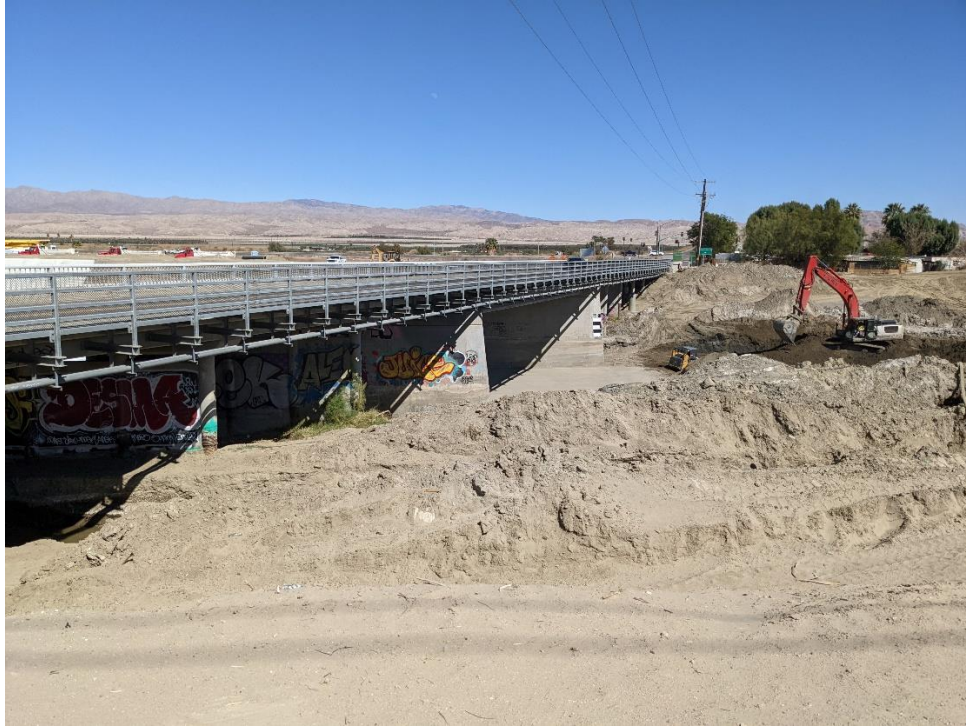
View of Whitewater River, showing CVWD Project currently underway, utility lines attached to the bridge crossing the river, and structural concrete under bridge that may contain asbestos (March 2022). Photo facing northeast.

Location	Description of REC Evidence Found	Description of Associated AUL
①	Airport Boulevard Bridge	The structural elements of bridges, including concrete, were potentially formed with asbestos containing material, if they were constructed before 1975. As the structure within the Project area predates 1975, any structural concrete to be disturbed by the Project may require testing for asbestos containing materials. The CVWD Project is currently lining the Whitewater River with concrete.	None Found

Location	Description of REC Evidence Found	Description of Associated AUL
		Retrofitting the Airport Boulevard Bridge requires the contractor to sample for asbestos containing material prior to bridge work. If available, the results of this survey, once conducted, will be used to determine if any asbestos containing material is within the structural concrete in the bridge; however, if the survey results are unavailable, a preliminary site investigation to conduct sampling and testing of the bridge for asbestos containing material will be conducted. The level of risk for asbestos containing material is low as standard practices for the demolition and removal of material would be implemented if asbestos containing material is found, which have a minimal impact on project cost, scope, and schedule. The sidewalks and handrails were recently constructed in 2021 as part of the adjacent Airport Boulevard Railroad Grade Separation Project and no asbestos or lead is anticipated to be contained in the concrete or handrails. There is no level of risk for the handrails as no hazardous materials have been identified as potentially being affected during construction of this project.

- A preliminary site investigation to conduct sampling and testing of the bridge for asbestos containing material is recommended to be conducted if the asbestos containing material survey results from CVWD channel lining project are unavailable. The preliminary site investigation would occur once site access is granted by CVWD.

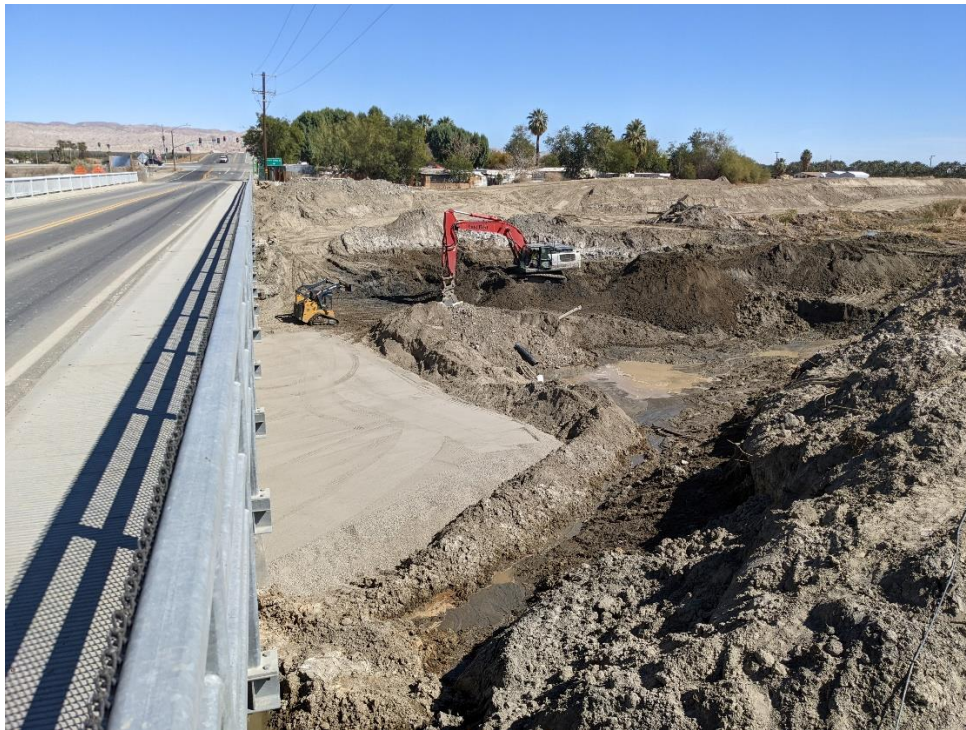
View of Airport Boulevard Bridge and Whitewater River showing recently new yellow striping along Airport Boulevard and new sidewalk and handrail (March 2022). Photo facing east.

Yellow thermoplastic striping was observed within the project area; however, all pavement has been overlain and yellow striping was replaced since 2005 when lead chromate was removed from thermoplastic paint. There is no potential to encounter lead chromate in pavement markings.

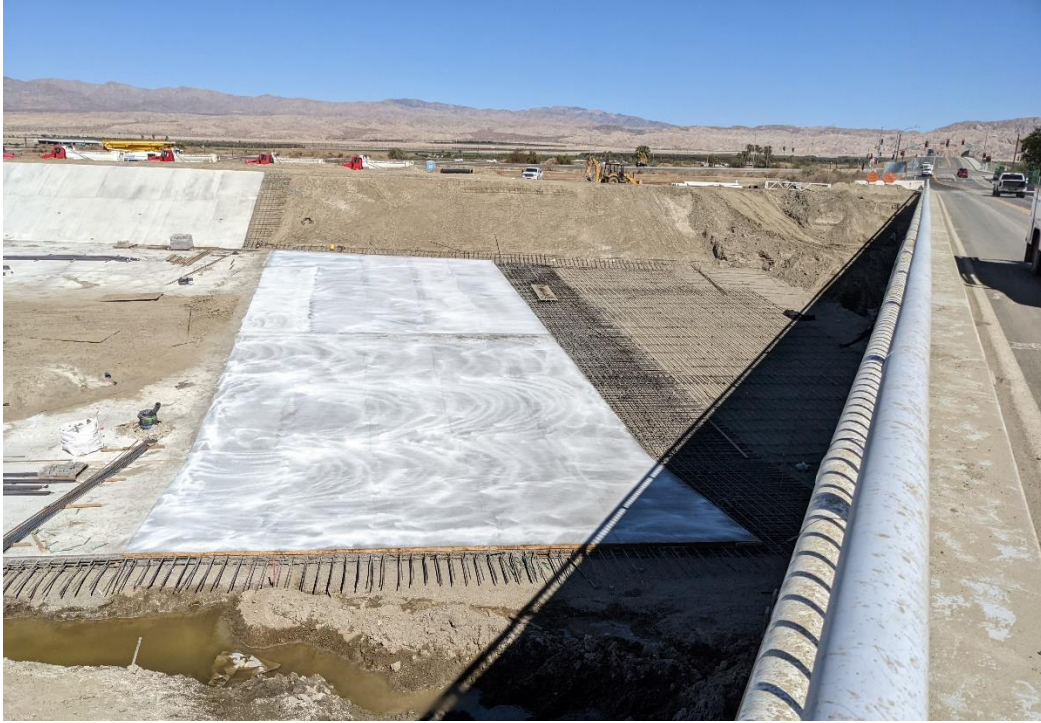
View of Airport Boulevard Bridge and Whitewater River showing new concrete lining under channel (March 2022). Photo facing east.

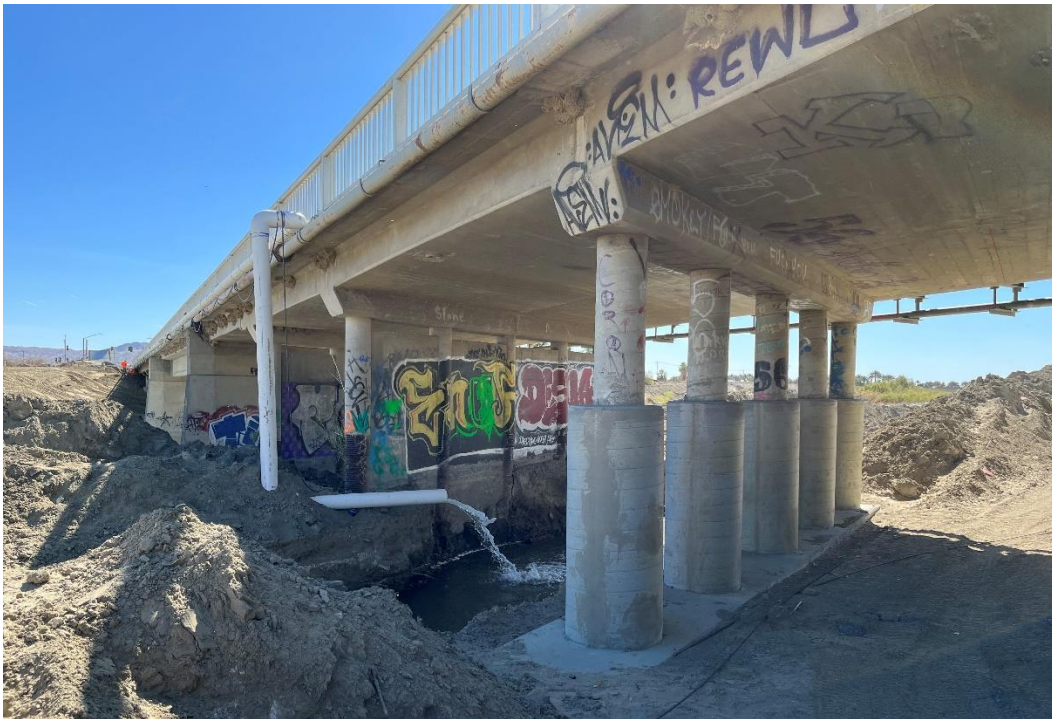
View of Airport Boulevard Bridge columns and exposed footings (March 2022). Photo facing south.

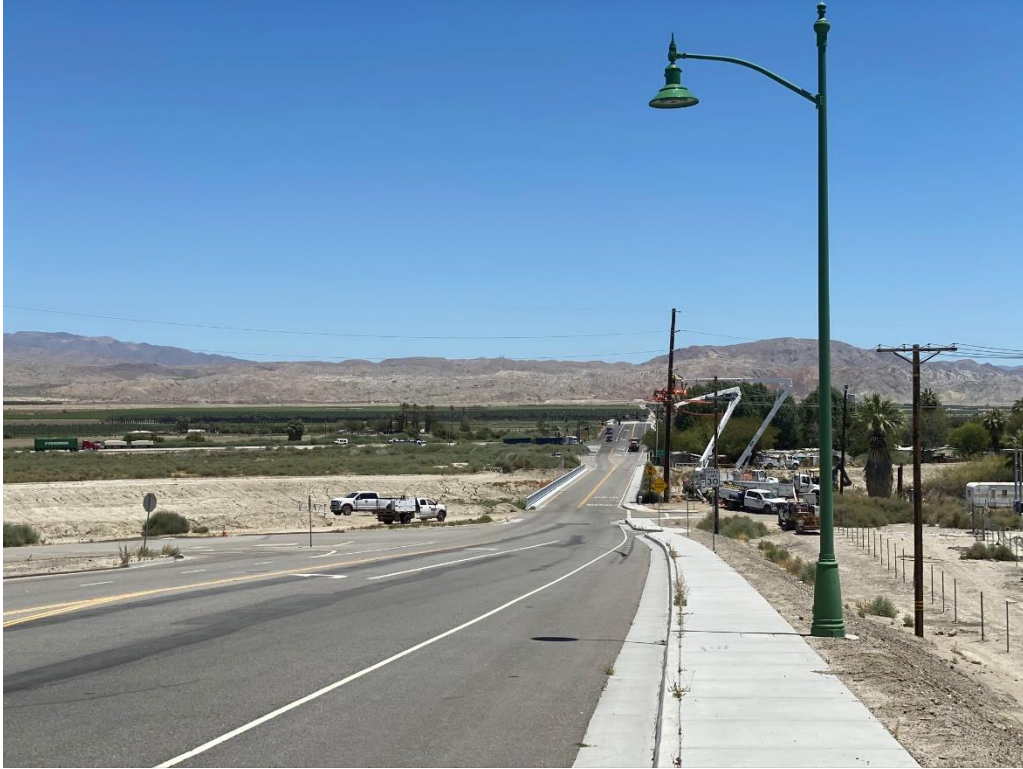
②	Treated Wood Debris	The Project Area contains treated wood utility poles which could potentially be disturbed during construction. Any treated wood encountered would be required to be disposed of as a hazardous waste. The level of risk for treated wood is low as standard practices for the treatment during removal of treated wood debris will be implemented, which does not impact project cost, scope, and schedule.	None Found
③	Various pole-mounted electrical transformers within or immediately adjacent to the Project boundaries.	Potential PCB's in pole-mounted electrical transformers. As of the date of this ISA, the existence and/or levels of PCB's associated with the pole- or pad-mounted electrical transformers, which may be encountered within the planned construction area, had not been determined. The level of risk for PCBs is low as standard practices for the treatment during removal of any encountered PCBs will be implemented, which does not impact project cost, scope, and schedule.	None Found

View of Airport Boulevard Bridge facing East showing utility poles, barren soils, and new yellow striping along Airport Boulevard (October 2020).

- Any chemically treated wood must be treated as Treated Wood Waste (TWW) and disposed of as hazardous waste. For the TWW, Department of Toxic Substances Control (DTSC) regulations §66261.9.5 provide alternative management standards (AMS) for TWW. Caltrans 2018 Special Standard Provision (SSP) for TWW, SSP 14-11.14, is based on DTSCs AMS regulations. This SSP directs the Contractor to follow the AMS including providing training to all personnel that may come in contact with TWW. This training must include, at a minimum, safe handling, sorting and segregating, storage, labeling (including date), and proper disposal methods.

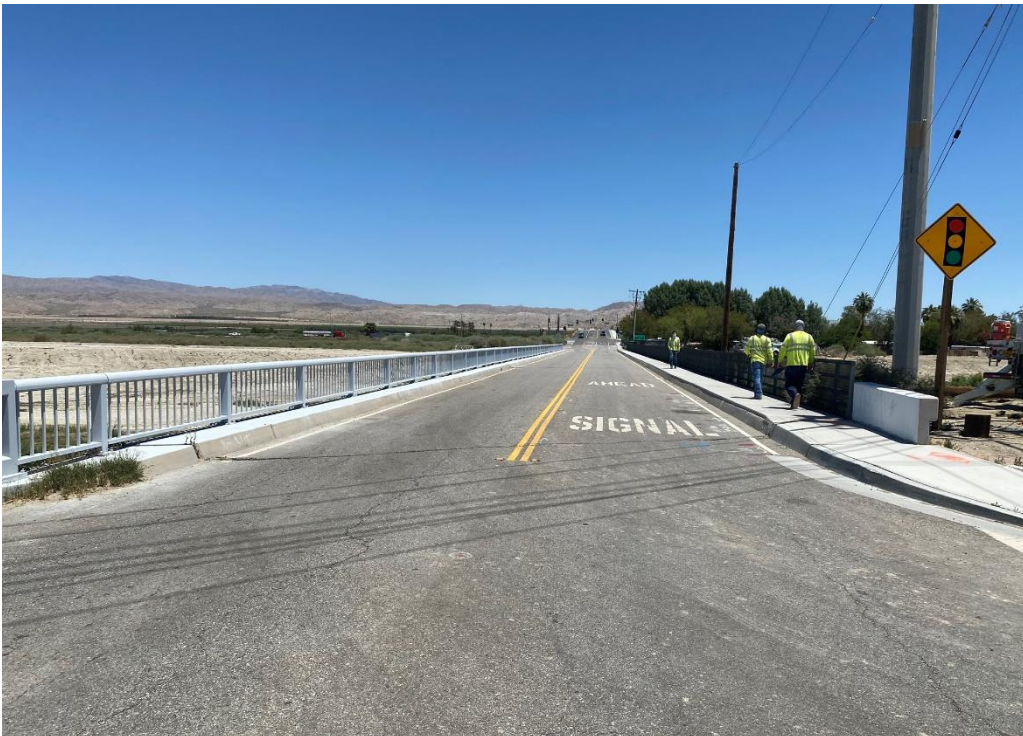
View of Airport Boulevard Bridge facing East showing recently new yellow striping along Airport Boulevard and new sidewalk and handrail on either side of the bridge (October 2020).

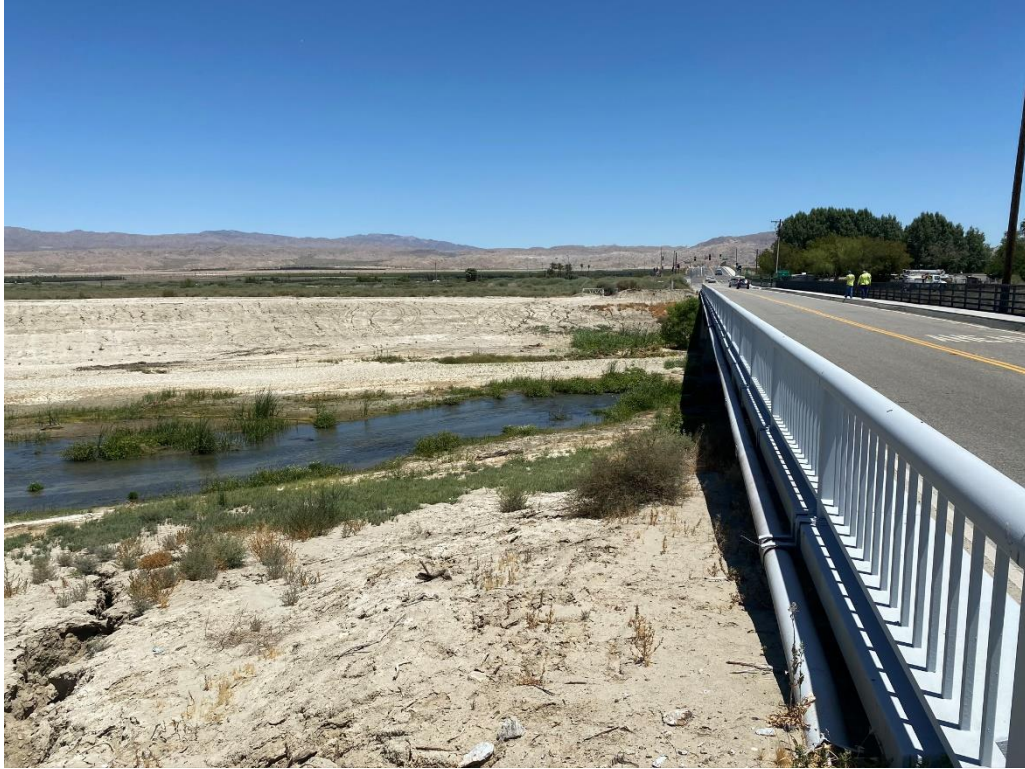
View of Whitewater River facing East showing river channel and utility lines attached to the bridge crossing the river (October 2020).

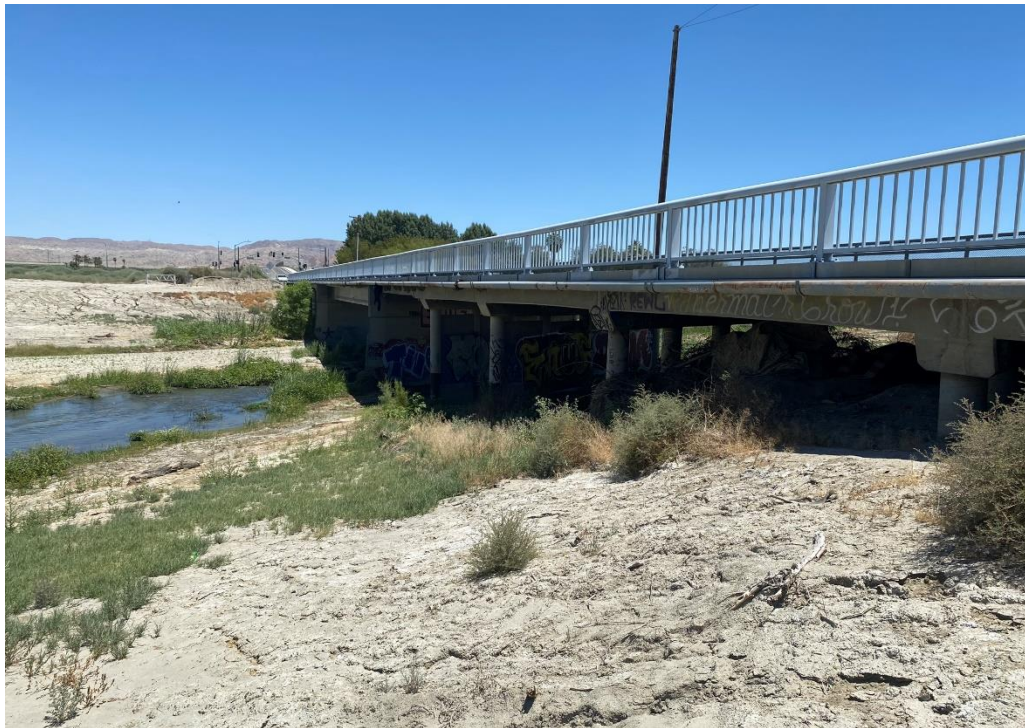
View of Airport Boulevard Bridge over Whitewater River facing East showing structural concrete under bridge that may contain asbestos (October 2020).

part of the CVWD channel lining project, a Preliminary Site Investigation is recommended for Asbestos Containing Material (ACMs) in the existing bridge that will be disturbed during construction. This investigation should be implemented once access to the site is available and will be documented as part of the Phase II ISA.
