Airport Boulevard Bridge Replacement Project NES

Discussion of a Biological Assessment, Aquatic Resources Delineation and Coachella Valley Multiple Species Habitat Conservation Plan Analysis

District 8 – RIV – Airport Boulevard - Approximately 0.10 mile southwest of Postmile RIV R16.861 from California State Route 86

November 2022

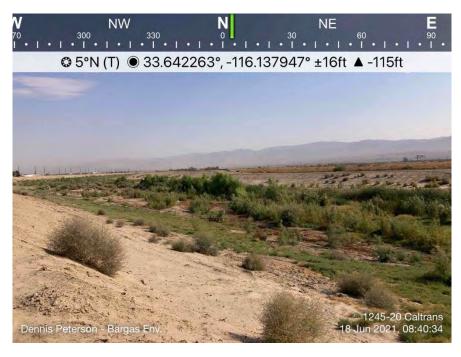
Photo 5. Disturbed area highlighted in the foreground between SR-86 and SR-111 in the northern portion of the project. The channel has been regularly maintained with frequent vegetation removal.

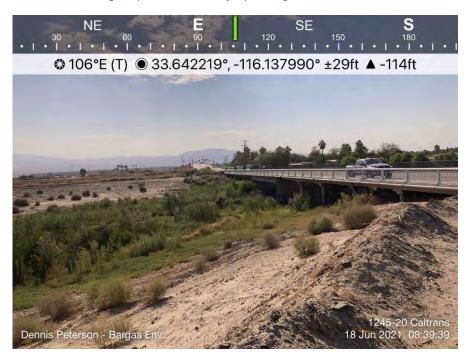
Photo 6. Active channel of Whitewater River with an overview of the Airport Blvd Bridge.

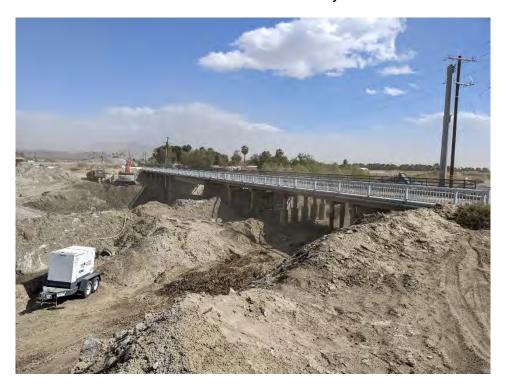
Photo 11. CVWD Stormwater Channel Improvement Project construction lowering the riverbed and replacing Whitewater River with a concrete lined channel at the Airport Boulevard Bridge in March 2022.

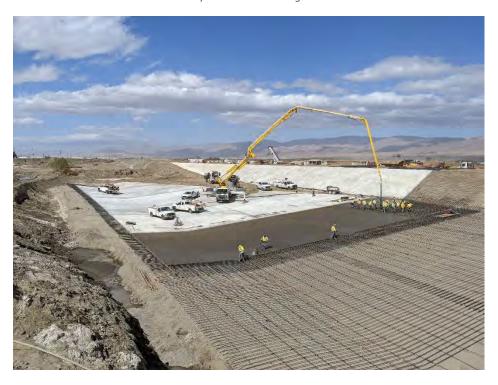
Photo 12. CVWD Stormwater Channel Improvement Project construction lowering the riverbed and replacing Whitewater River with a concrete lined channel at the Airport Boulevard Bridge in March 2022.
